RESTORATION OF HYDRO GENERATORS IN A FLOODED UNDERGROUND POWER HOUSE

SURAJ DHIMAN

*Senior Manger (Mech.), NHPC Limited
Parbati-III Power Station
Behali, P.O. Larji, Distt. Kullu (HP)*

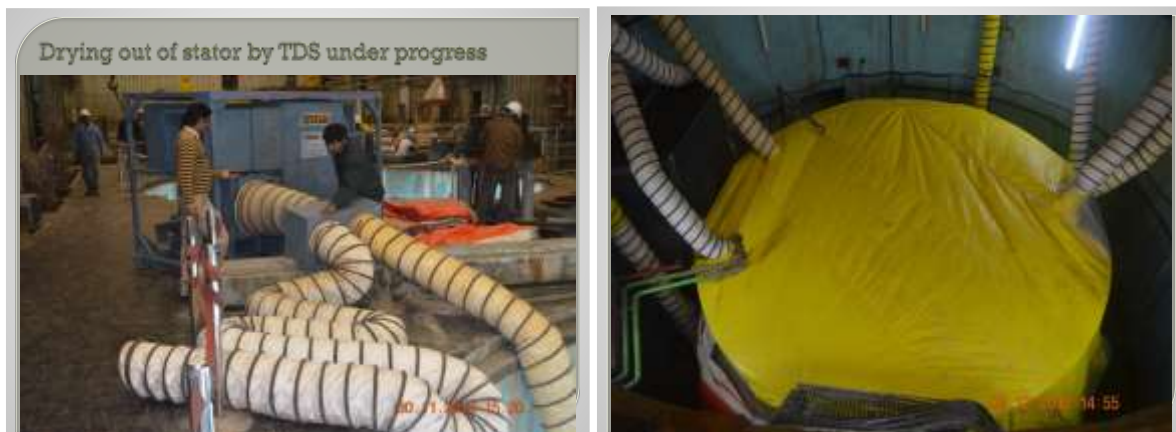
Initially, the dry out was planned through hot air blowers with stator completely covered through tarpaulins. However, no significant improvement was observed in the Insulation Resistance (IR) values.

Figure-1: Dry out of stator through hot air blower

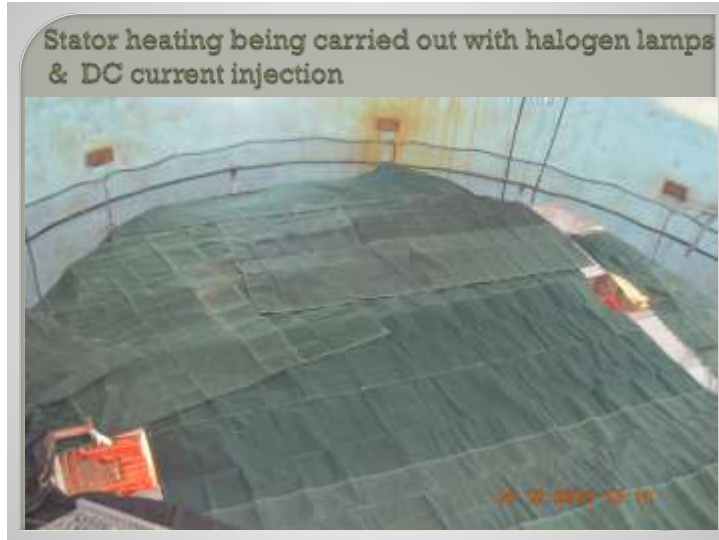
In the next stage, the stator heating was carried out with halogen lamps and DC current injection. Significant improvement in the IR values was achieved at this stage.

Figure-2: Dry out of stator with halogen lamps and DC current injection

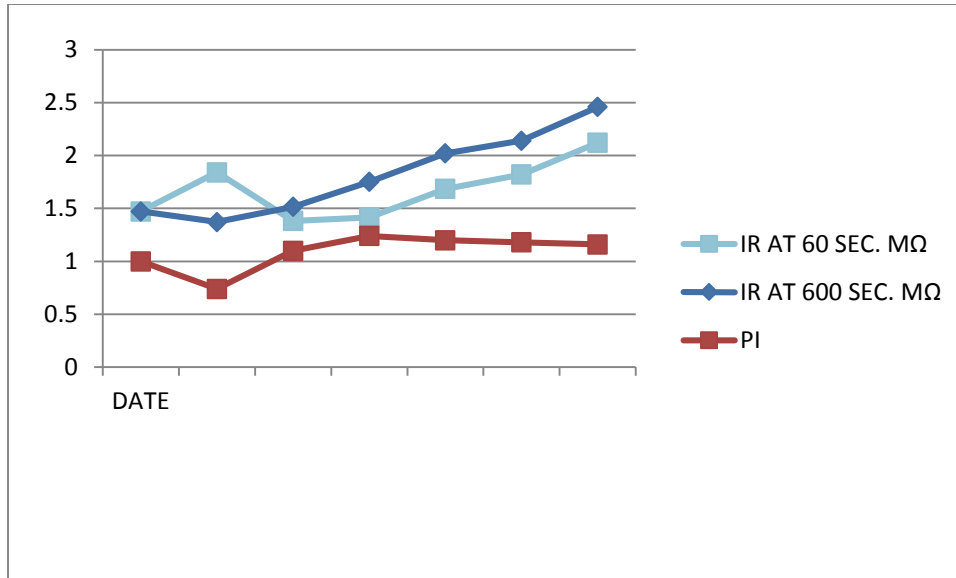
The machine was put under dry run on 14.04.2014. During the dry out process logging of IR and PI values at regular intervals were carried out. The IR and PI values are shown in Table-1.

Figure-3: Graph showing IR & PI values of generator during dry run
