MODIFICATION OF CONSEP ASSEMBLY OF ARU 500 MW CPU NTPC FARAKKA-A CASE STUDY

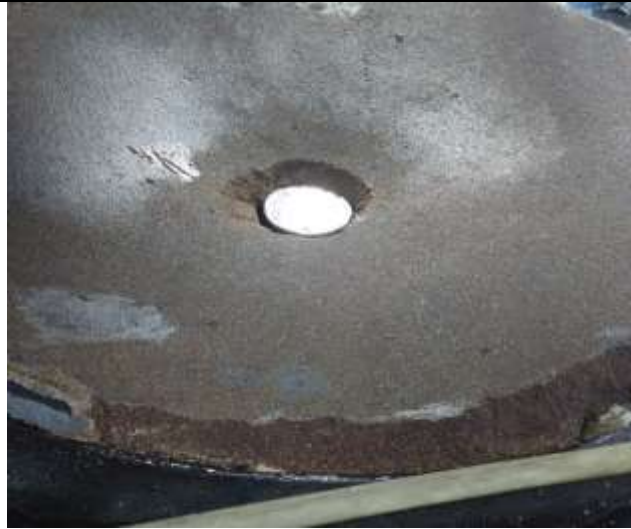
FIGURE 1

After dismantling the bottom CONSEP assembly it was observed that the central disc and its nearby sand matrix has got cracked (Fig1 &2) .It was decided to remove the entire sand material and laterals and collectors were exposed (Fig-4&5). Layerwise samples were collected as shown the figures below .It was found that bottom CONSEP assembly is casted in different size of sand grains and bonded with unknown chemicals.

- 5)Loosening of sand matrix due to sudden impact of air scouring ,backwash water and loosening of adhesive bonding over a period of time figure -1 .
- 6)The high DP across sand bed due to clogging of pores over a period of time figure 2 .

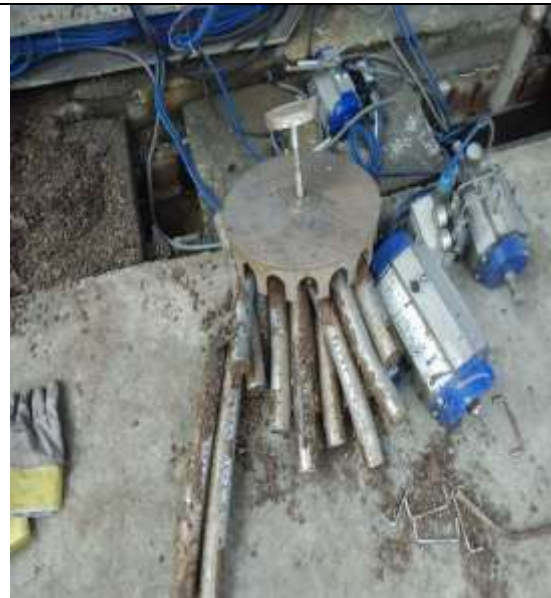
FIGURE 4

- 3)The central spindle was found with welded joint which was a major cause of misalignment which should not be the case with fresh assembly .fig -5
- 4)The holding clamps which should have been mounted as support to lateral members were found embedded randomly scattered in sand layers which means the support was not at all robust .fig -4

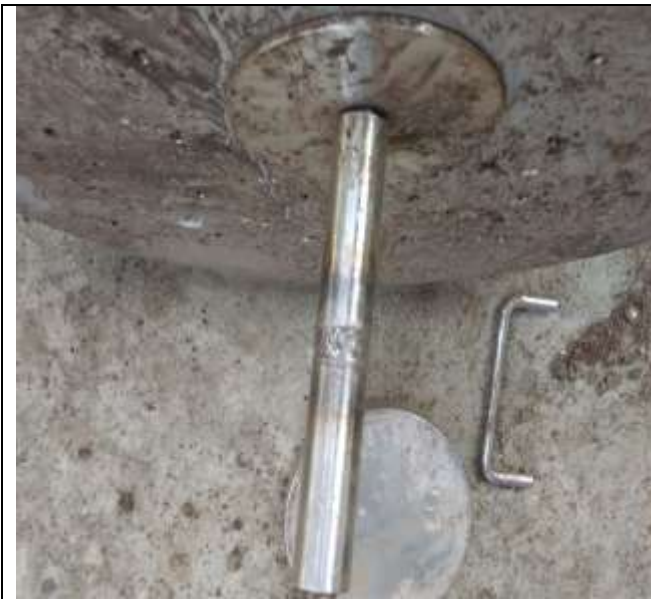
FIGURE 5

- 2)One of the major observation was that at the central portion where a SS disc was mounted over a stud ,the surrounding portion was found damaged .This has happened because of misalignment of central spindle as this was found welded joint and improper casting of sand layers around the disc.fig -5

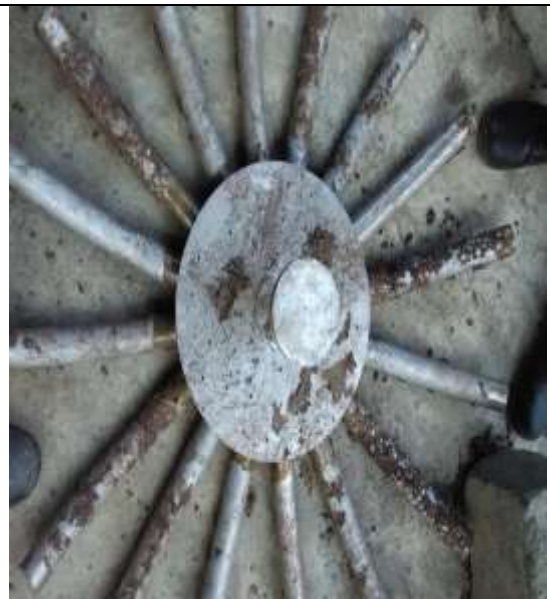
FIGURE 6

- 1)It was observed that distributors and collectors at the bottom most portion were not supported with clips at the end and one end was held by the SS perforated plate.As because the coarse grains near the laterals got disturbed during air scouring and water flow during initial operation of the unit ,the cascading effect continued towards top of the CONSEP assembly developed a crack.fig -6
