# HP TURBINE BREECH NUT REPLACEMENT-JHAJJAR EXPERIENCE

## (500 MW BHEL KWU)

**Vikram Jeet Saini, Manager (TMD), NTPC Jhajjar**  
**Sanjay Nandal, Manager (TMD), NTPC Jhajjar**

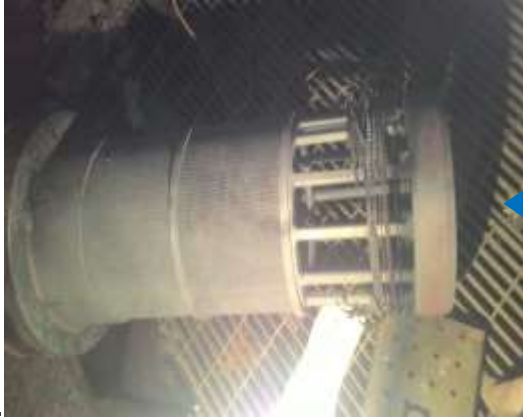
**Damaged MS Strainers-RHS**

The jobs were going on smoothly, but on the 11<sup>th</sup> day while dismantling the MS strainer – RHS found severely damaged, 30% element strips were missing. Total one third portion of element was damaged. Some unidentified pieces also found inside MS strainer. Subsequently the other strainers of HP & IP turbine were also opened and inspected. These strainers were found intact however with some more foreign materials. Hence it was suspected that portion of MS strainer element is passed through HP turbine.

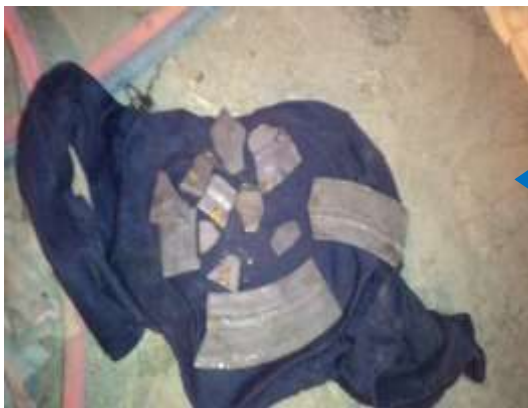
**MS valve stellite liner pieces in**

Unidentified pieces found inside MS strainers were look like seat of stop valve hence inspection of both main steam stop valve carried out by the BMD group. It was found that the stellite liner of MS valve (LHS) on the upstream side was found in damaged condition

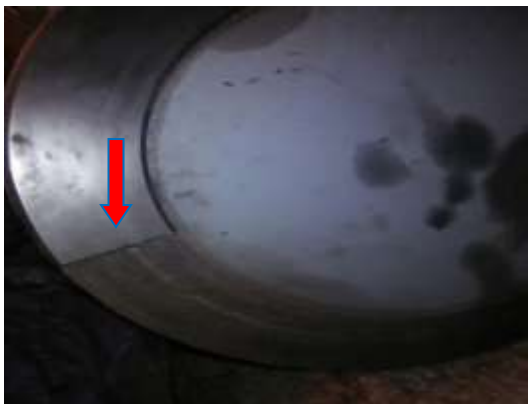
**Damaged valve wedge of MS valve**

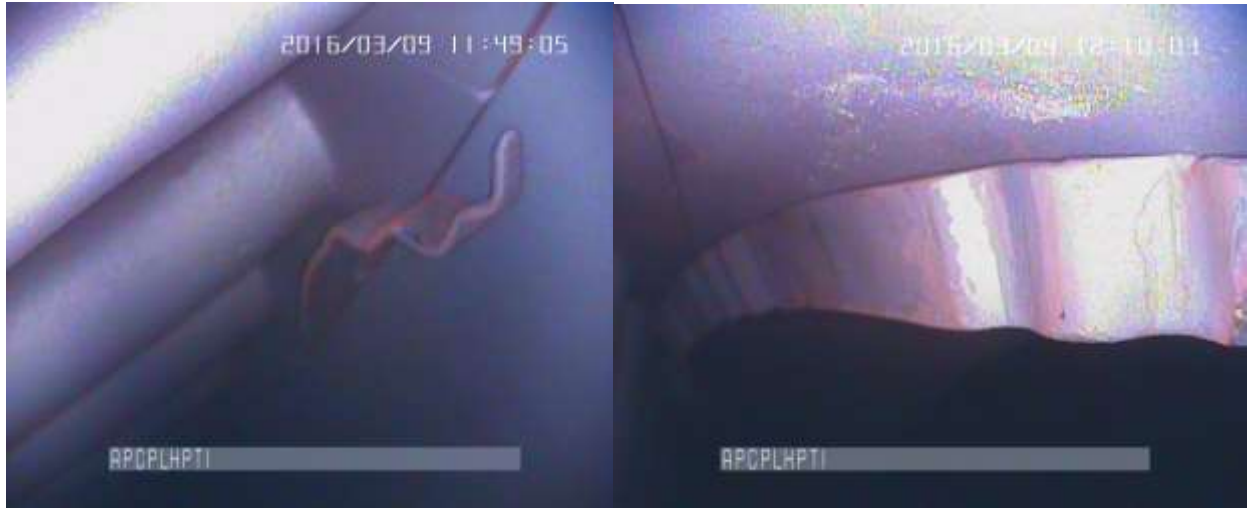
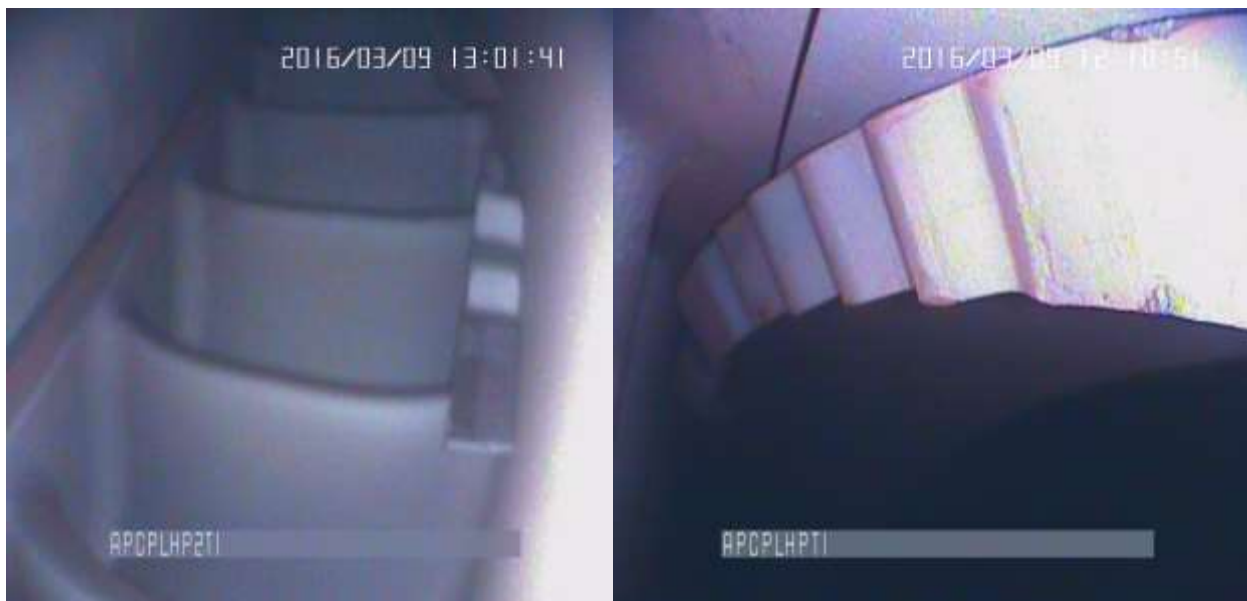
To examine suspected damage, internal inspection of HP turbine was carried out by Boroscopic videography. Few pieces of elements of upto 100 mm length found lying near first stage guide blades.

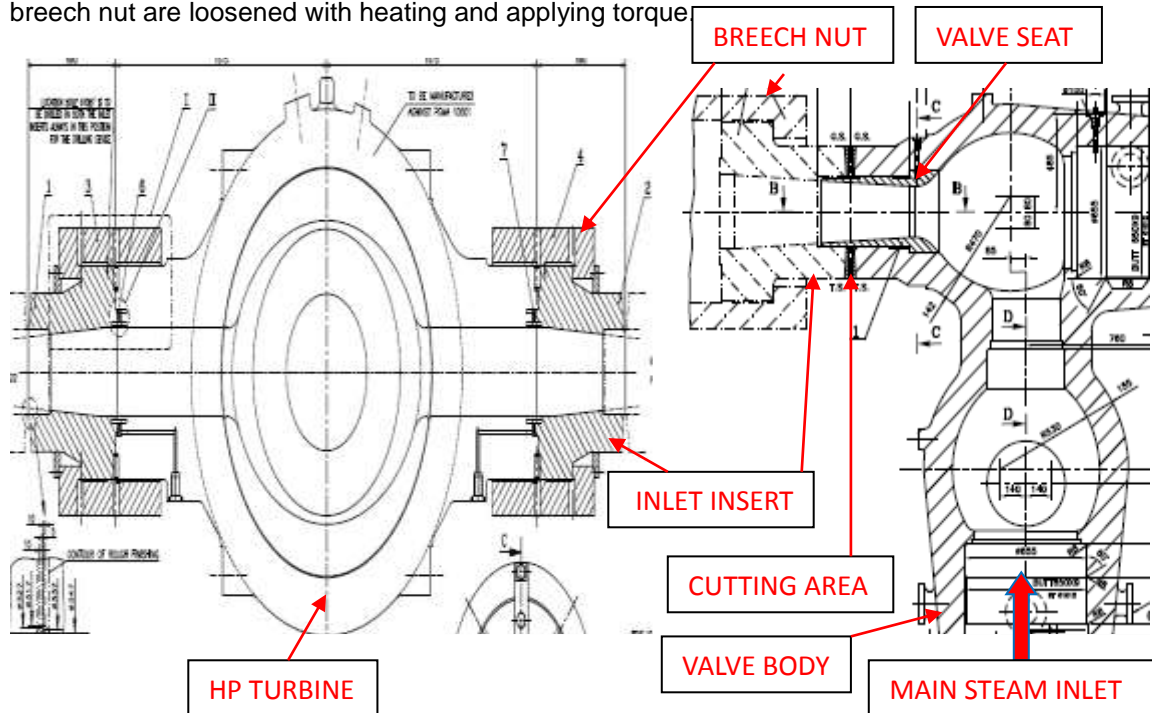
During HP Turbine dismantling LHS Breech Nut jammed after loosening the few threads. Despite repeated attempt of loosening the nut by gas & induction heating up to 400 degree from outside and quenching by dry ice from inside, the nut didn't get loosened. A **C-type clamp** was fabricated for applying torque force on breech nut, but could not be succeed, after the effort of about 8 days. So it was decided to cut the breech nut in consultation with the TG-OS group.

After cutting of breech nut with gauging for 2 days, HP module removed from position and shifted to zero meter for dismantling work.
