Isolated Phase Busbar Connection between Generator and Generator Transformer Bank – A Review

**NTPC LIMITED
INDIA**

Background

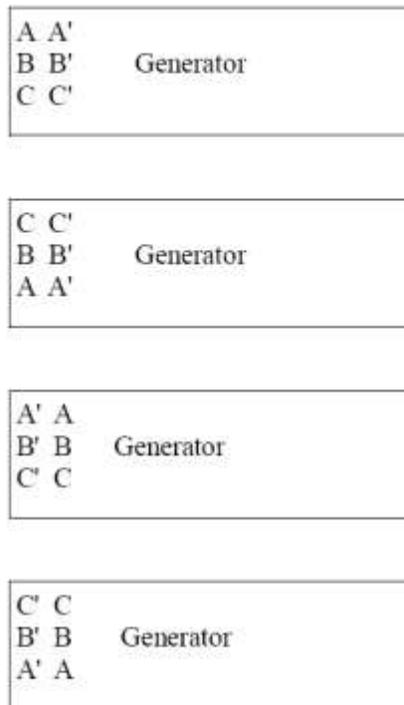
FIG.1 Different Configuration of Generator Terminals

- a) The Transformer manufacturers have different physical orientation of HV Bushing.
- b) The IEEE standard is clear vis-a-vis definition of vector group, whereas IEC standard is not.
- c) The generator manufacturers have different winding bushing terminal arrangement and phase sequence (Fig.1).

The peak voltages appear in time in the order A-B-C-A-B-C-A-... for the given direction of the rotation of field (i.e rotor).

The physical direction of rotation of rotor is associated to the Terminal Markings and the same should appear on the Generator Outline drawings as well as Turbine Outline (or the composite Turbine-Generator) drawings. It is pertinent to mention that the DOR as seen from Generator non-driving end (NDE) is either Clockwise (CW) or Counter Clockwise (CCW). This varies as per manufacturer's standard practices. Different arrangements have been observed even for the same manufacturer too.

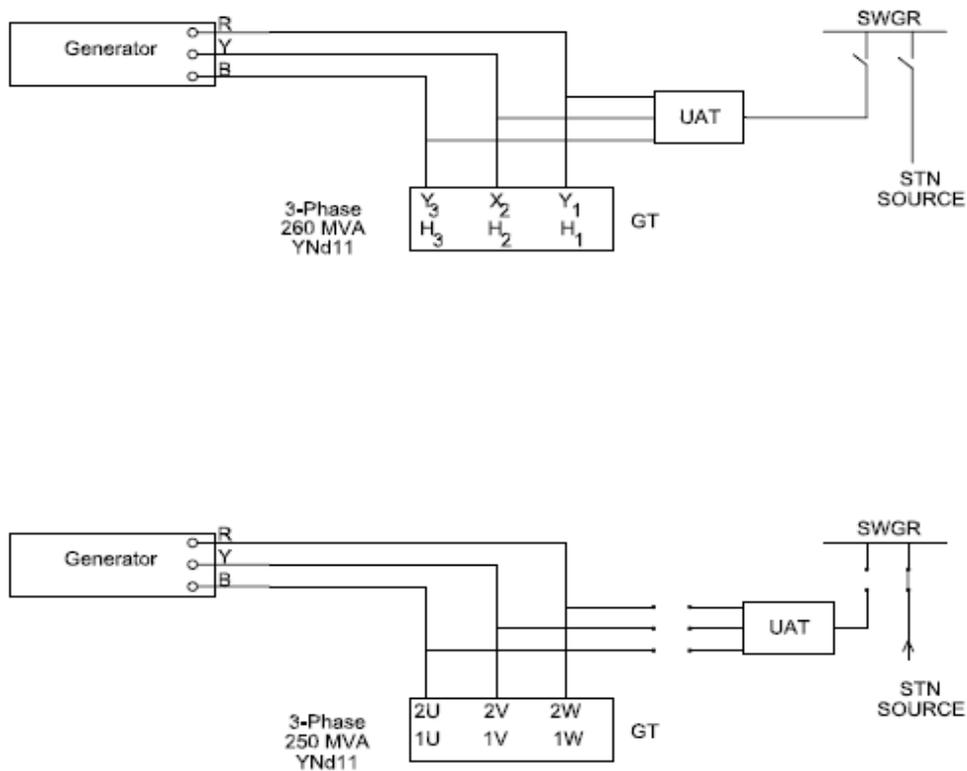
Fig.2 Utility case of 3-phase GST replacement

The issue resulted in availability of large number of transformer with same vector group having different phase sequence and thus a transformer conforming to same vector group (as per nameplate data) is not good for replacement at another power station.

This resulted in mismatch of vector group when user tried to change one make generator transformer with another make. The above illustration discusses the typical case, where user has replaced one transformer

confirming IEEE vector group by another transformer confirming to IEC vector-group.

A temporary solution was reached by disconnecting the UAT (see Fig.1) and restoring the generating unit (with reduced reliability). At a suitable time subsequently, the UT connections were changed internally and the whole system was normalised (involved extra efforts and costs).

The solution lies in matching requirements in IEC and IEEE and also in the National Standards. The IEEE scheme can be adopted.

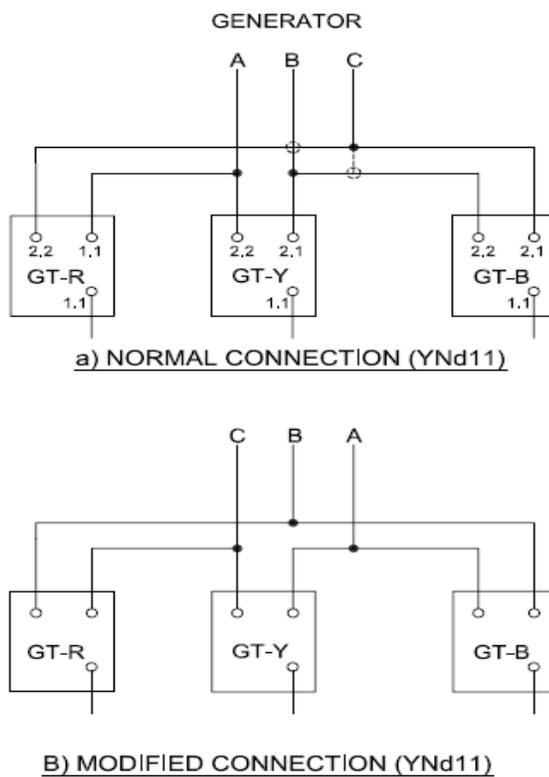
Fig.3 Utility case of Bank formation using 1-phase GSTs

The standard terminals of a single phase transformer are shown in Fig.3. A typical formation to achieve vector group of Ynd11 is also shown.

instance, scheme for future application has been developed where with shifting of one pair of flexible link from one location to other, the phase sequence can be matched/corrected. The scheme works for various combination of Generator phase configuration and bank of single (1) phase transformers provided with standard arrangement of bushing terminals as per manufacturers standard. See Fig.3 of proposed installation.

The action taken for carrying out such changes have been discussed in the paper. It may be noted that the replacement can be done without carrying out any modification in the busduct.

Cost: The scheme envisages an additional of four (4) numbers of T-joints i.e. two (2) in Main run and two (2) in Delta run with necessary cover plate to have the option of flexibility in the standard design.
