# A CASE STUDY OF PARTIAL DISCHARGE AND ELECTRICAL TRACKING IN A 11KV METAL CLAD SWITCHGEAR

#### **CASE STUDY:**

In NTPC Singrauli, there is a Siemens make 11kV metal clad Switchgear named as a Colony Switchgear as supply to the colony and NTPC SSTPS township is taken through this switchgear. This switch gear consists of 14 cubicles having VCB including 2 Incomers and one bus coupler units.

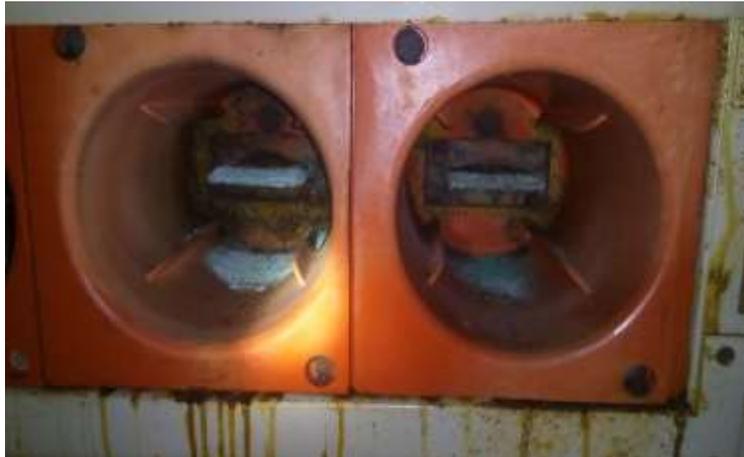
Figure 1

Probably the most noticeable sign of partial discharge is the smell of Ozone, since this is its major byproduct. Early stages of corona may not show any visible signs. Typically the effects of partial discharge on rubber based insulators, tape, and insulation board will leave a white, fibrous powder residue or dust as shown in Figure 1. This dust is the physical breakdown of the material making the material prone to damage as this condition persists.

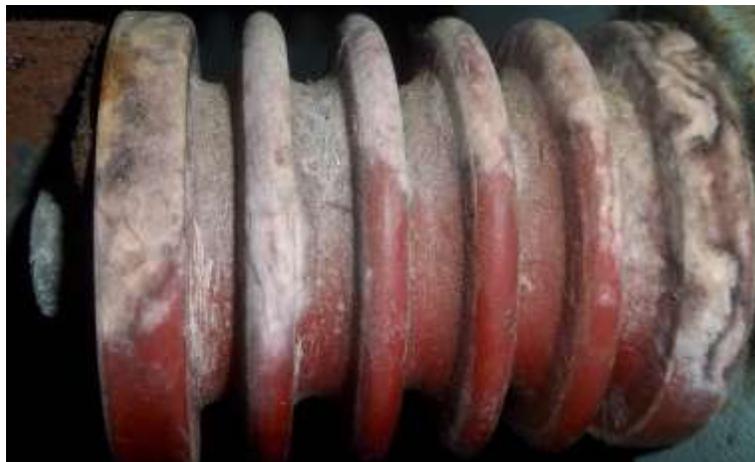
Figure 2

As the condition worsens, carbon track develops on conductors and insulators as shown in Figure 2.

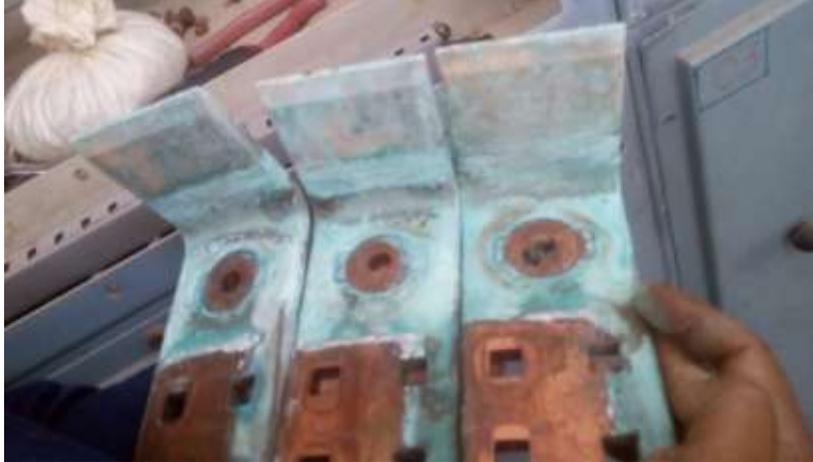
Figure 3

Other indicators include pitting and discoloration on cable and bus bar as shown in figure 3.

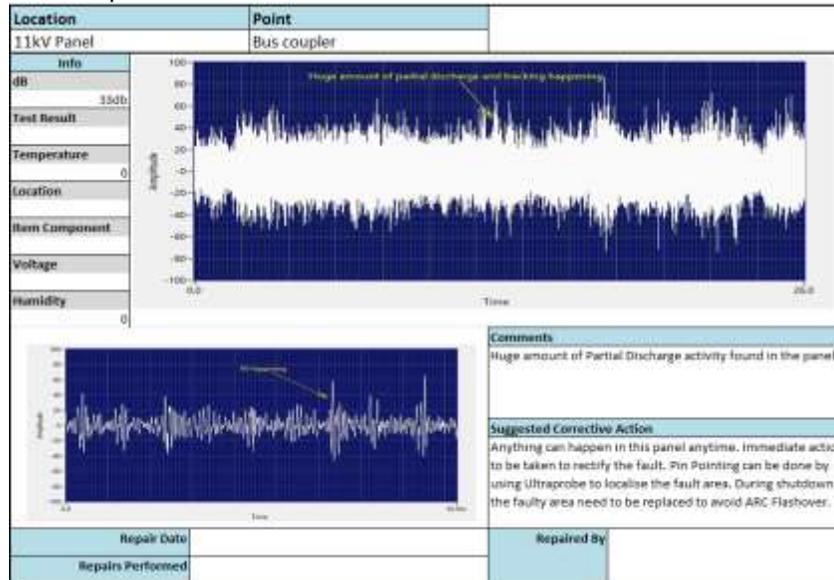
After acoustic Ultrasonic test, we found severe tracking phenomena happening in the switchgear in almost all the cubicles, but the severity level of the bus coupler unit was much more compared to the

other cubicles. The test result associated with the bus coupler unit is shown below in Figure 4 . The bus coupler breaker was in test position.

Just a day after ultrasonic test, a flashover occurred in the bus coupler panel causing damage to the breaker unit and associated insulating components. Both the incomers were tripped on earth fault and over current causing disruption to the colony supply and other associated feeders.

Immediately permit was taken and Isolation was done and confirmed. After opening the bus coupler cubicle we found the breaker unit was carbonized and associated support insulators and other insulating materials were also affected badly.

Now once again the bus coupler unit was diagnosed and the area where corona was seen was analyzed. It was found that the glass fiber insulating sheet was brittle. The glass fiber insulating sheet was the culprit which aggravated the discharge and tracking phenomena was happening because of this. The sheet was taken out, get varnished properly and then placed. After that, the IR value was taken and found okay i.e. greater than 100 Mega ohms.

Cleaning of all the panels were done with acetone and CRC thus removing all the powdered materials and varnishing of bus bar was done. Along with the cleaning, IR values of all the support insulators and spouts were taken. Few insulators and spouts were having low IR values.
