LEARNING BY FAILURES – A TRANSFORMER CASE STUDY

A QUALITY PRESPECTIVE

NTPC, Regional Inspection Office, Bhopal

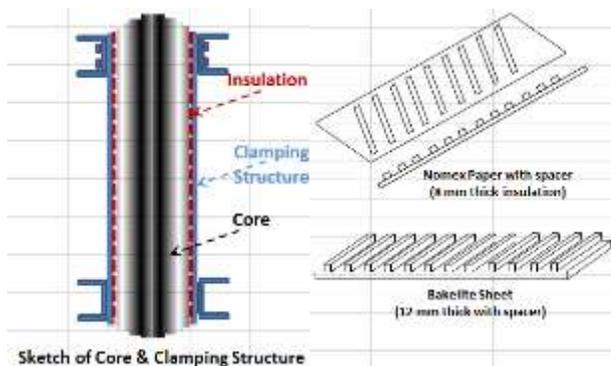
Investigational isolation tests were done by separating various parts of core clamping structure. On investigation it was found that the HV side top and bottom, LV side top structures withstood the test. However, LV side bottom along with LV side clamp plate could not withstand the voltage.

An 8 MM insulation of Nomex paper board was used to withstand 10 KV between clamp structure and core. Although Nomex paper is having good electrical properties but mechanically it is compressible (soft). Due to compression of insulation paper the designed thickness got reduced and the insulation failed to withstand 10 KV voltage.

The details of failure were reviewed by the design group of collaborator and the Indian manufacturer. It was observed that the Indian manufacturer conventionally is using Bakelite plate in between the core and clamp along with paper insulation to provide specified dielectric strength. Bakelite is non-compressive having good mechanical strength and therefore more suited to withstand the technical requirement. Hence, it was agreed that the manufacturing be redone using Bakelite plate after replacement of Nomex sheet.

In this case whole process was rewind up to core building stage i.e. unlacing of core, removal of coils, removal of whole insulation between the core and clamp and so. Now, the Bakelite sheet having channels for oil flow along with nomex paper was used as new insulation between Core laminations and Core clamping structure. After VPD again the

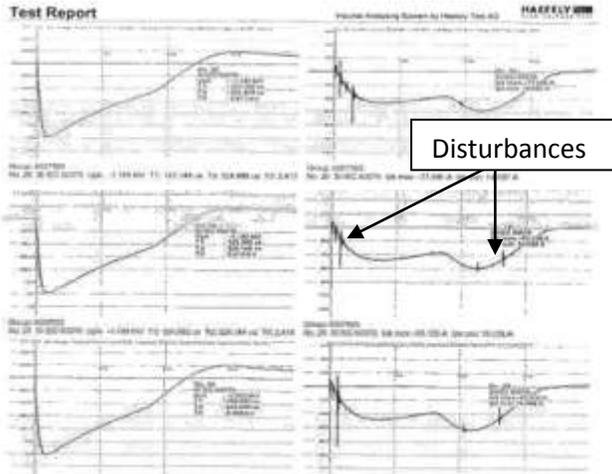
Subsequently switching Impulse test (SI) was conducted. This test was successful on 'V' & 'W' phase HV terminals at 100% test level of 1175 KVp. However, HV 'U' phase terminal sustain the 100% BIL level with no distortion in voltage trace but, **disturbances were noticed in current oscillograms of all three shots, near the starting point and also near end of the current trace.**

Pic 1 : Disturbances observed in current oscillogram.

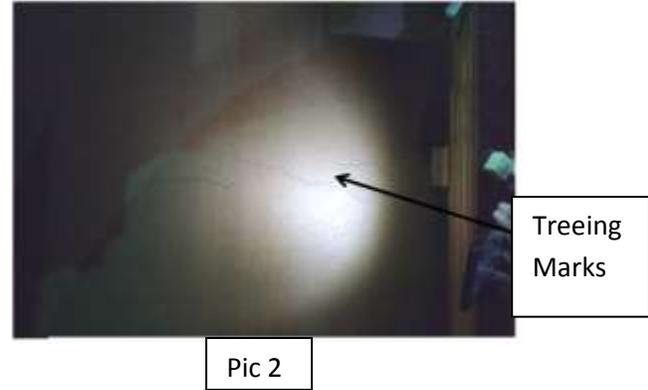
Pic 2

- i. Internal surface of tank was clear and there were no blackening marks etc.
- ii. No abnormality noticed in the vicinity of any HV, LV or Tapping Leads. The OLTC was also clean and there was no abnormality.
- iii. However Tracking/ treeing marks observed on the outer surface of outermost pressboard barrier of U-phase coil (Pic.2). These marks were on diametrically opposite side of HV lead & approximately at centre location vertically. The progression of treeing/ tracking marks was in horizontal direction i.e. along horizontal periphery of outer surface of outermost barrier in the vicinity of high voltage discs.
- iv. No abnormality was observed on inner surface of the outermost barrier.

- a) The failure was a result of surface discharge phenomena i.e. treeing/ tracking on outer surface of outermost pressboard barrier.
- b) Various literatures related to this phenomena was studied and after analysis the phenomena, it emerged that fundamentally such treeing/tracking can be attributed to either of the following reasons :

Problem was due to exposure of outermost pressboard barrier to moisture during bushings mounting at case fitting stage as the dry air contained moisture. Dry air dewpoint was not measured by the manufacturer before using it for the bushing mounting operation.

- A) It was communicated to manufacturer to measure the dewpoint of dry air before its application.
- B) A checkpoint in QAP is also added in which NTPC will verify the dew point of dry air measured by the manufacturer.

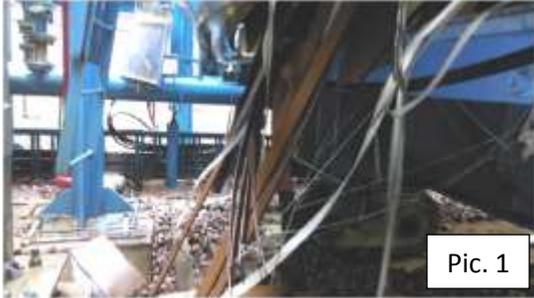
Pic. 1

- a. Top tank severe bulging noticed at rim location on LV side with heavy leakage of oil and fire. Fire got extinguished immediately. (Pic. 1)

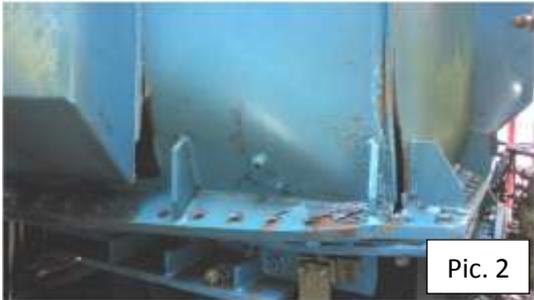
Pic. 2

- b. LV side tank rim badly distorted with the gap of about 8 inches with shearing of rim bolts. (Pic. 2)
- c. LV bushing porcelain at (2.1) terminal found damaged. Clamping member of (2.2) terminal found dislodged.
- d. HV bushing overhead connector found sheared and found disconnected. However HV bushing appeared to be intact.
- e. Bus-duct post insulator in the vicinity of LV bushing connection found shattered.
- f. Although LAVT cubicle of Y & R phases were intact but the LAVT of B phase door got opened with shifting of PT. The associated LA was found damaged.
- g. Buchholz relay found sheared at conservator end. Gas collecting device dislodged.
- h. No damage noticed in the coolers, associated pipe work, conservator assembly, and Motor drive unit and marshalling box of the GT.
- i. The failed GT transported to manufacturer works for further investigation.

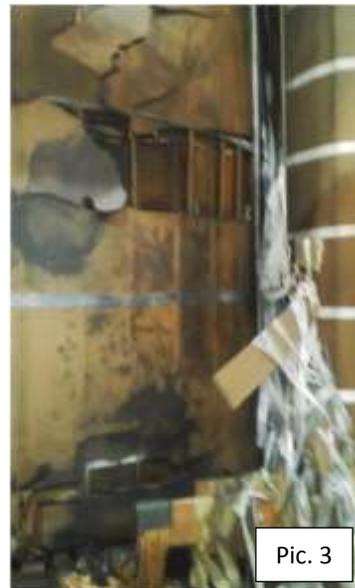
Pic. 3

- b. Coil assembly outer pressboard barriers near bottom LV lead take off (2.2) and upto center height of coil assembly found severely damaged and blackened. Pressboard barrier on other peripheral and near HV line lead take out of coil found intact. (Pic. 3)
- c. Flashover marks found in one of steel bracket of LV bottom lead takeoff busbar support. The Udel wood support of copper bus-bar was found broken and blackened. (Pic. 4)

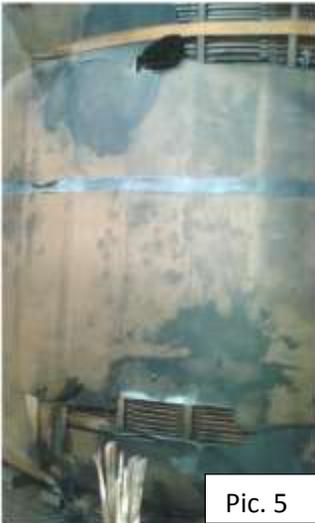
Pic. 5

- e. No physical abnormality observed in core assembly. No physical abnormality observed in Tap changer, tapping leads, HV line lead take off and LV top lead take off (2.1).
- f. HV-II: Pressboard barrier immediately near the winding found blackened and punctured at the middle (line disc of HV winding) at radial location of above bottom LV Lead takeoff. (Pic. 5)
- g. On LV side, out of total 6 nos. pressboard barriers over HV winding, only 1 no. found in position as above. Other 5 nos. barriers were shattered and fallen off from the GT tank opening at site and in transit. Some broken pieces with tracking and blackening marks were found inside the tank. (Pic. 6)
- h. All six nos. HV winding outer barrier sections on the HV bushing takeoff side were found intact with no tracking marks.

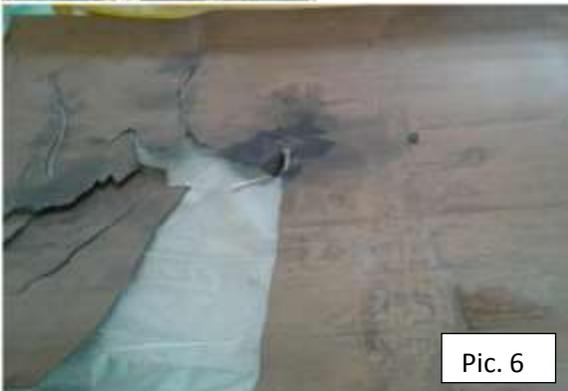
- c. One of the probable reason contributing to the failure could be the presence of certain foreign conducting particle trapped between the two pressboard barriers, causing discharges and further damaging the barrier. This would have been aggravated till the occurrence of arcing and failure. However looking into the nature of treeing/ tracking over significantly larger surface area of the pressboard barriers (Pic. 6) possibility of failure due to foreign conducting particles is very remote.

- d. Based on investigation and analysis, presence of localized trapped moisture in pressboard barrier appears to be the main reason of the failure. In Pic. 6 above, tree shaped white marks seen on the surface of some pressboard piece and black carbonized tree and tracking marks on the surface of another pressboard piece. Excessive moisture content in the pressboard significantly deteriorates dielectric strength on the surface and partial discharge inception voltage is reduced to a much lower voltage level. The white mark is the path of partial breakdown of cellulose due to localized moisture present in the pressboard. The partial discharge forms chain reaction and further aggravates at consistent voltage stress and stimulates the treeing process. The treeing process propagated towards lower/ ground potential and finally bridged the gap of high voltage to lower/ ground and leads to arcing.

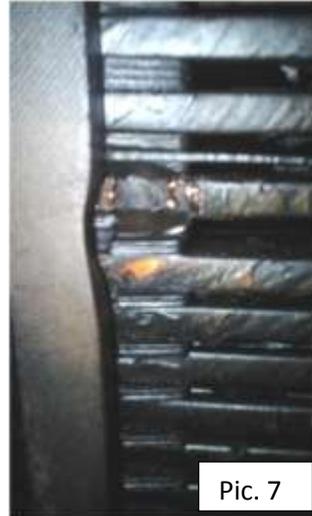
Pic. 7

- i. On removal of barrier, melted HV winding strands at the location of punctured pressboard barrier was observed. (Pic. 7)
- j. No physical abnormalities observed in Tap Winding and HV- I (approx. 15%) winding.
- k. No abnormality observed in Pressboard barriers between HV, TAP & LV windings

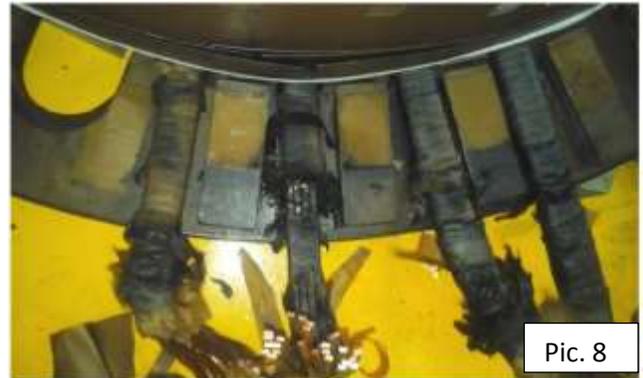
Pic. 8

- l. Bottom LV Lead Take Off (2.2) was found having localized insulation burning and melted copper, immediately below the outer insulation barriers and below HV burnt conductors. The takeoff lead 2.1 and LV winding do not have any other abnormal physical observation. (Pic. 8)
- m. Burning mark of approx. 4 mm dia. and 3 mm deep also found in Udel wood bottom ring support of coil assembly below LV lead burn mark position.

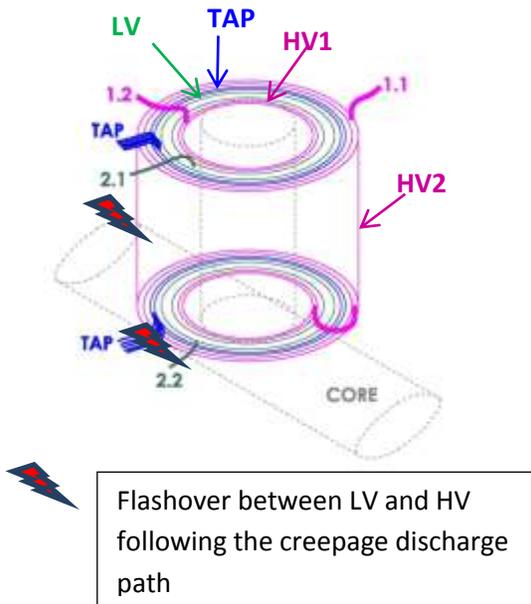
- a. From the observation and further deliberations, it is inferred that the GT failure is due to arcing between 400 kV HV winding line disc to 13.8 kV LV bottom lead take off through outer pressboard barriers. This type of failure mode is unique and no previous incidence of this nature has been experienced.
- b. There was a ground fault also inside the transformer after occurrence of the fault which is corroborated with physical finding of flashover marks on one of steel bracket (ground potential) of LV bottom lead take-off bus-bar support.**(sketch of failure)**
