REPAIR, RESTORATION & RETROFITTING OF IN SERVICE CONCRETE STRUCTURES IN POWER PLANTS

Satish Sharma, TVG Reddy & Ankit Sharma
National Council for Cement and Building Materials

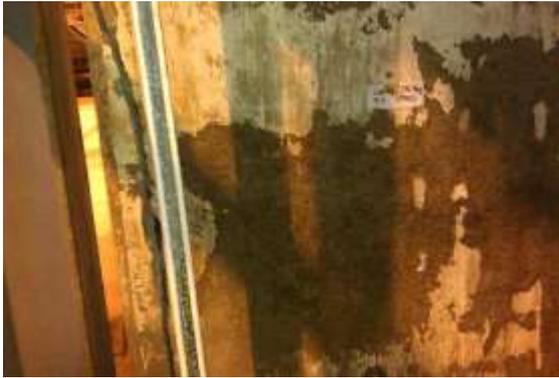
Visual Survey: During the visual survey, distress in the form of vertical cracks, spalling of concrete and exposure of corroded reinforcement was observed at different locations in the RC Columns as shown in fig. 2 & 3. Only two faces of two RC Columns were found distressed due to abrasion/erosion of concrete surface due to constant splashes of sea water leakage from pipes adjoining the RC Columns.

Fig. 2: Shows vertical crack and abrasion of concrete surface in RC Column located in power house near sea shore

1. Removal of all soft and loose concrete from the visible distressed portion and chipping using light hammer (2lb hammer)
2. Cleaning of rust wherever required followed by anticorrosive treatment.
3. Applying two component epoxy bond coat conforming to specifications of ASTM C 881 - 13 TYPE II to ensure the effective bond of old substrate obtained after chisel cutting of cover concrete and new concrete.
4. Applying the Polymer Modified Mortar (PMM) to build the profile of structural members in damaged cover portion as per ACI Committee report (ACI 548.3 R-03).
5. Strengthening of distressed RC Columns using indigenously available nonmetallic composite fiber wrapping system.
6. Applying protective coating on surface of RC Columns to protect from the further corrosion to reinforcing bars.

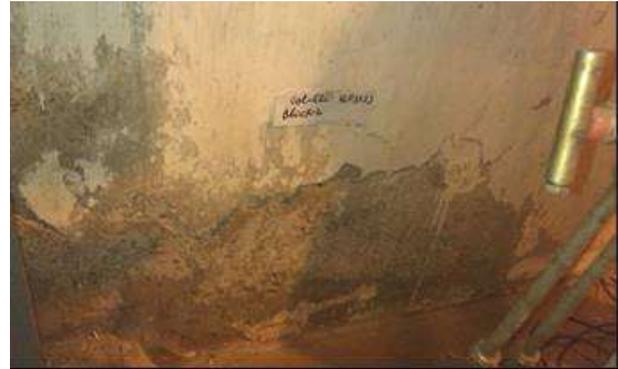
Fig. 3: Shows horizontal crack and abrasion of concrete surface in RC Column located in power house near sea shore

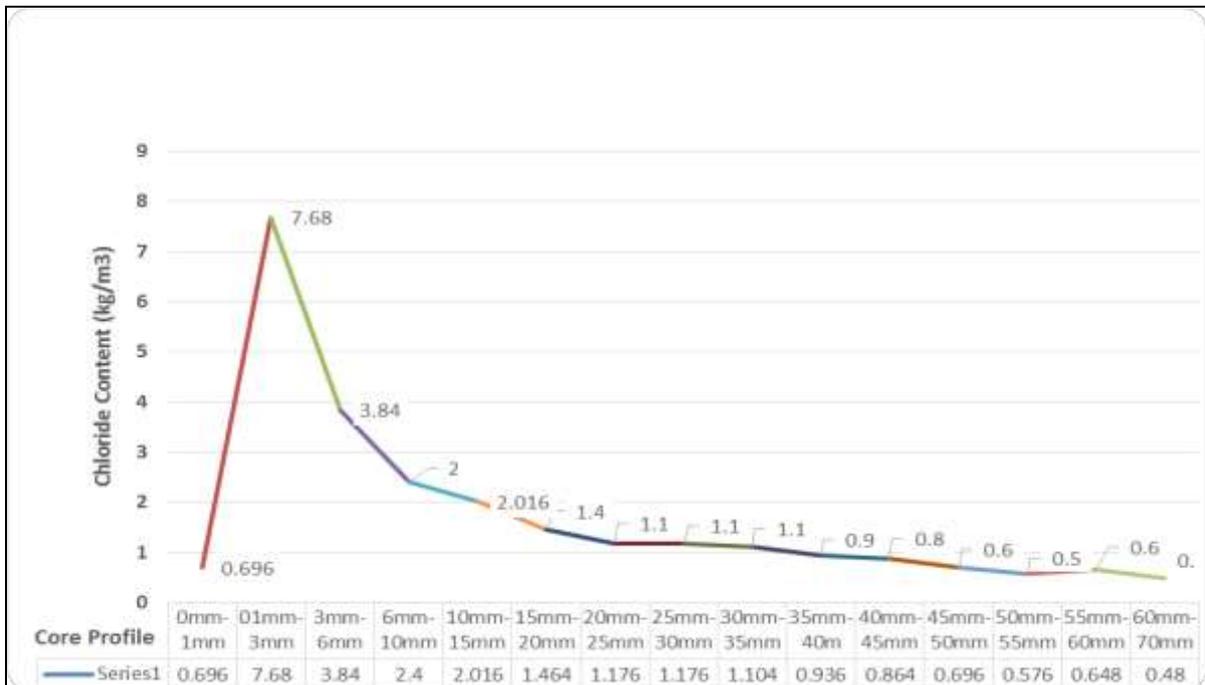
During the field and laboratory investigation it was found that the amount of chloride in the cover portion of the concrete was very high and it reduced as the depth increased. The pH values were also found to increase with depth. The sulfate contents were found to be within prescribed limits. The water used was sea water. Test results of water sample drawn from the pipes adjoining the RC Columns indicated excessive chloride, sulphate, organic & inorganic matter was beyond the prescribed limit of IS 456 – 2000.

Fig 4: Test results of chloride content of RC Column located in power house near sea shore obtained after profiling

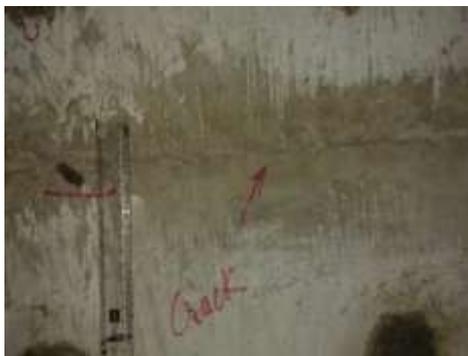
The investigated RCC structure is 25 years old 210 MW Turbo Generator (TG) foundation with turbine running @ 3000 r.p.m. While in operation, the TG stopped due to excessive vibrations caused by sudden appearance of cracks (refer fig. 5) on the surface at different locations of RCC columns supporting the TG Deck. The width of crack at the surface of different RCC columns was assessed by using optical Crackscope (refer fig. 6). Width of cracks when measured by using Crackscope was found to vary from 0.5mm to 1mm.

Fig.5: Horizontal Crack in RCC Column C11

Based on the tests conducted, it was found that the quality of concrete in the top portion of the RCC columns i.e. portion between horizontally aligned cracks & soffit of TG Deck, was considerably lower as compared to the portions below the level of the horizontally aligned crack. Results clearly indicated the presence of voids/honeycombing in the top portion up to -500mm below TG Deck soffit in various RCC columns. The presence of honeycombing was verified by extracting core samples from the effected portions of the RCC columns. The poor quality concrete in upper portions of the columns could not withstand the vibrations of TG deck over the period and lead to cracks which in turn increased vibrations and thus further increase in distress.

The main objective of the repair and strengthening of RCC Columns supporting TG Deck was to develop a repair scheme to resist/eliminate the chances of appearance of cracking during operation/functioning of TG for power generation using indigenously available technology. After careful evaluation it was decided to use multiple epoxy grouting system (refer fig. 7) to fill the large and small voids and to repair the cracks found in the upper portions of columns. But even with extensive grouting, strengthening only could have been achieved and weakness would have remained, strengthening of upper part using GFRP wrapping system was also recommended.

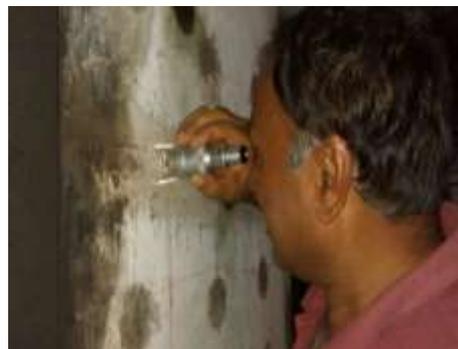
Fig.6: Crack width being assessed by using Crackscope at site

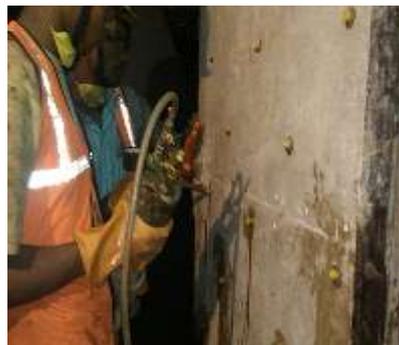
Fig. 7: Grouting being done in Column C11 of TG Deck Unit#1

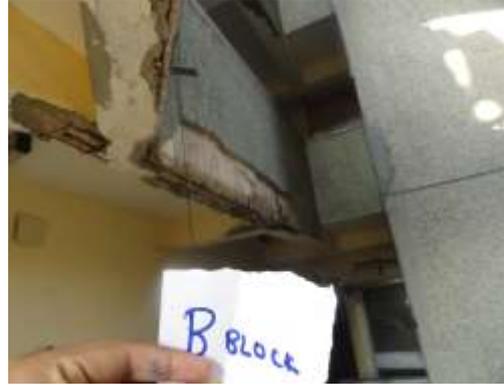
Distress in the form of cracking, spalling of concrete & corrosion of reinforcing rebar was observed at work site in different RCC members of different blocks of the society. Cracks were observed along the longitudinal direction of reinforcing rebar. Based on the geometric line of cracks, it seems corrosion has caused these cracks. Grit wash applied on the RCC members of different blocks was found to be de-bonded at many locations. Water Proofing was observed to be damaged in terrace. The quarters were 16 years old.

Fig.9: Spalling of concrete & exposure of reinforcement In RCC Beam

The test results were analyzed to work out the cause and extent of damage and find out the suitable specifications for repair. Based on Ultrasonic Pulse Velocity & Rebound Hammer testing done on representative samples by random sampling technique on RCC Columns, RCC Beams and RCC Slabs, overall quality of concrete is graded as ‘ Good’ and ‘Medium’ at some locations. The test results of concrete cores indicate that the equivalent cube compressive strength values for RCC Columns/beams/slabs is found to meet the specified characteristic compressive strength of M20 grade concrete. Based on the half cell potential measurement, corrosion is found to be alarming state in RCC Columns whereas in transit state of corrosion at few other locations. Carbonation is found to be within the cover of concrete. Chloride was found to be beyond the specified value of 0.6 Kg/m³ as per IS 456:2000. Hence the cause of damage for distress in structure is found to be chloride content. Based on the cause & extent of damage, repair & strengthening measures are recommended.

- (i) Removal of all soft and loose concrete from the visible distressed RCC members and chipping using light hammer (2lb hammer) from RCC Columns/beams and slabs.

- (ii) Cleaning of rust from corroded reinforcing steel and providing additional steel bars wherever required to compensate for corrosion losses followed by anticorrosive treatment.

- (iii) Applying concrete penetrating corrosion inhibitor (CPCI) as per manufacturer/supplier specifications over the entire finished surface.
- (iv) Applying two component epoxy bond coat conforming to specifications of ASTM C 881 - 13 TYPE II to ensure the effective bond old substrate obtained after chisel cutting of cover concrete and new concrete.

- (v) Building up the profile using Polymer Modified Mortar in 15-20 mm thick layers with application of bond coat between each layers.
- (vii) Strengthening of distressed RCC Columns using nonmetallic composite fiber wrapping system.

- (viii) Applying protective coating on surface of RCC Columns/beams/slabs to protect from the further corrosion to reinforcing bars.
