# **KOLDAM SPILLWAY GATE FAILURE**

**Anand D Varma, Prahlad Halder & Y Ravi Kumar**

Metallurgy & Failure Analysis laboratory, NETRA, NTPC LIMITED

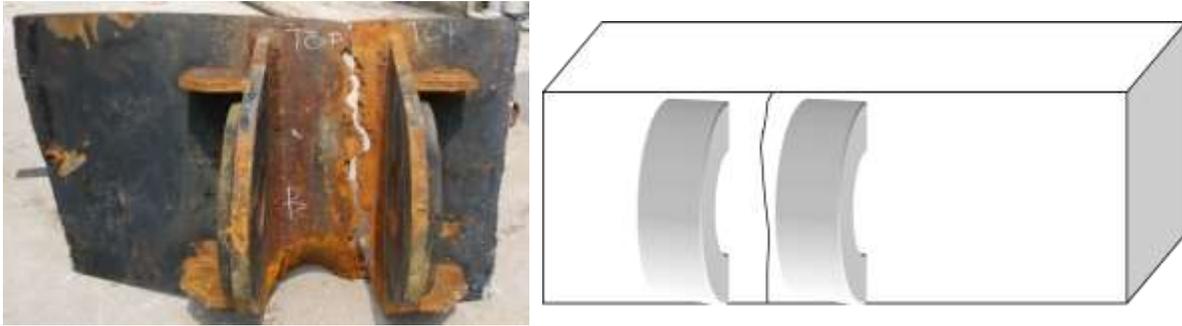
During inspection by site, it was observed that front plate of the rectangular box beam/girder was found sheared in between the lifting brackets. The plate between the spindle support flanges cracked in the middle. The beam plate

got detached from the girder plates on either side due to the tearing of shop welded joint along the length of girder. (Fig-1). Secondary damages were also observed (Fig-2). Representative samples were collected from site for investigation at NETRA. The sample details are given in Table -1.

Figure – 1 (a-left) Failure in the plate between the spindle flanges, (b-right) Schematic diagram showing the failure in between the spindle support flanges. Spindle is bolted across the flanges. Bolt was missing. No damage observed to the holes in the flanges

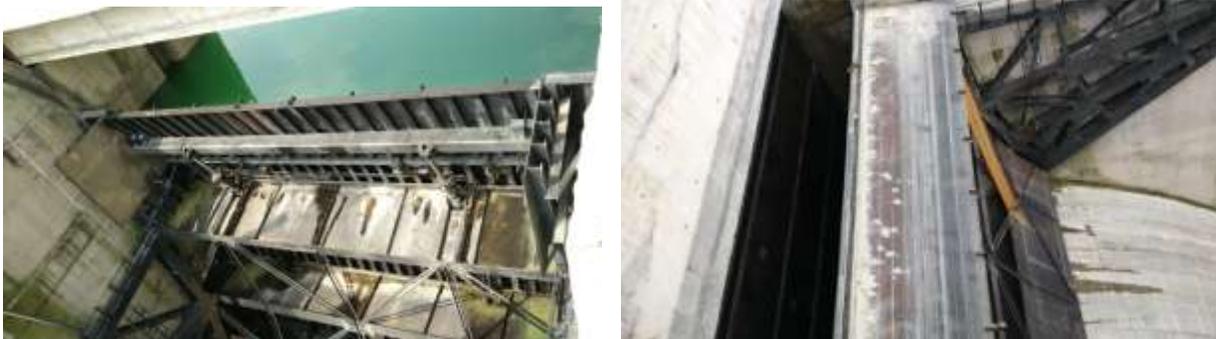
Figure – 1 (c-left) Photograph showing operational spill gate (back side view) Note the arrangement of rectangular girder beam and the two spindles on either side for operation of the gate (d-right) Photograph showing failed spill gate (top view). Note one of the girder beam plates jettisoned out in the failed spill way gate

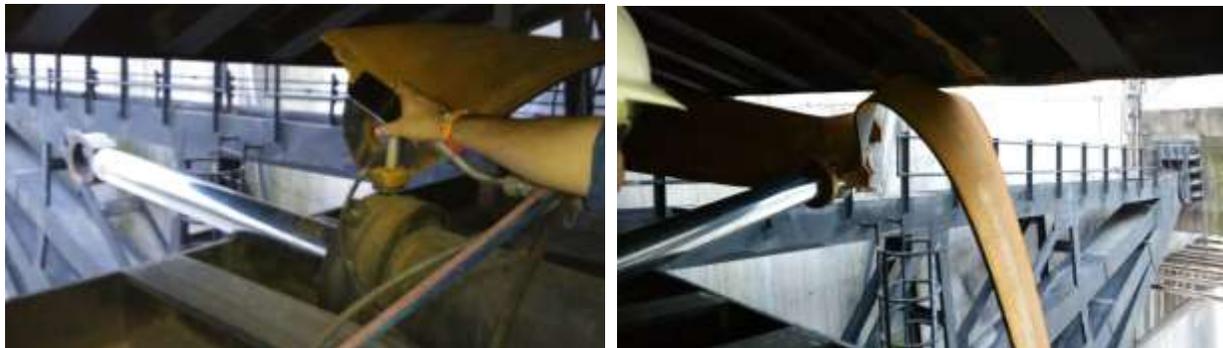
Figure – 2 (a-left) Spindle in free state after failure RHS plate broken, (b-right) Spindle in place after failure LHS plate got deformed

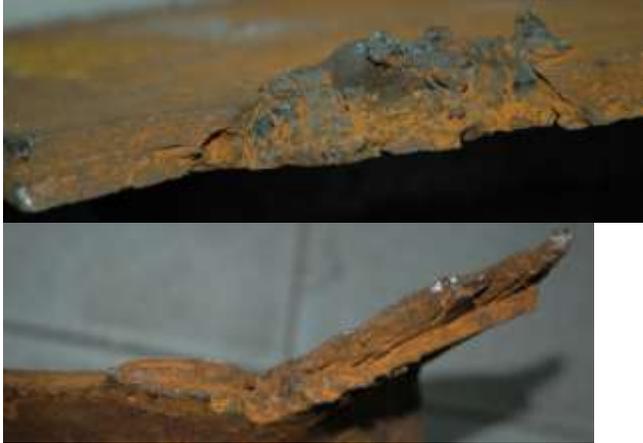
Spill way flap gate plate failed in between flange area across the 400mm width of the plate. The inner surfaces of the plate showed weld splatter deposits on the fracture edge just below the top surface.

Figure – 3 Weld splatter observed on the inner surface (inside the box beam) near the fracture (top & middle). Plate edge (bottom)

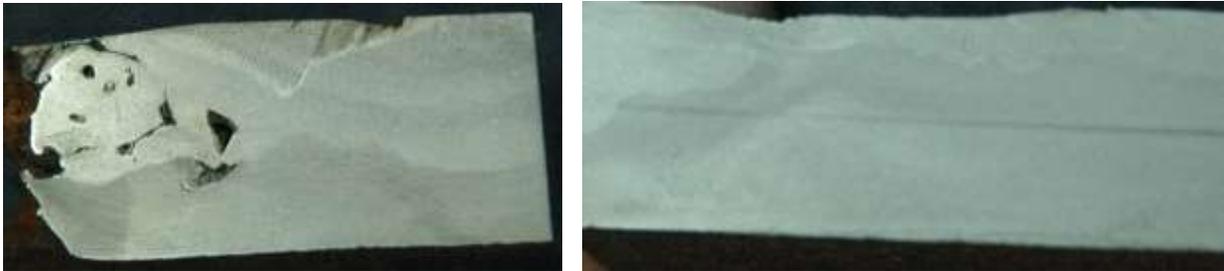
Microstructural analysis of the plate near fracture edge showed presence of weld porosity & oxidized edge. Further weld structure with different layers was observed at the surface of the plate. Weld build up was observed in all the samples studied along the fracture edge. The thickness of the weld build up varied and was as high as half the thickness of the plate (14 mm) in some places.

Figure – 5 Polished surface of the failed plate in two different locations – cross section near the metal deposit due to the weld torch and cross section across the length of the plate

In the present case the failure of individual gate valve has not resulted in any serious consequence but the possibility exists if breakdown occurs at a critical time of flood release. It appears that the spindle support flange was inadvertently welded short of distance so as to support the spindle head. To rectify the mistake the welded flange was removed using gas cutting as was evident by the presence of molten metal near the fracture edge. The flange was then properly welded at the required distance so as to correctly hold the spindle. To fill up the gap welding was done with similar material composition. Microstructural change & hardness values through the thickness have established this fact. At spillways, the gates, hoists and controls are all made up of similar plate material and failure of a single gate can be followed by failures at other gates. Therefore the practice of weld repair in seemingly insignificant location should not be allowed.

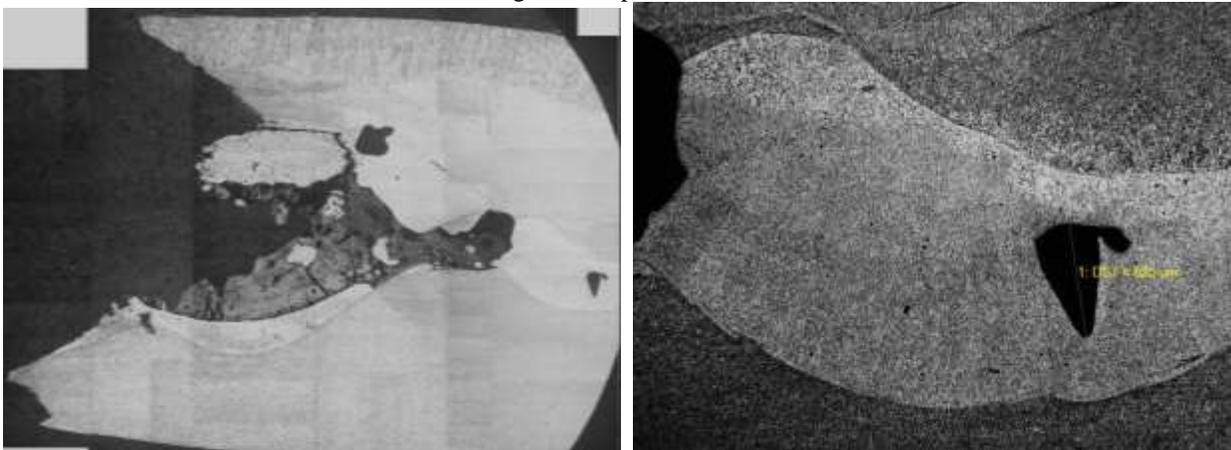
Figure – 6 Microstructural observations showed weld deposits near to external surface in the fracture edge sample. Slag and porosity were observed.

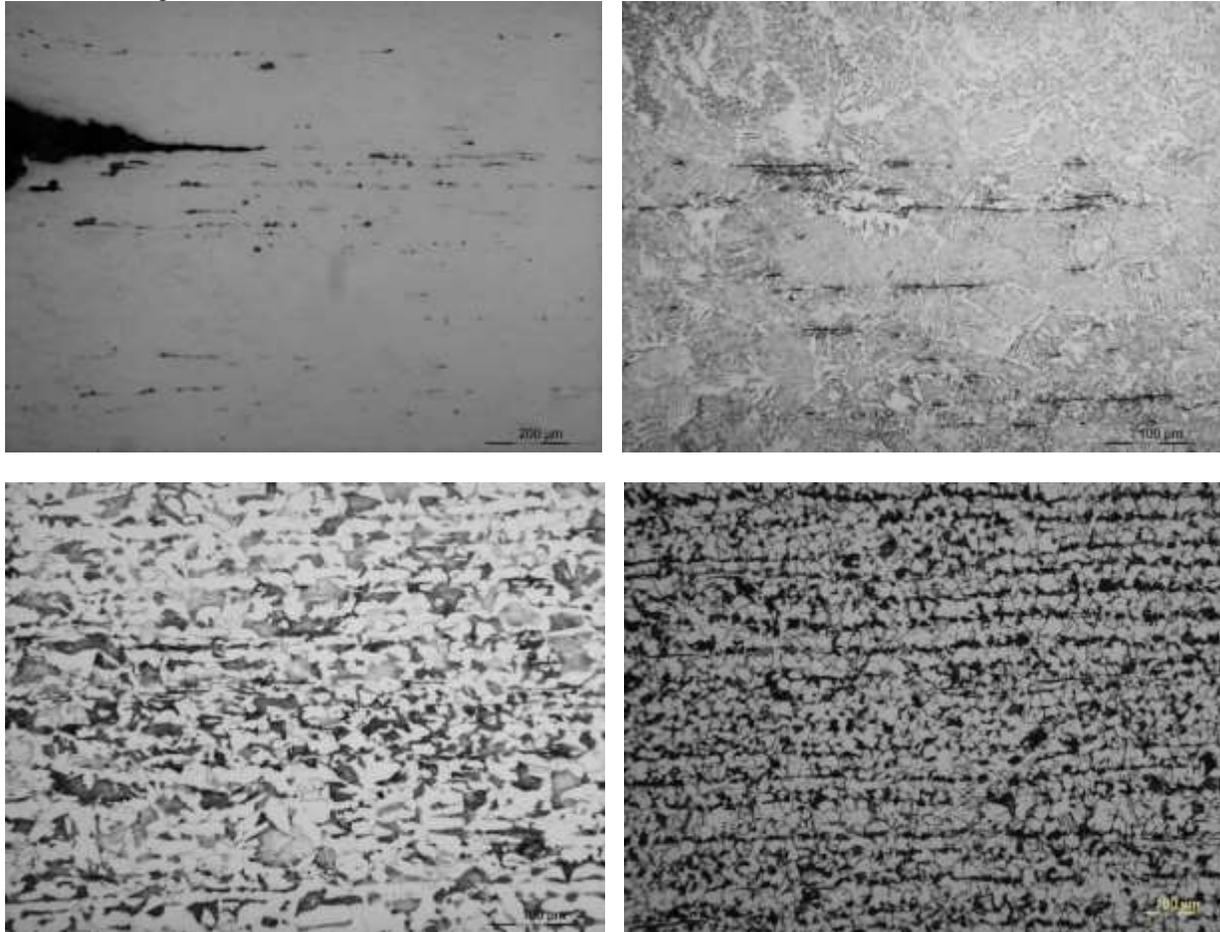
Microstructure of the plate material showed inclusions near the fracture edge. However, the IS code does not specify inclusion rating.

Figure – 7 Microstructural observations showed inclusions near the fracture edge as well as in the plate material away from failure. Ferrite & pearlite structure was observed.
