A CASE STUDY ON BOILER TUBE FAILURE AT JPL

Introduction:

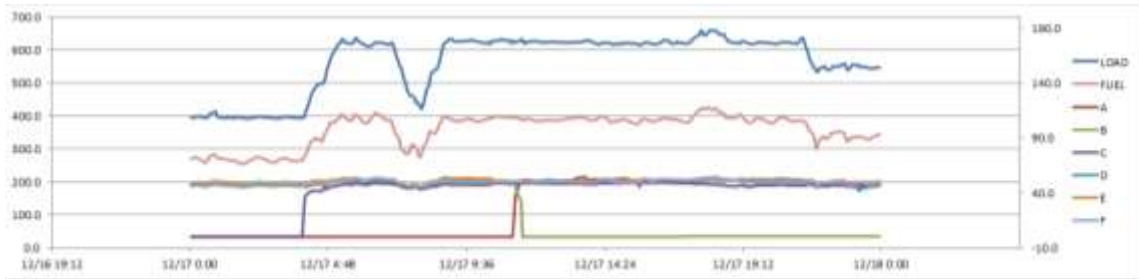
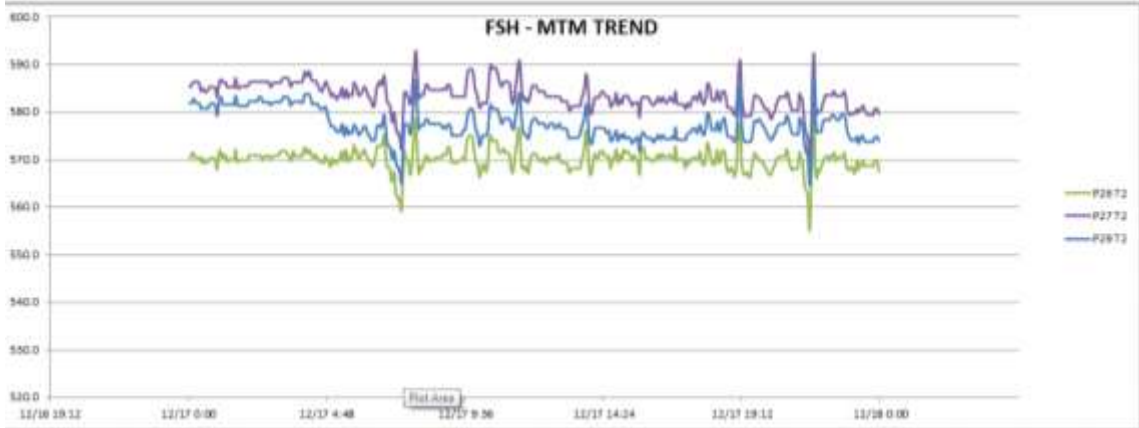
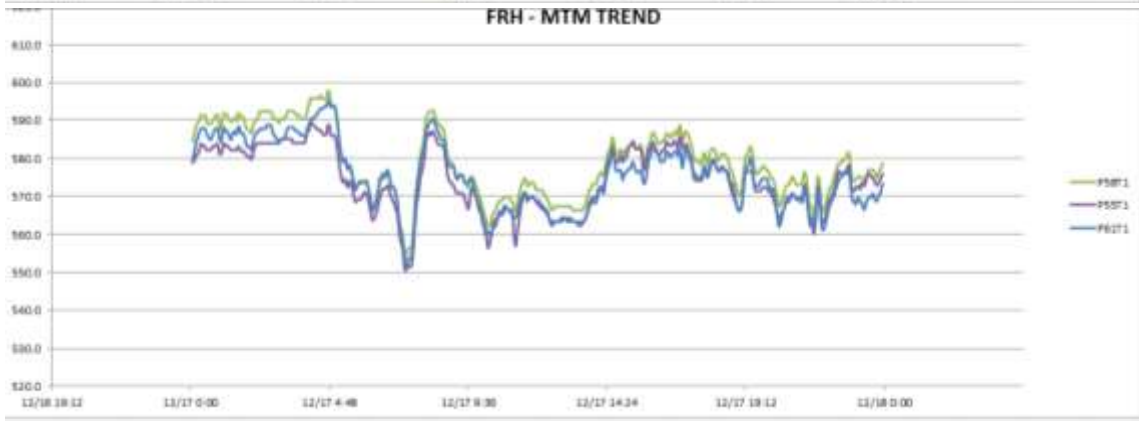
Final Super Heater Short term Overheating – Back to back after long shut down and reserve shut down

These leakages were found twice back to back in FSH, both being fish mouth failures in FSH coil on both sides of boiler

Thick loose internal oxide scales were observed on the inside portion of the failed tubes.

It was concluded that, after long term lay up of wet preservation the scales might have peeled off or dislodged and during start up the loose scales have clogged the coil tube leading to failure in the high temperature exposed (High MTM) tubes

However we are monitoring metal temperatures of FSH coils and FRH coils on daily basis for analysis purpose. (As below)

MS & HRH Steam temperature reduced to keep metal temperatures of FSH/FRH coils in control.

Maximum metal temperature of FSH is restricted to <590°C and FRH <600°C

Preservation of boiler changed from wet to dry mode for non – drainable steam circuits for long lay up

Existing TP347H tubes in FSH to be changed to TP347HFG or Shot peened tubes for boiler HT coils on term basis – as per the study it was observed that fine grain structure of base material are proven for reduced oxide layer formation. By shot peening (surface deformation by compression by high speed shots) further reduction of oxide layer is possible
