# BOILER PERFORMANCE IMPROVEMENT BY RETROFITTING OF BOILER AT NTPC-KANIHA

## ABSTRACT:

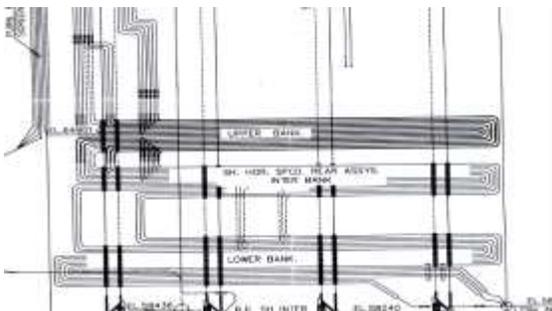
Figure-2: LTSH Bank addition

- Low MS temperature. The attainable temperature was 500-510 deg C against 540 deg C at Superheater outlet. The Turbine inlet temperature was nearly 500. This was more predominant for operation of the boilers with bottom mill combination.
- Imbalance in MS temperature between left & right hand side. There was a difference of as high as 20-30 deg C.
- Although a design of zero Reheater spray was planned, but as the Reheater metal temperature was increasing beyond 600 deg C, so even after bottom mill operation, adjustment of burner tilt, temperature control was difficult. Reheater Spray of 30 TPH-60 TPH was required. Also, Operation with top mill combination was nearly difficult to achieve design load.
- Imbalance in Hot Reheater steam temperature between left & right was also noticeable.

- Addition of 2942Sq. M of Heat transfer surface in LTSH: A complete bank of 130 coils to be added over the existing two banks. In all there will be three banks. The arrangement is as illustrated in figure-2. The coils are of full length with 12 tubes in each coil.
- Shifting criss-cross from LTSH outlet to between divisional superheater and platen superheater. A scheme is as illustrated in figure-3 for better understanding.

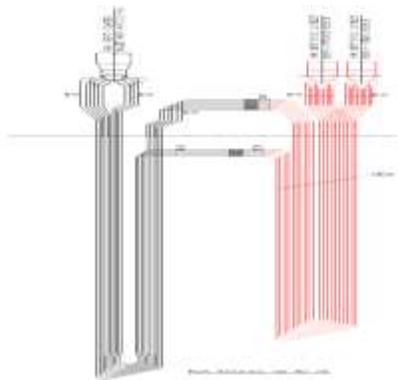
Figure-4: Material up gradation of final Reheater in 23 assemblies (Coil-56 to Coil-78)

**c. High Reheater tube metal temperature inside penthouse:**

- i. Upgradation of Reheater material in the Gas touched length of 10 elements in final Reheater(rear) from T91/T22 material to Stainless steel TP347H material in assembly (coil) No 56 to 78 (23 assemblies) as illustrated in figure -4.
- ii. Up gradation of Reheater material in the Gas touched length of 4 leading tubes of T91/ T22 material will be upgraded to TP347H in assembly (coil) No 1 to 55 (55 assemblies) as illustrated in figure-5.

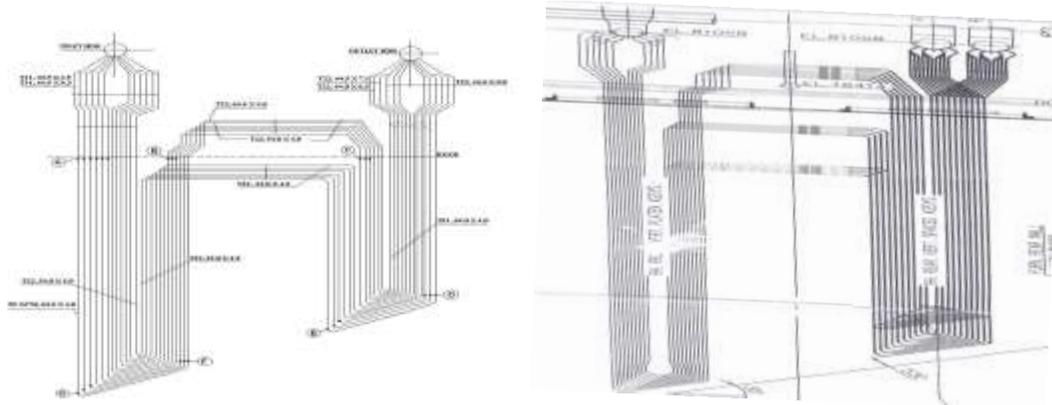
Figure-6: Modification of single Reheater Outlet header to Siamese header

**d. Imbalance in Hot Reheater steam temperature between left & right:**

- i. Introduction of Siamese headers with T 91 header nipples in place of existing single Hot Reheater header with T22 nipples as illustrated in figure-4.
