FAILURE OF HP CONTROL VALVE IN 210 MW STEAM TURBINE

MUNNA LAL YADAV, DGM (NTPC)
M K RAGHUVANSHI, DGM (NTPC)
RAJVEER SINGH PUNIA, SR. MANAGER (NTPC)
TANVEER ALAM, MANAGER (NTPC)

At NTPC Dadri Stage-I Turbines (4X210MW) are of KWU make. It consists of two sets of HPCV, which regulate the steam flow to the turbines. Recently a problem was faced in which the Unit load was not increasing beyond a particular value, which was due to the failure of HPCV. The paper covers the root cause analysis of the problem.

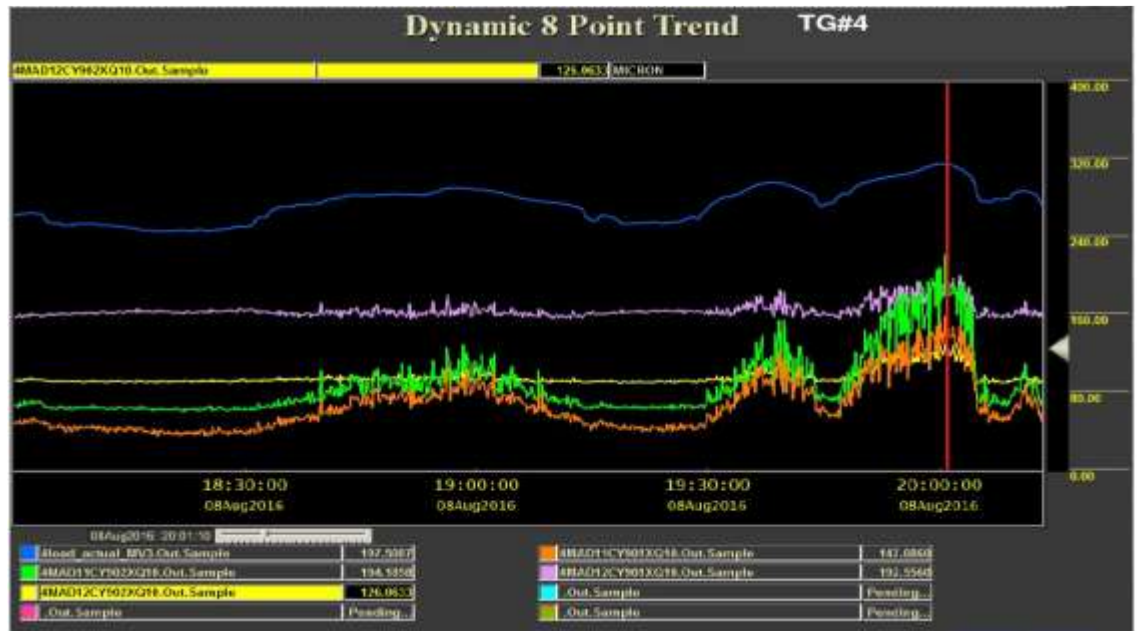
Fig 2:- Vibration trend

1. Boiler side MS pressure-L/R were matching before synchronization, however 2-3ksc pressure difference developed at load and maximum difference was approx. 6ksc.
2. HPBP and LPBP passing checked in local and found normal.
3. On raising load beyond 170 MW, **HPT shaft F/R** vibrations were increasing and hunting as well (Fig.2). Maximum value of HPT Front shaft vibrations (1x/1y) reached up to 150/202 Microns at 197 MW.(At 140 MW vibration were 1X/1Y- 37/58 microns.

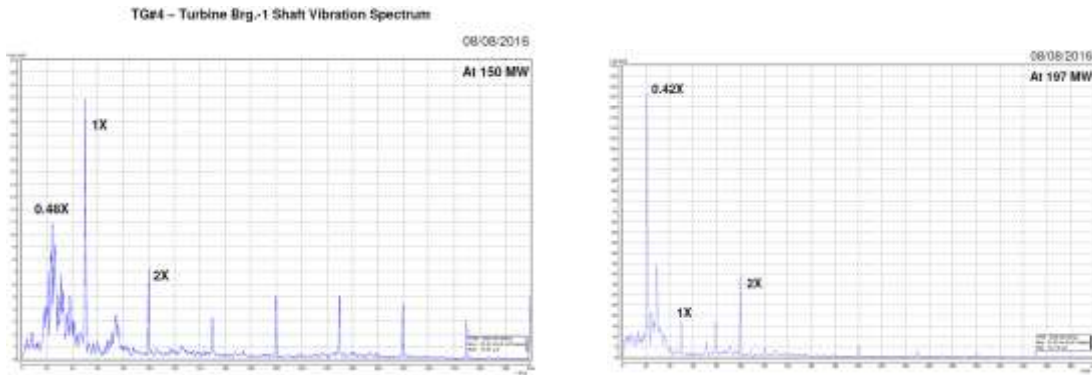
Vibration Spectrum taken for bearing-1 at different load

Spectrum showed vibration frequency of 0.42X to 0.48 X (X-rotating speed).It was suspected to be related to flow induced instability.

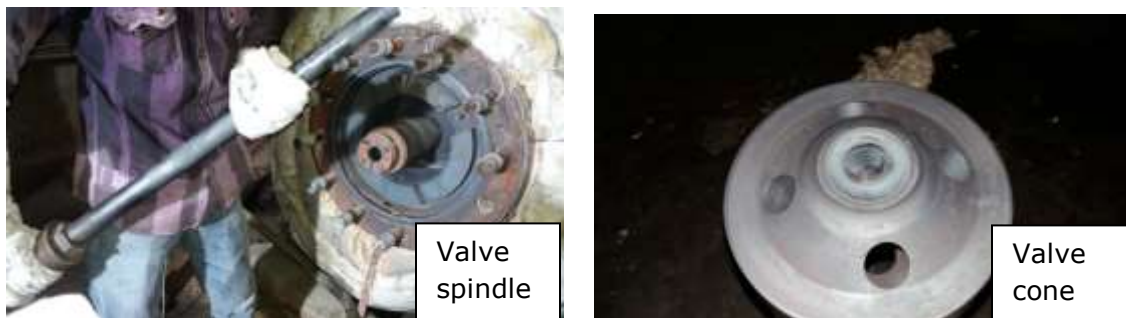
Fig. 3

So it was concluded from the above observations that HPCV-1 path was restricted and the steam flow was diverted towards HPCV-2. Due to high steam flow through HPCV-2, sound intensity was also found on the higher side (95 db). The steam flow imbalance in HPT was also causing increase in HPT Front shaft vibrations with increase in steam flow/load.

HPCV 1 dismantled to check the cause. Valve spindle and cone were found broken (Fig. 3). HPCV Spindle and cone assembly replaced with new one and assembled. Unit brought back smoothly.
