MINOR ISSUES - MAJOR CONSEQUENCES

LEARNINGS OF KOLDAM MECHANICAL MAINTENANCE DEPARTMENT

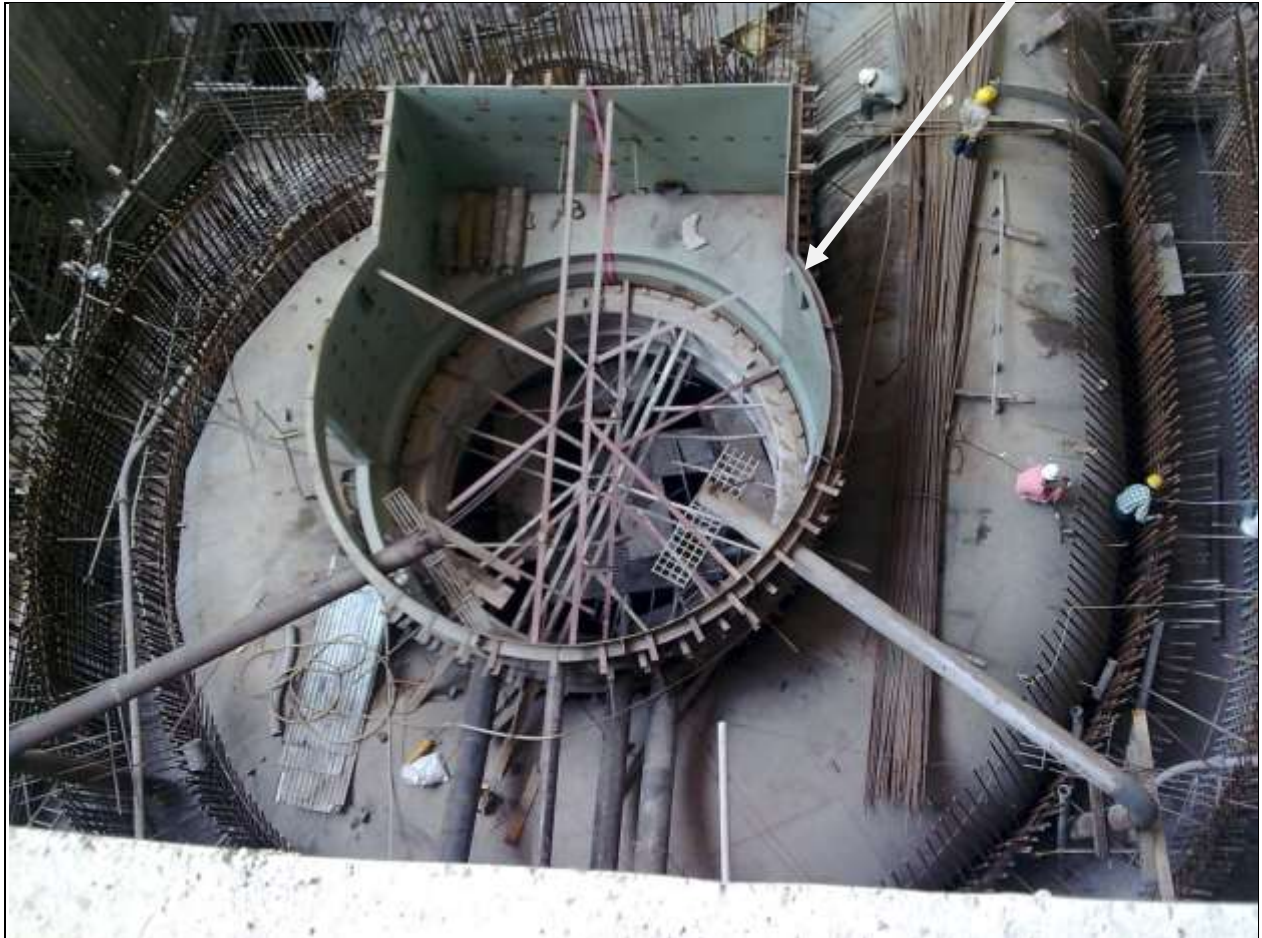
During routine inspection bulging of the Upper pit liner as shown in Fig.1.1 of Unit #01 was observed. The Bulging resulted in pressing of the governing oil lines and hydraulic Lock oil lines. This pressing of oil lines was leading to unsafe condition. Calcite formation was also observed on upper pit liner walls due to the water seeping out of the concrete.

Upper Pit liner which bulged due to spiral leakage.

Temporarily, to release pressure, 8 mm holes were drilled in the upper pit liner. High pressure, small volume water jets appeared. Jet disappeared as unit was shut down and appeared again on opening MIV Bypass valves and during the unit running, linking the source of water to the water conductor after the Main inlet valve.

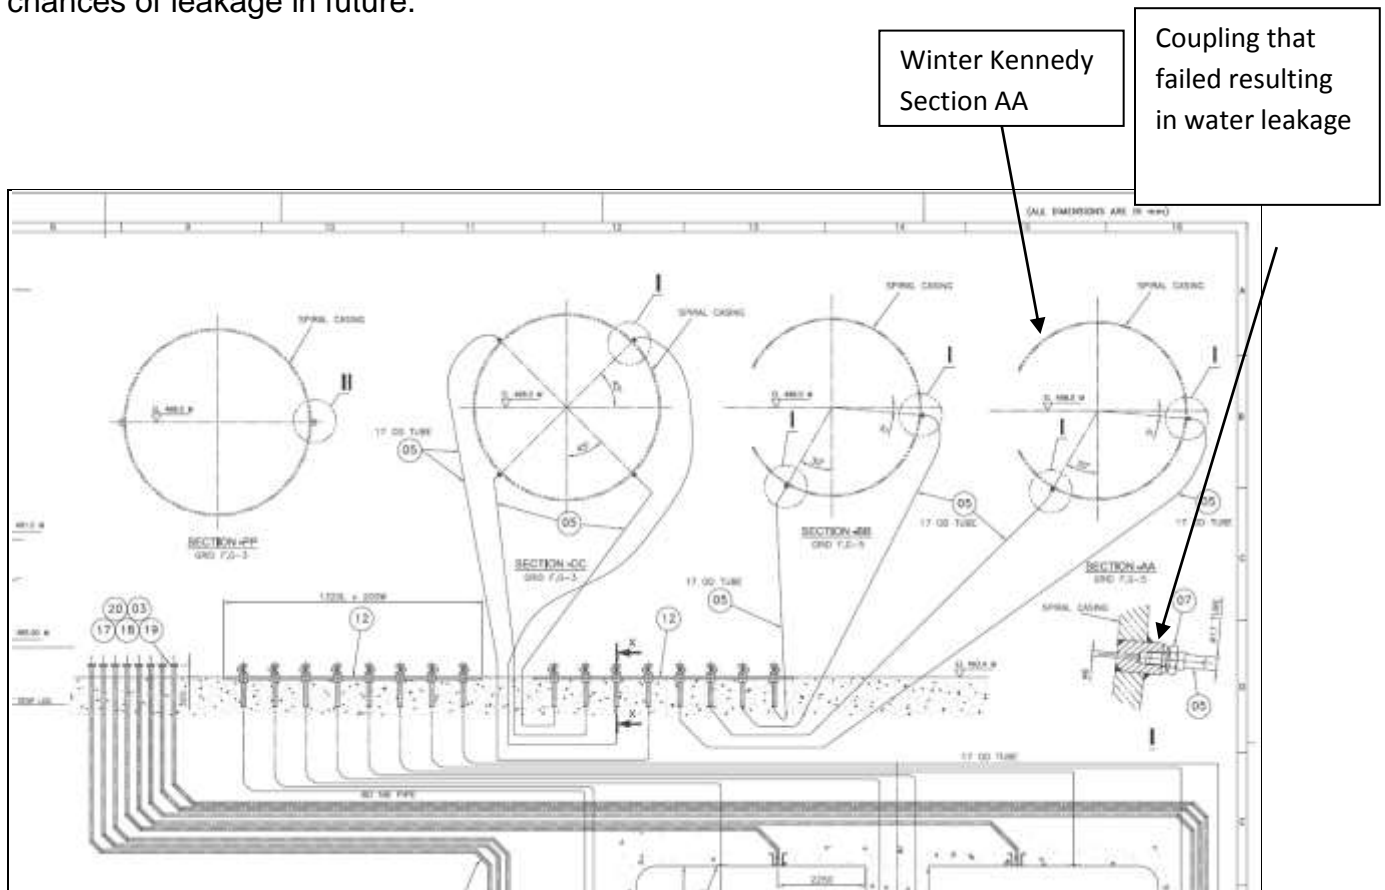
Fig.1.2

Arrangements made for pumping dye in to the cavity during unit # 01 shut down from upper pit liner side. During inspection of spiral casing after spiral dewatering, water was observed continuously seeping in from High Pressure side tap of Winter Kennedy discharge measurement (SECTION A-A). As shown in Fig1.2

Air pressure given from upper pit liner, observed seepage of water in spiral increased confirming this as the defect location. Thread Tapping done at Section A-A High pressure and low pressure taps, plugged and welding done to further eliminate any chances of leakage in future.

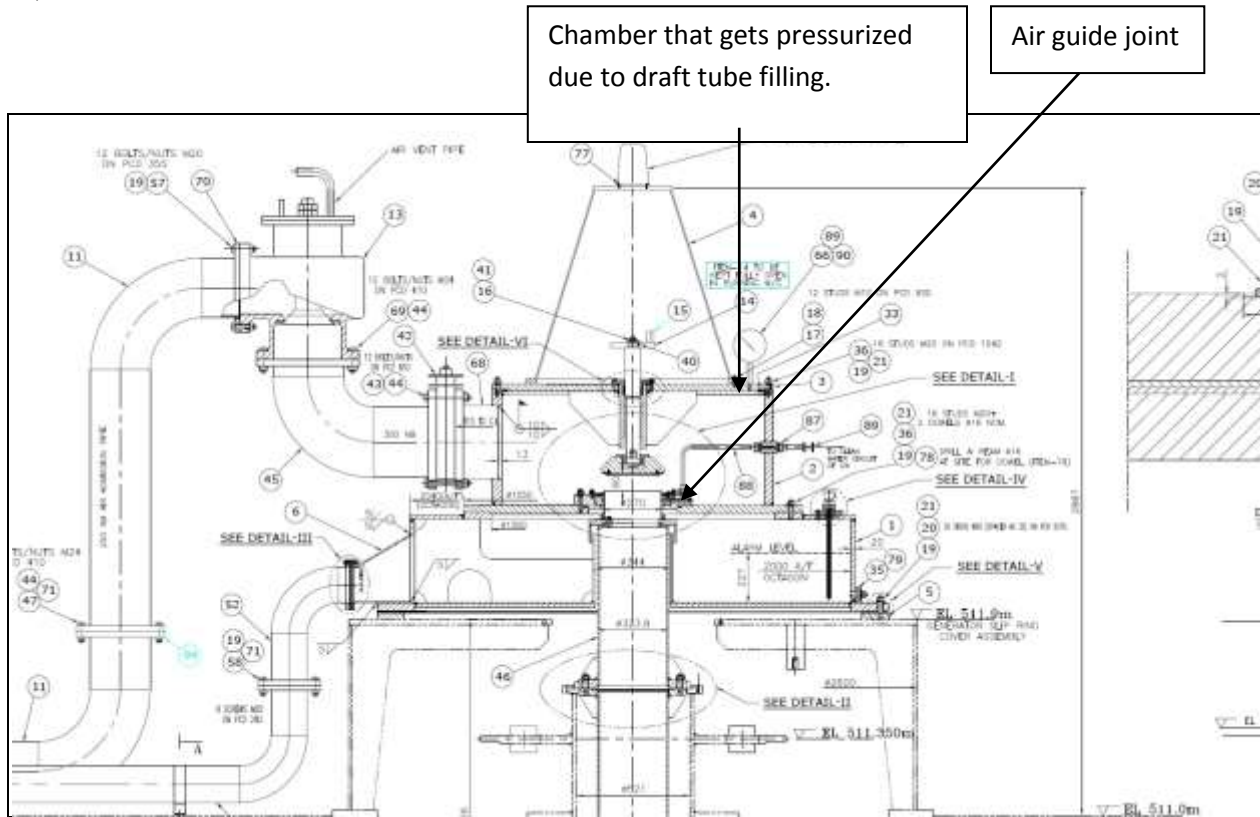
Fig. 2.1

Draft tube and spiral casing was drained to attend a defect in MIV bypass valve. After attending the problem, Draft tube filled as per the standard procedure after shut down. Unit #03 Slip ring /rotor IR value deteriorated to zero. Water was observed in slip ring area and upper guide bearing area. Water was also dripping from runner aeration system housing at the top of Slip ring area shown in Fig 2.1 . Tail race level at the time of draft tube filling moment was – 503.00 M, Aeration system housing level is – 512.40 M, Runner bottom level is - 496.37 M.

Sealing ring cooling water accumulated above housing was drained off. It was observed that there was no air venting arrangement at the top of runner aeration housing. It was suspected that

During draft tube filling area gets pressurized leading to leakage from the Air guide joint. The O-Ring of the air guide joint was suspected to be damaged. O –Ring of the Air guide joint to be replaced. To avoid the pressurization of the runner aeration housing, two solutions could be adopted:-

01. Bypass of the Runner aeration NRV to be installed and opened during draft tube filling to release air pressure.
02. Hole of M20 could be tapped in the bottom of upper chamber, connecting the two chambers of the Runner aeration housing. This connects upper chamber to atmospheric pressure and avoid accumulation of water and pressurization during back filling.

Since the root cause of the problem was the air pressurisation, servicing of spiral air release valve and its availability was of utmost importance.

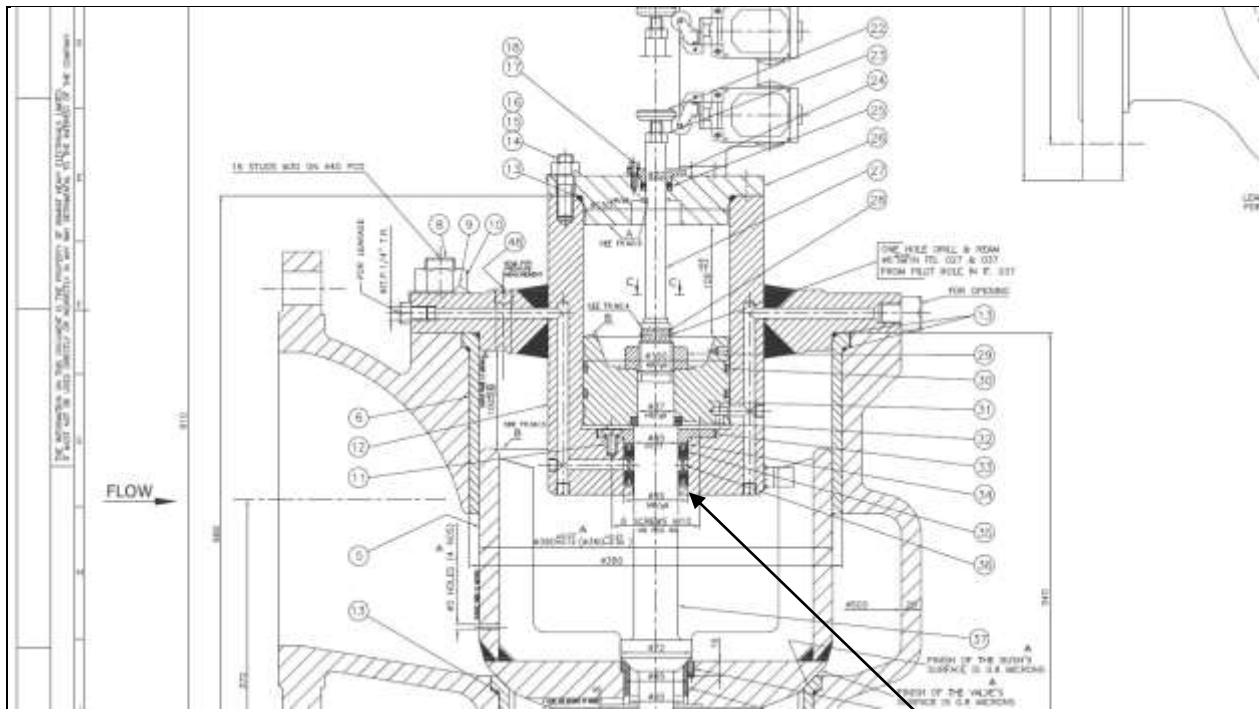
Abnormally slow movement of hydraulically operated MIV Bypass valve Fig.3.1 of Unit#03 was observed during the normal start-up of the machine. Hydraulically operated MIV bypass valve shown in fig 3.1 has a leakage ring, water was found to be coming out of the leakage ring. Water content increased in Hydraulic oil. It was inferred that the cup seal of the water side was damaged and high pressure water from the penstock (14 ksc) was ingressing into the opening chamber of the cylinder which was connected to the Power pack set return line when the valve was in the closed position.

Water side cup seal that got damaged

In order to immediately stop the further mixing of water in the hydraulic oil and ensuring availability of unit in peak hours, upstream manual MIV bypass valve was closed so that water pressure is reduced.

Unit # 03 shut down taken after peak hours, Bypass valve dismantled for assessing the water side cup seal condition, cup seal found damaged. Cup seal replaced. Unit made available before the next peak hours.

Design issue discussed with OEM – M/s BHEL. Isolation of oil circuit from water circuit may be done by design modification.

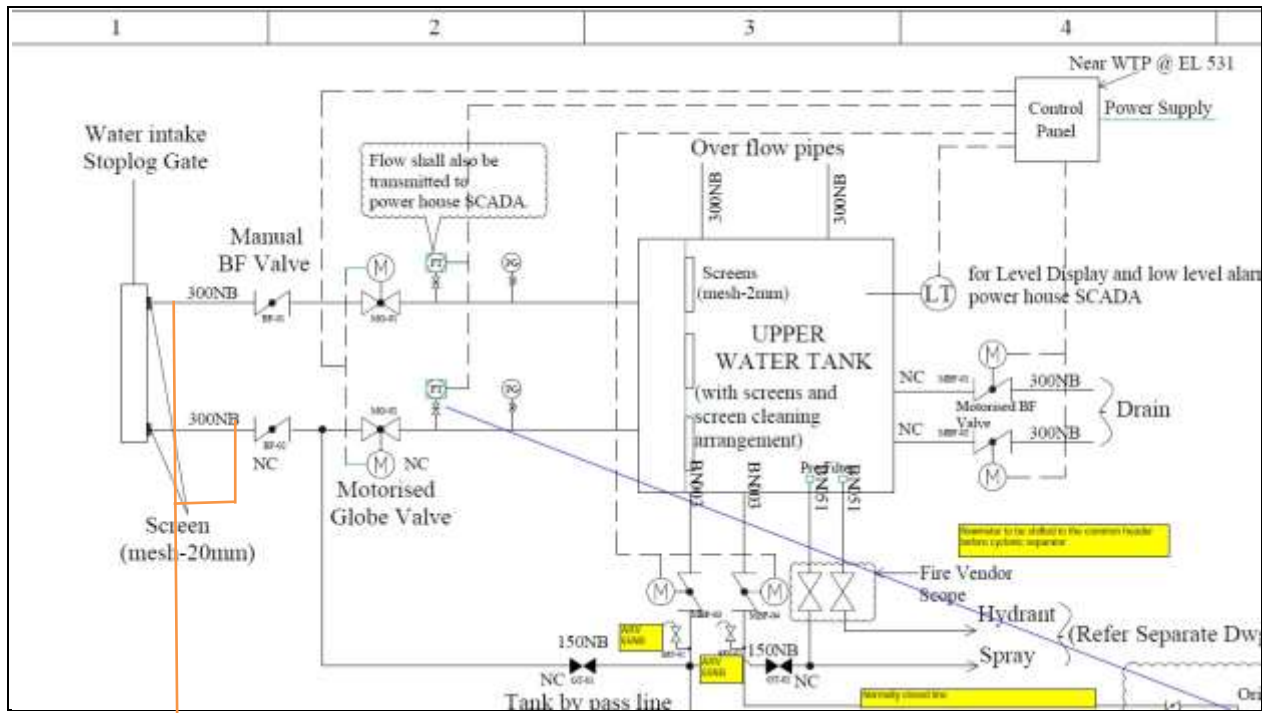
Fig.4.1

Industrial water supply for Koldam Power House is directly from Dam at EL 635.50 m which is below MDDL of EL 636.00 m Fig. 4.1

Inlet mesh/filter provided at the suction of these lines chokes frequently with debris from the river causing reduced flow of the industrial water used for various purposes in power house such as treated water formation for generating unit requirements, fire fighting system, and various other critical applications.

Industrial lines punctured for backflushing through Portable compressor (Modification)

Both the lines installed with back flushing arrangement by compressed air from downstream side. Valves in the downstream to be closed when back flushing, line gets pressurized, and throwing away the debris from the inlet mesh.

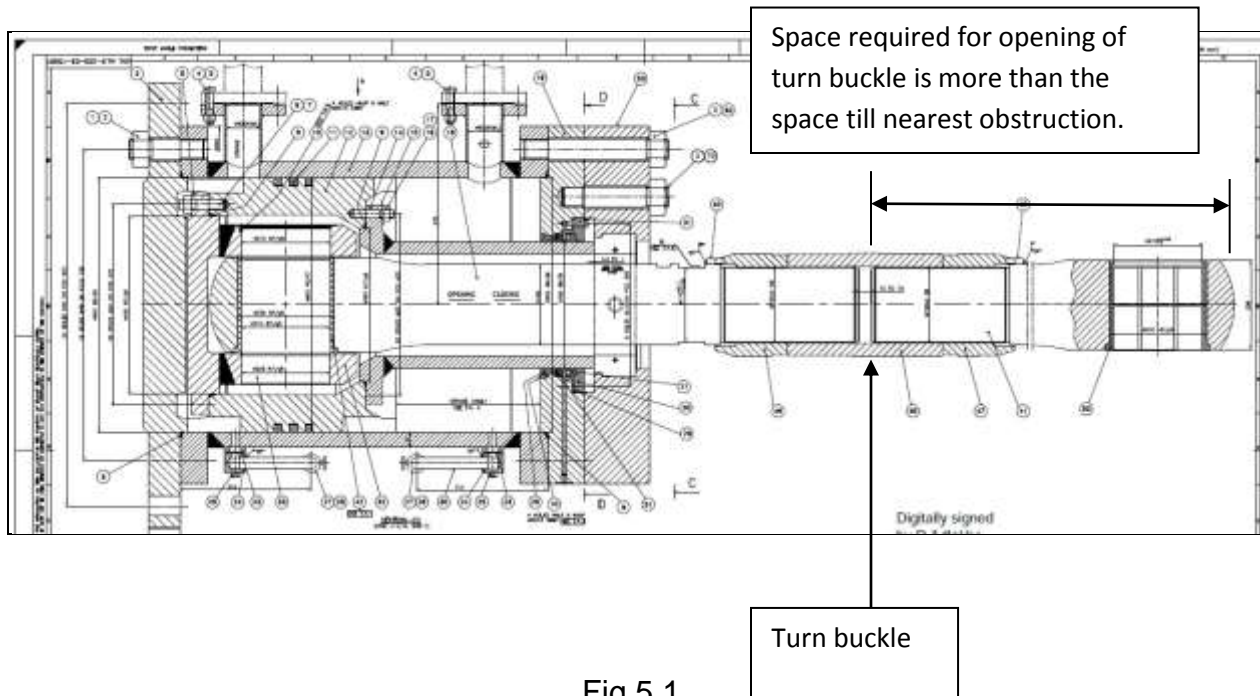
Fig.5.1

For maintaining Guide vane bedding, locking of the regulating ring is required. The turn buckle opening Fig 5.1 was not possible without the individual movement of the servomotors. Hydraulic

Isolation of the faulty servomotor from the hydraulic circuit is done by blanking the opening closing lines to that servomotor. The faulty servomotor was operated for replacement of cup seal through 4-5 bar air pressure of service air. Use of air for servomotor movement lead to reduced downtime of the servomotor. Restoration of guide vane servomotor done in six hours, and making unit available.

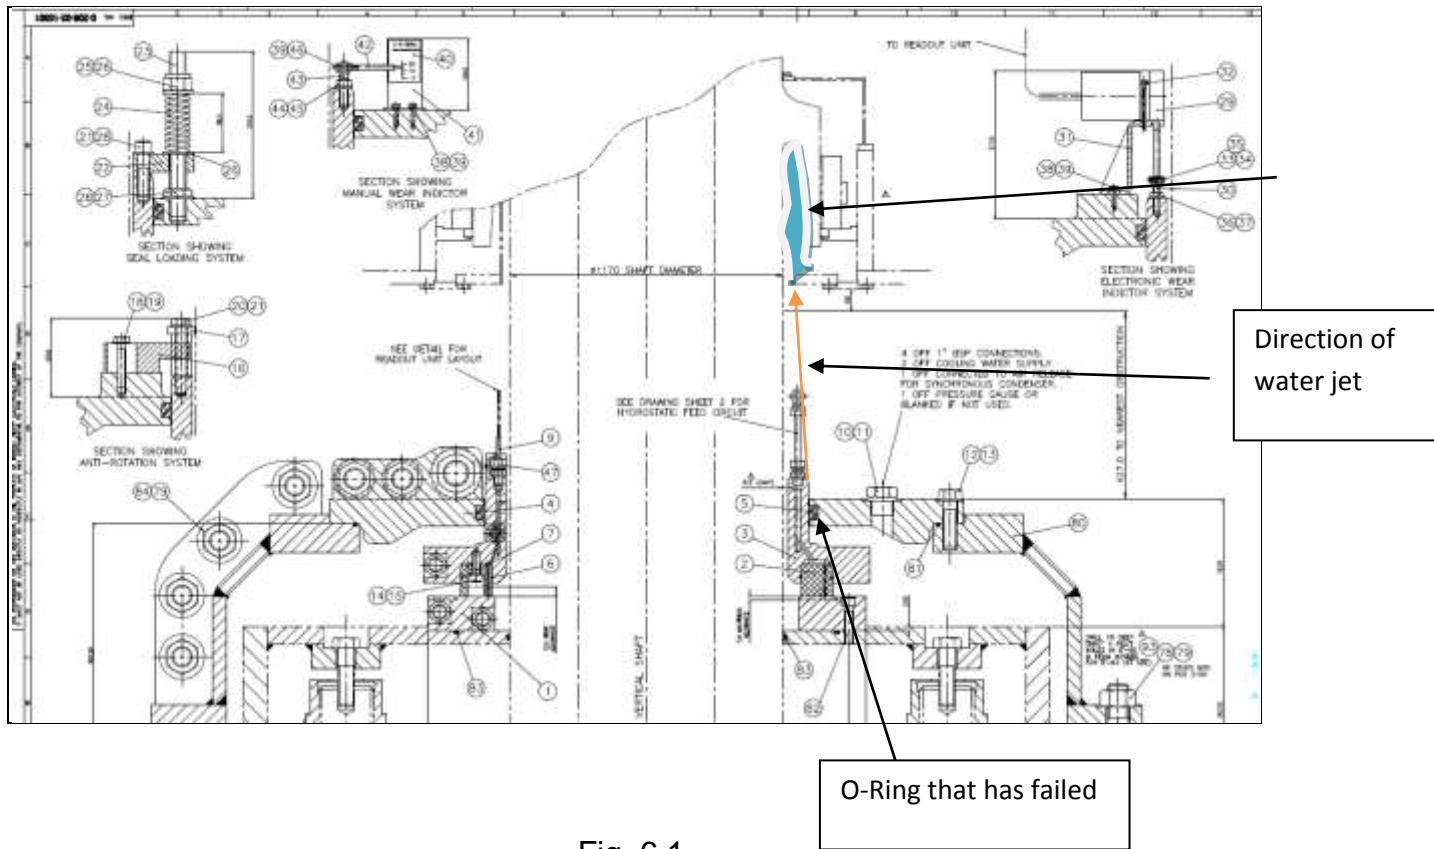
During routine inspection of Unit # 03, TGB oil level found increased, water PPM in Oil also found increased. Enhanced shaft seal leakage observed with abnormal sound.

During shaft seal assessment vertical high pressure jet observed which crossed the centre piece to the TGB oil housing Fig. 6.1

Water Entered into oil housing after crossing the centre piece

Since problem observed in peak season immediate solution was required to ensure Unit availability. The water jet was diverted by fixing a diversion plate. Shaft seal leakage was continuously observed.

O-ring being replaced in Unit shut down for annual maintenance.
