“ONSITE REFURBISHMENT OF POWER TRANSFORMER” AN EXPERIENCE.....

1. *Suresh Chandra Behera , DGM(EMD) , NTPC/TTPS.*
2. *K J PRASANNA KUMAR , DY MANAGER(EMD) , NTPC/TTPS.*

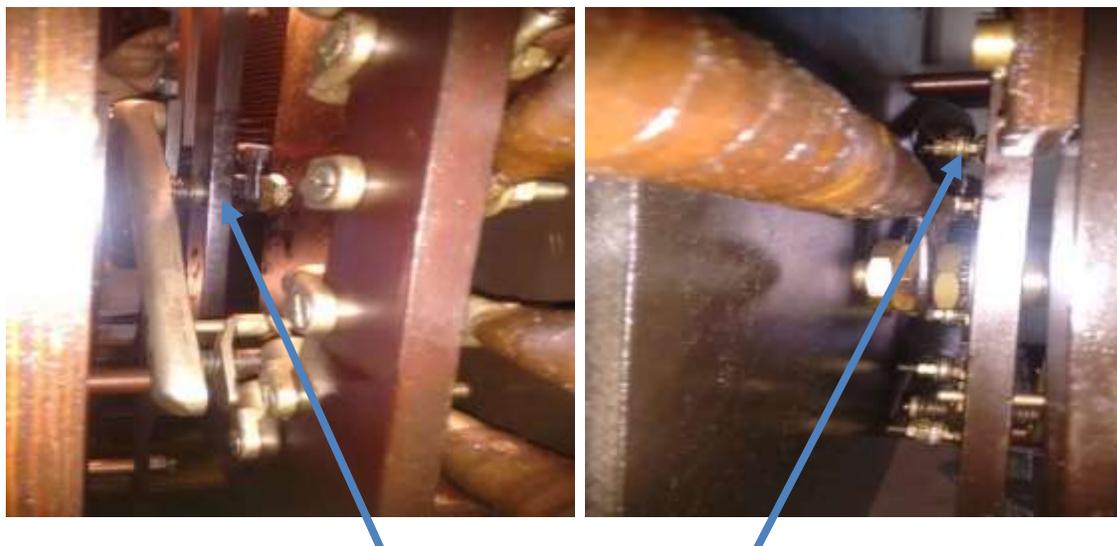
DGA results show high amount fault gases violating all limits. It shows severe overheating/bad joints/arcng etc. Thorough internal inspcion is recommended to find out the source of the fault.

Figure-1 Carbon deposit observed on HV Leads coming out from the windings.

1. Silver brazing at the pitting area was done. After brazing, grinding of the surface and blue matching of the joint was carried out to ensure proper contact.
2. Winding resistance measured at all taps and found OK.
3. Supports carrying HV leads were tightened properly.
4. All the three phase leads are re-tapped with paper insulation.
5. All clamps checked for tightness including core coil assembly supports.
6. WTI CT checked for healthiness and found OK. Secondary side of CT shorted with 2mm rigid copper strips

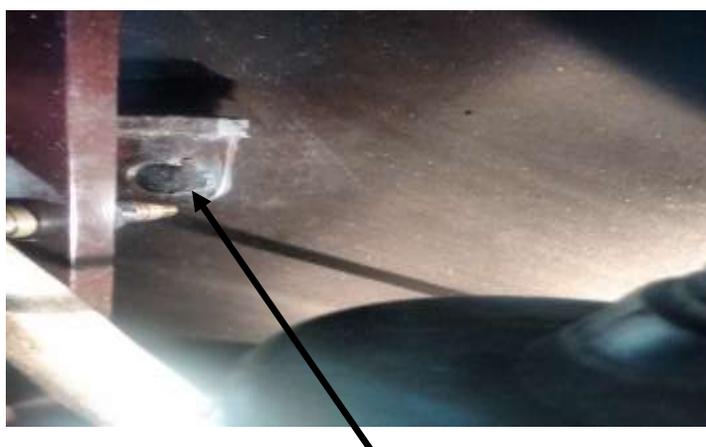
Figure-2 After disconnection of lead wire it was observed that some portion of copper got worn out and pitting mark was observed.

Figure-4 Silver brazing at the pitting area was done. After brazing ,grinding of the surface and blue matching of the joint carried out to ensure proper contact.

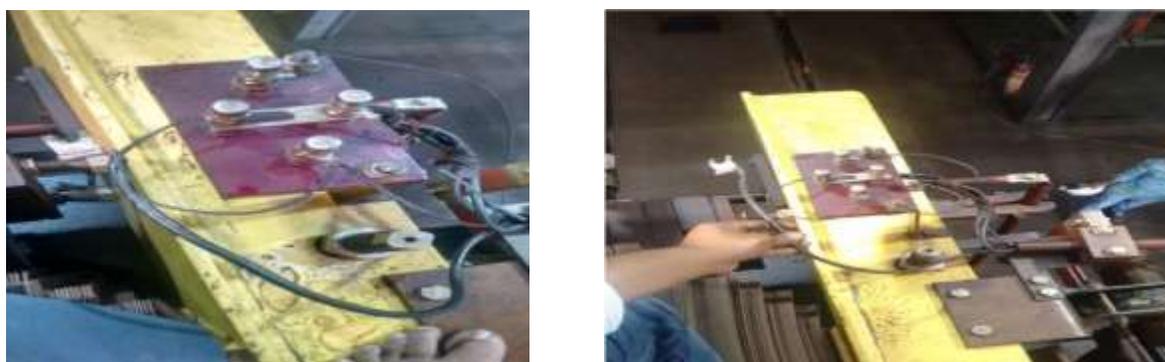
Figure-3 WTI CT secondary side opened
