# **400KV HCB ISOLATORS FAILURES AFTER COMMISSIONING – DIAGNOSIS & RECTIFICATION AT NTPC/ VINDHYACHAL SWITCHYARD**

**NTPC Vindhyachal**

Repeated Hot spots / Failures of 400KV HCB Isolators of newly commissioned NTPC Vindhyachal stage- V Switchyard has led to root cause analysis and paved way for reviewing the design aspects of said HCB Isolators.

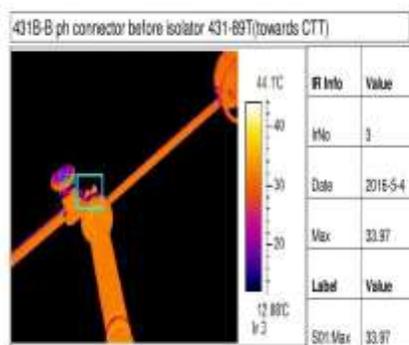
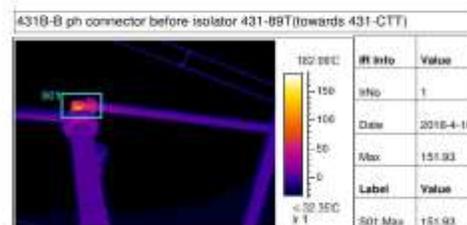
Figure 02 - Thermoscanning of Isolators.

The Hot spots were in the range of 40 -60 degree centigrade, OEM Siemens clarified that these Hot spots may be due to fine dust ingress at the contacts and may go out with time .

BAY 431-GT#13, LOAD 478 MW, Ambient temp. -37 deg.

Hotspots in the numbers of Isolators at full load that too just after the six months of commissioning was something that requires further investigation and attention and further it was apprehended that during fault conditions these Hot spots may even melt the contacts and pose serious issues. So decided to have through checking on the Isolators as during that time mandatory spares were there with NTPC for repair / replacement.

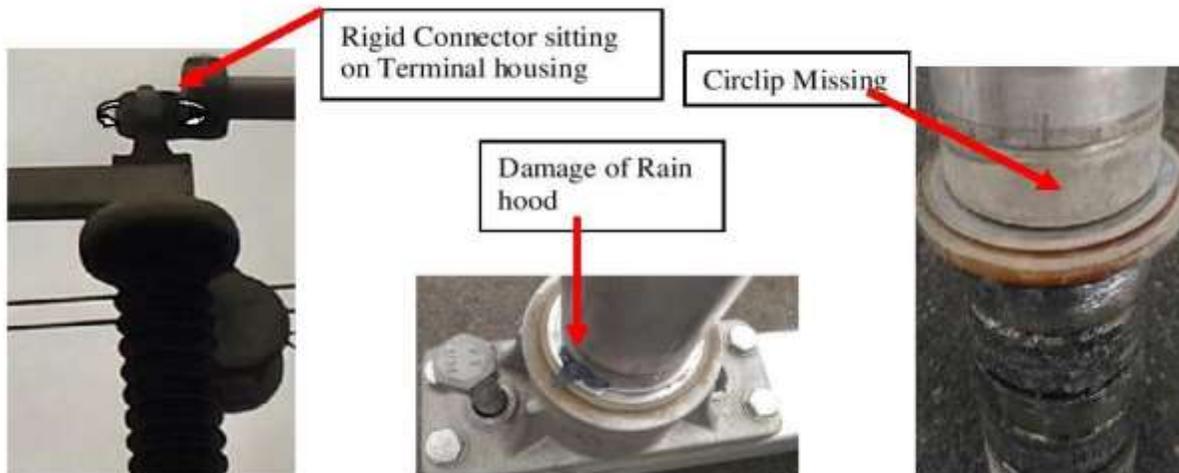
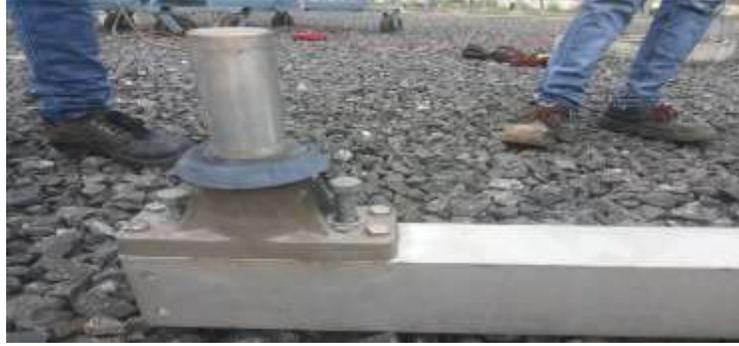
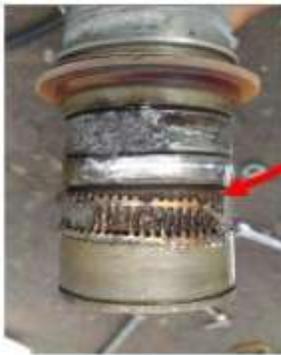
Figure-03 Terminal Housing Assembly

- Terminal stems of the Terminal Housing were found partially melted
- The contact grease found completely dried up.
- MultiLams contact could not be traced as completely burnt.
- Terminal stem of the moving contact assembly found stuck with each other, it was very hard to dismantle (they were found stuck due to melting).

Burning of Multi  
Contact and  
melting of stem

Observation on both set of Isolators are almost similar and at the same location so envisaged for similar type of problem.

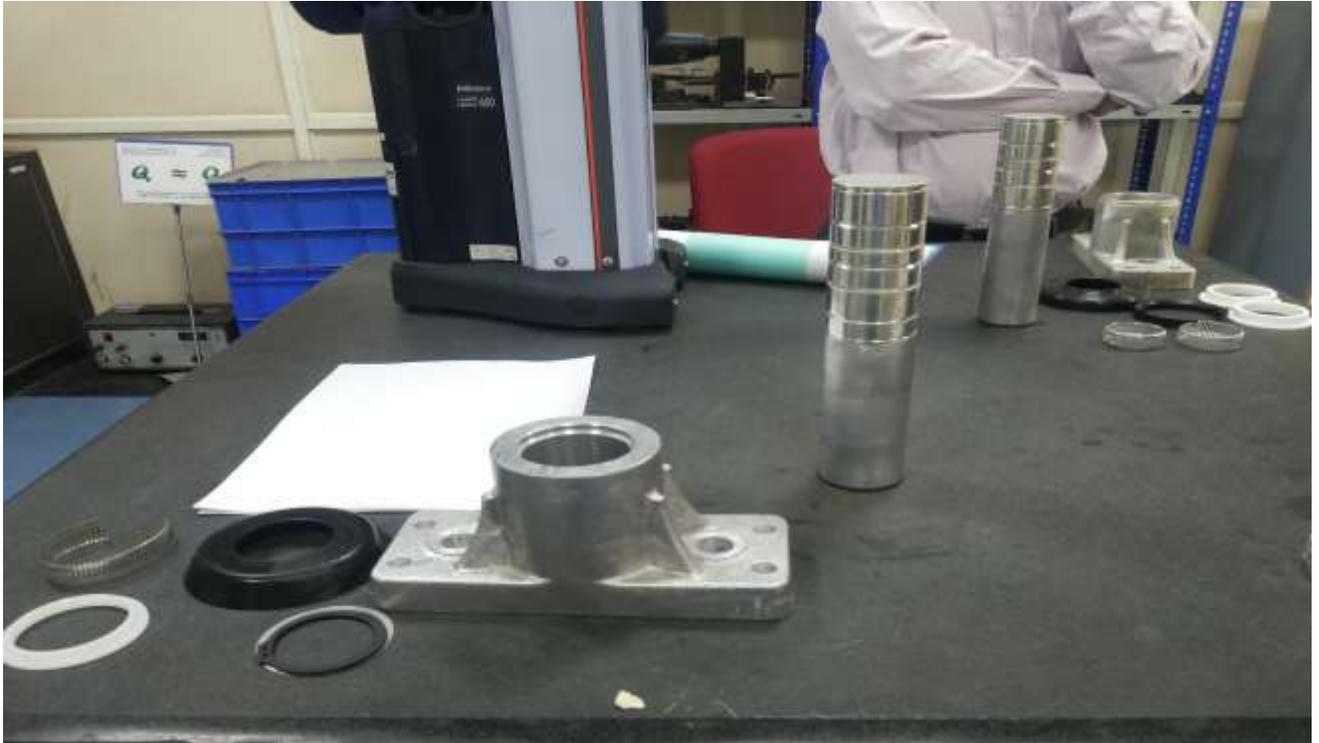
Figure -04 Terminal stem Hardness increased to 95 BHN , Housing Hardness increased to 120 BHN.

- The cause of the Black slush may be rubbing powder generated during operation of Isolator and the Hot spot may be due to the impressions appearing on the stem which might be creating gap over a period of time causing heat generation. This may be due to inconsistency of hardness of the stem .
- The copper plating and the tin plating of the stem and the housing might not be consistent, due to which Multilam may become loose and thus subsequent increase in resistance cause heat generation leading to burning of stem.

- **The terminal Stem material hardness reviewed and has been changed from 80 BHN to 95 BHN ( AC 64 )**
- **The terminal housing hardness reviewed and has been changed from 95 BHN to 120 BHN( AC 100)**
- **Copper and Tin plating check point has been included in the quality assurance plan.**
- **Locking ring has been provided on the multilam for securing the position as well as preventing the rotation on the stem.**
- **Rain hood cover material modified to PA 66 and also thickness increased to prevent breakage as well as withstanding to environment conditions.**
- **V seal arrangement has been provided to prevent ingress of dust and water in terminal housing assembly.**
- **Graphite oil is being used at contact locations.**
- **All POM Bushes ( Bearing bushes ) have been modified to TEFLON glass filled to enhance the mechanical strength as well as thermal withstand capability**

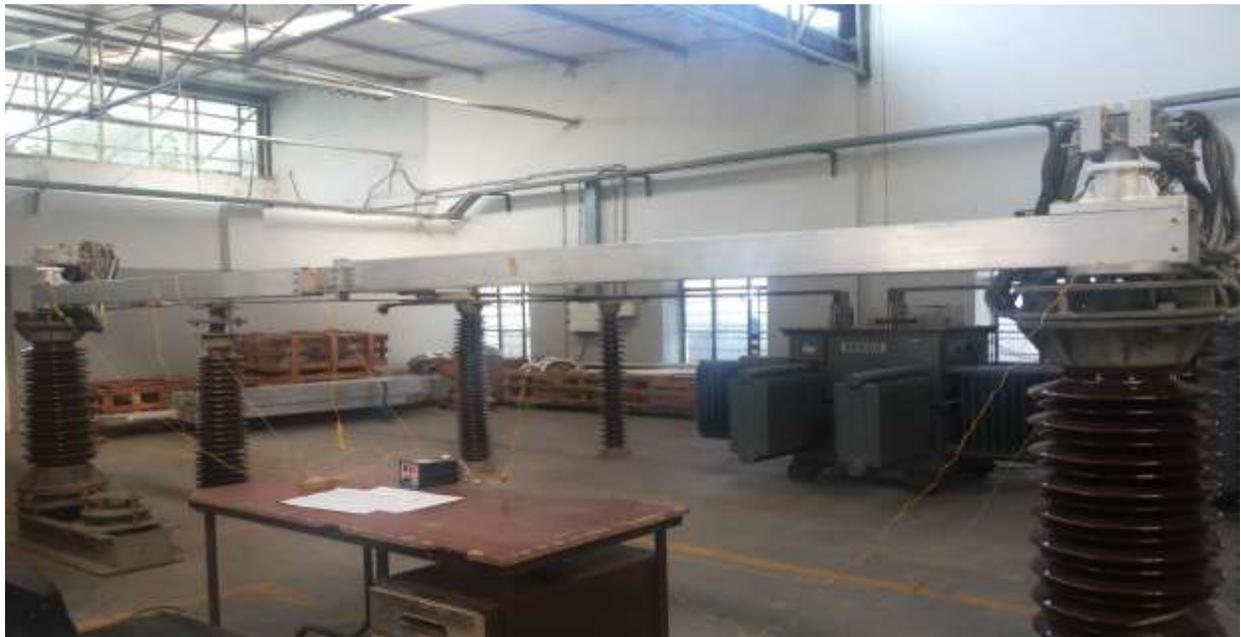
Figure – 06 Temperature rise test on modified design Isolator

The test results of temperature rise carried out before and after 2000 close- open operation are found to be well with in the specification limits of IEC 62271-102.

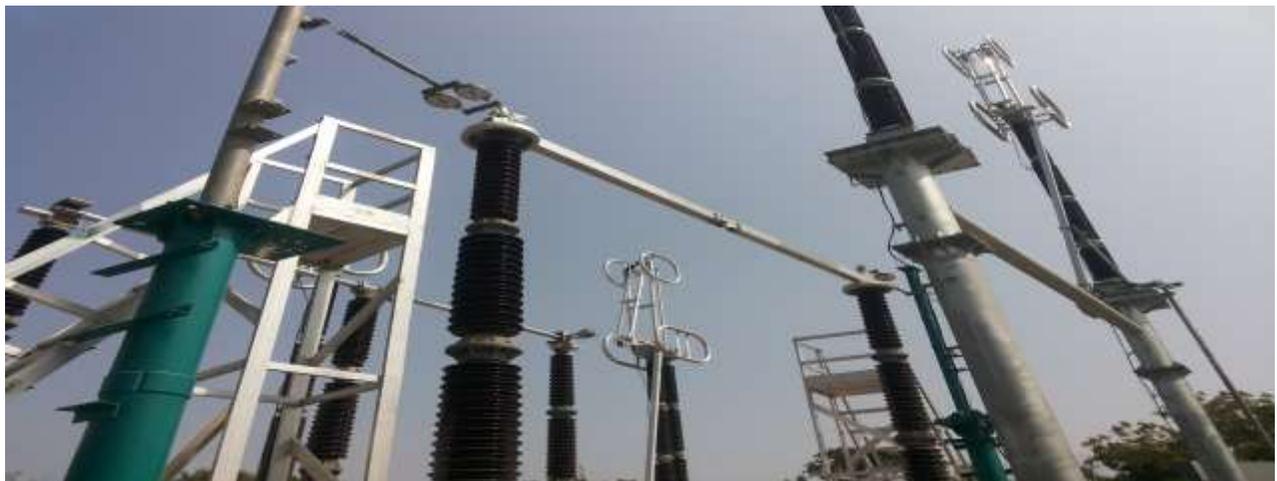
Figure -07 Mechanical Endurance test .

- No dimensional variation is observed on the Terminal Housing and the stem.
- Slight impression has been observed on the terminal stem and on balance components no wear and tear is observed.
- Multilams are found to be in healthy condition.

**For the slight impression on the terminal stem, it has been apprehended for increasing the hardness of the terminal stem similar to the terminal housing which is 120 BHN.**
