**RESTORATION WORKS FOR THE COLLAPSED PORTION OF**  
**CIRCULATORY WATER CHANNEL**  
**AT NTPC/TSTPS**

**M N Santosh, Mgr. (Civil), TSTPS**

**B Ramesh , Dy. Mgr. (Civil),TSTPS**

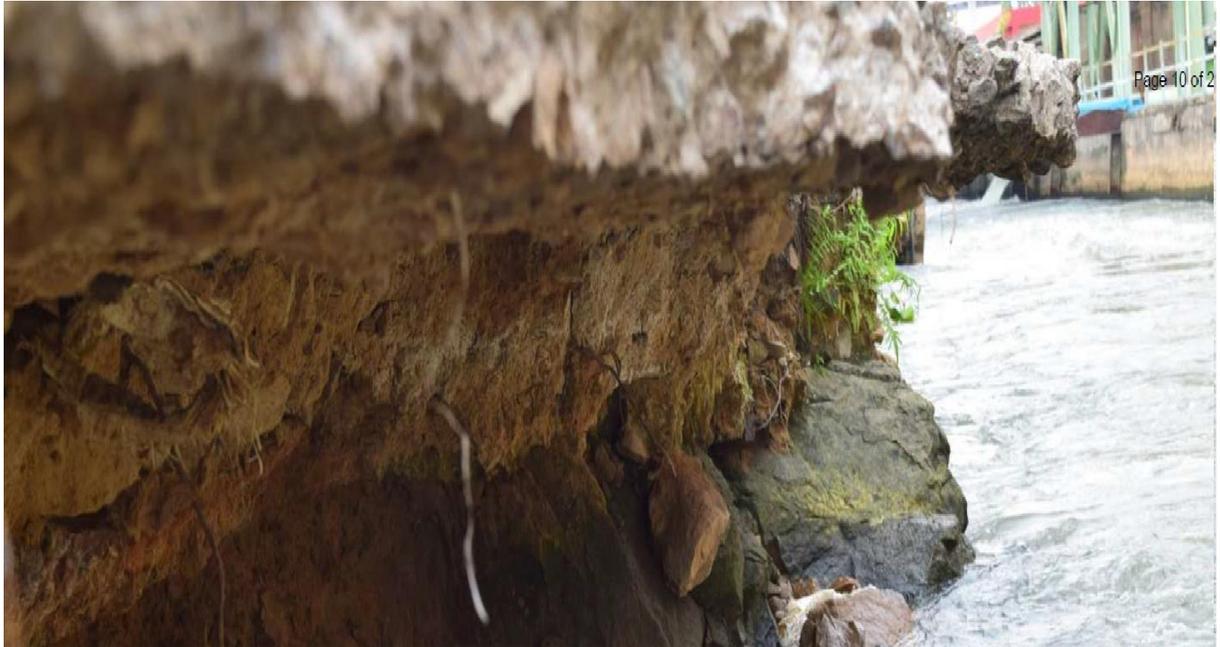
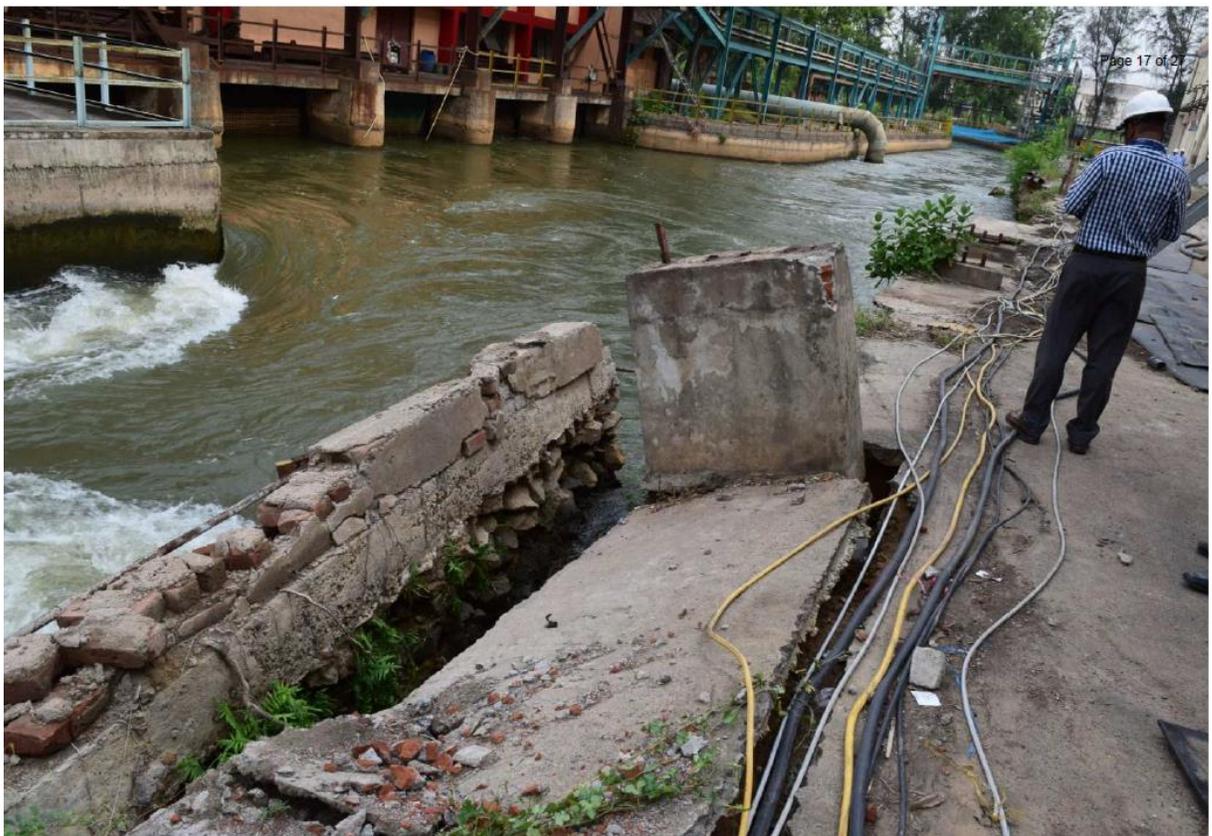
b. Damages caused by erosion of the CW channel bank

And simultaneously, it is learnt that the erosion and scouring had taken place on the banks of the CW channel, thereby, making the banks of CW channel much unsafer and causing impact on the functioning of pumps and turbines due to siltation of channel. After considering all the exigent conditions, it has been decided to take up this work by consulting with M/s L&T. Accordingly, this contract is awarded to M/s L&T to complete the task of restoration works of CW channel.

It represents preliminary details of the topographical survey carried out close to the damaged portion of the channel. Based on survey observations, the total length of damaged portion is approximately 55m . The damage along the vertical direction of the channel section is not fully visible presently hence not clear at this point of time. Based on the initial assessments, it is assumed that a part of the RCC side wall is damaged and there are remnants of the damaged portion still held by the reinforcements which are presently under water. Present topographic survey is prepared based on the temporary bench mark created near to the channel.

After reviewing all possible options for the restoration, a scheme with vertical sheet pile wall held by horizontal and inclined tension members connected to steel piles penetrated sufficiently into the rock is being proposed.
