## **OPERATION OF ONCE THROUGH COOLING WATER SYSTEM – THE CHALLENGES**

*Steag O&M Company Pvt Ltd, Vizag.*

## TOPIC: POST COMMISSIONING AND STABILIZATION ISSUES OF NEW PLANT

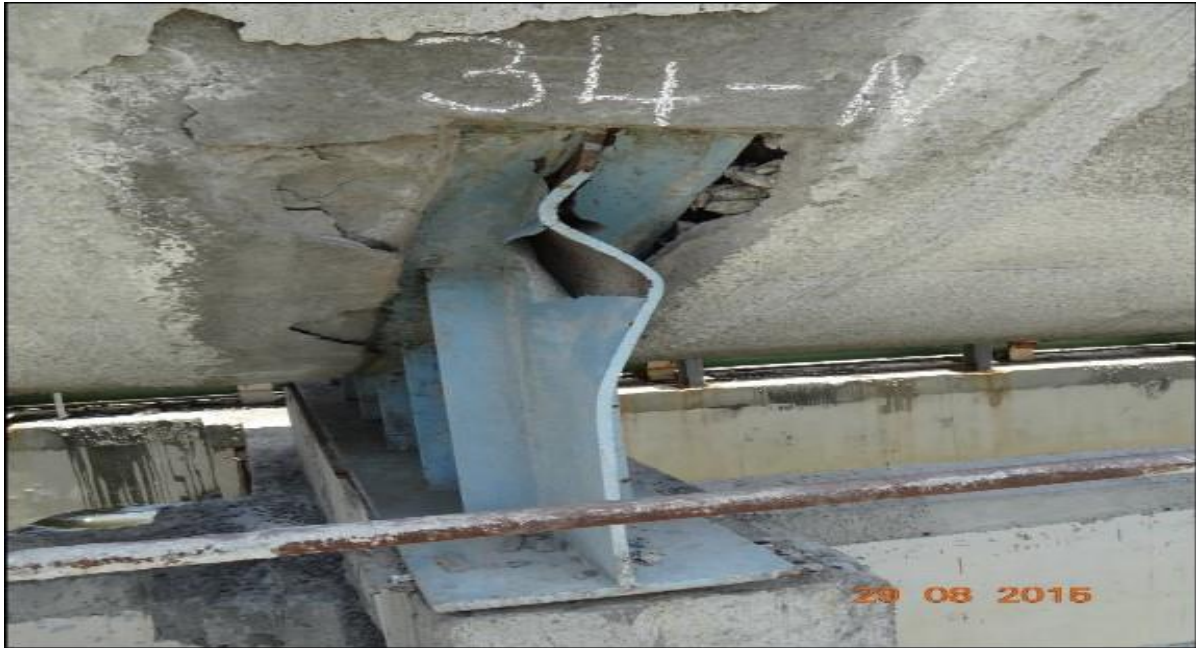
Fig-2

After tripping of the pump, deformation was noticed in the pump discharge pipe support structures and the buckling of the intake pipe. Major deformation of the supports on jetty was observed on the portion of pipe adjacent to the expansion bellow and on both sides of the expansion bellow.

- Additional air release valves were installed at the header on jetty, at the place where maximum disturbance was created
- Discharge valve closure period adjusted as recommended in the transient analysis report
- The saddle contact area with the pipe was increased from 120 degrees to 180 degrees, for proper distribution of load
- Cleaned the surfaces of PTFE bearings and ensured the required contact area between insert plate and PTFE bearing

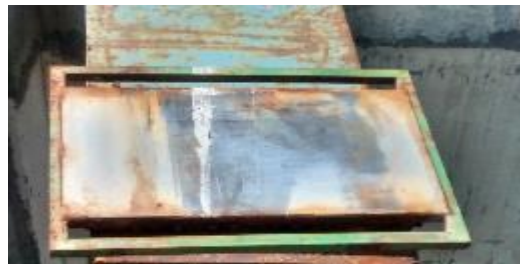
- ❖ PTFE bearing surfaces, on which the pipe support saddles rest, was found with grit and concrete debris, which might have restricted free movement. The insert plate on which the PTFE bearing was resting, was found deformed and the point of contact was not full, which could have affected the load-bearing capacity of the bearing.

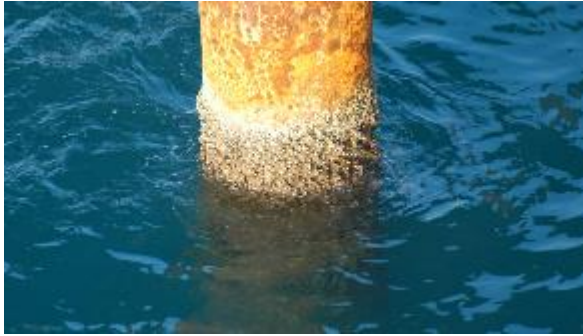
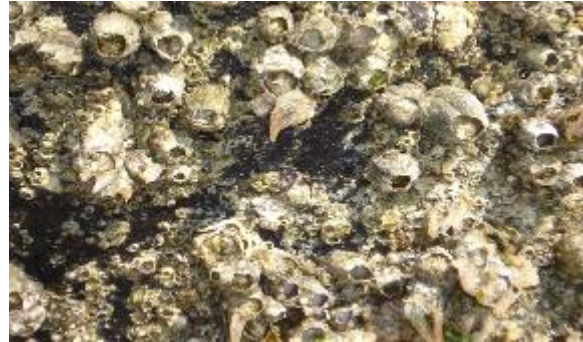
The major challenge encountered during the operations are the bio-fouling, which comprise of both micro fouling and macro fouling. Bio fouling consist of barnacles, tube worms, mussels and debris, which grow and colonize in circulating water system. Of these, *M. Sallai* is the most dominant, which

grows at very rapid rate – deposit of 30 mm in 15 days. About 100 kg/Sq.M of fouling debris accumulates per annum.

The greatest hazard of these marine fouling is that they grow, detach and block condenser tubes, cause reduction in efficiency.

Marine fouling along with high turbidity, silt and aqua-culture is causing choking of ultra-filtration system in desalination plant, ACW self-cleaning strainers and debris filters at condenser inlet, thereby affecting the availability and efficiency of the equipment.

Bacterial slime can be controlled by injecting chlorine at 2-3 ppm for 15 min every 6 hour. But this had little effect on mussels as they close up when the chlorine is on, and open up and start feeding as soon as the chlorine is switched off. Later, the schedule was revised to continuous dosing and intermittent shock dosing to maintain a minimum free residual chlorine (FRC) of 0.5 ppm.

A modification in hypochlorite dosing system was made to ensure equi-distribution of Hypo Chlorite across the caisson to prevent entry of aqua-culture.

To control the entry of aqua-culture and silt in the feed water of desalination plant, settling chambers were introduced. Later, hydro cyclone separators were introduced to further minimize the ingress of silt in the ultra-filtration system.
