DESIGN ISSUES IN GENERATOR BUS DUCT CT MOUNTING SYSTEM

**Suresh Waryani; AGM.(EM)
NTPC Ltd. MSTPP
Sachin Garg; Manager (EM)
NTPC Ltd. MSTPP
V.S.C.Gupta; Manager(EM)
NTPC Ltd. MSTPP**

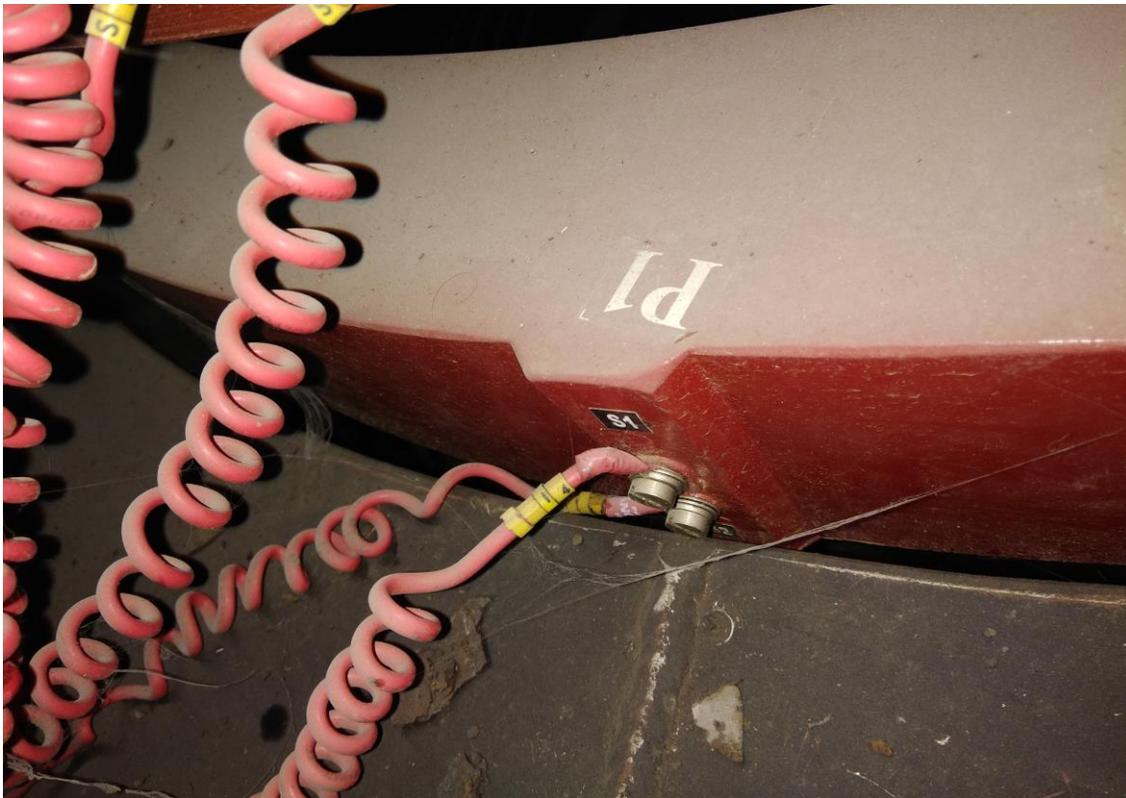
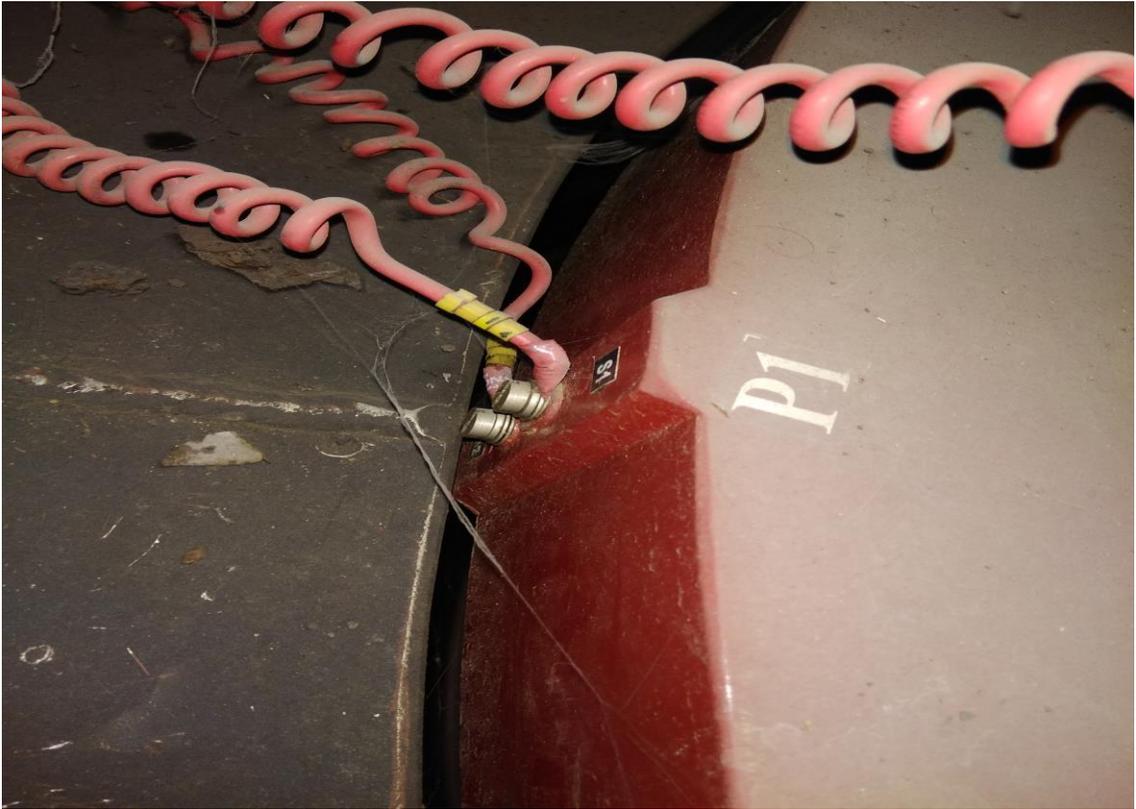
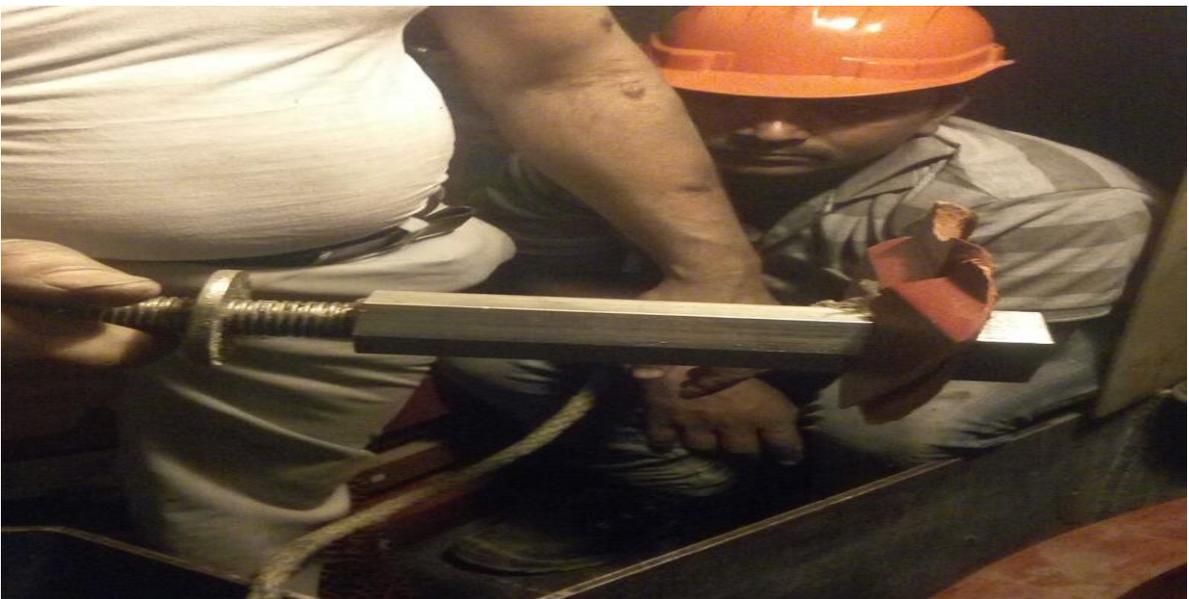
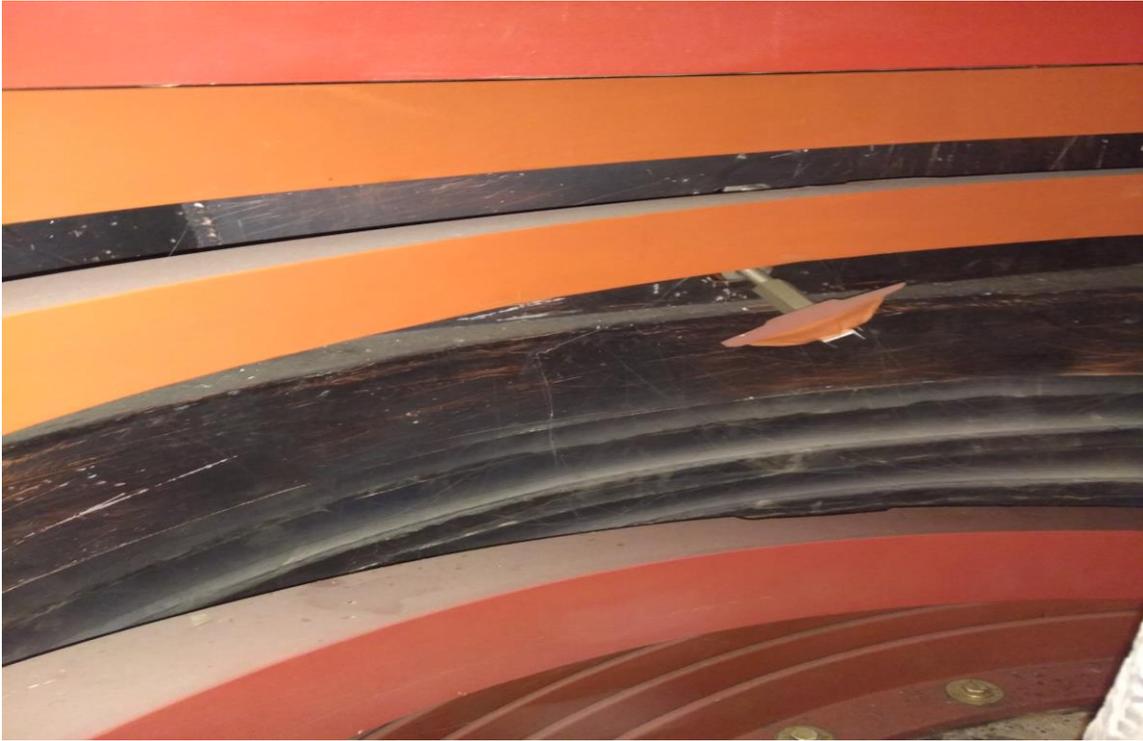
3. After opening of Generator bus duct cover, it was found that many of the CTs are dislocated from their mounting positions and R phase CT of the phase side was found touching the metallic structure of bus duct causing the protection relay to operate. The CT got detached from the support and dislocated from normal position.

4. In Unit#3: The epoxy mounting neck in three CTs found damaged and in another three CTs cracks observed in epoxy mounting area.

1. Replacement of existing long length adaptor with additional aluminum (nonmagnetic) bracket support and short length adaptor. An additional locking nut was also provided for additional support.
2. Damaged six number CTs have been replaced with new CTs. Mounting of the CTs were done after proper centering and then they were mounted on specially fabricated C type brackets as shown in the picture.
3. CT secondary terminals were protected by providing insulation to avoid similar occurrence.

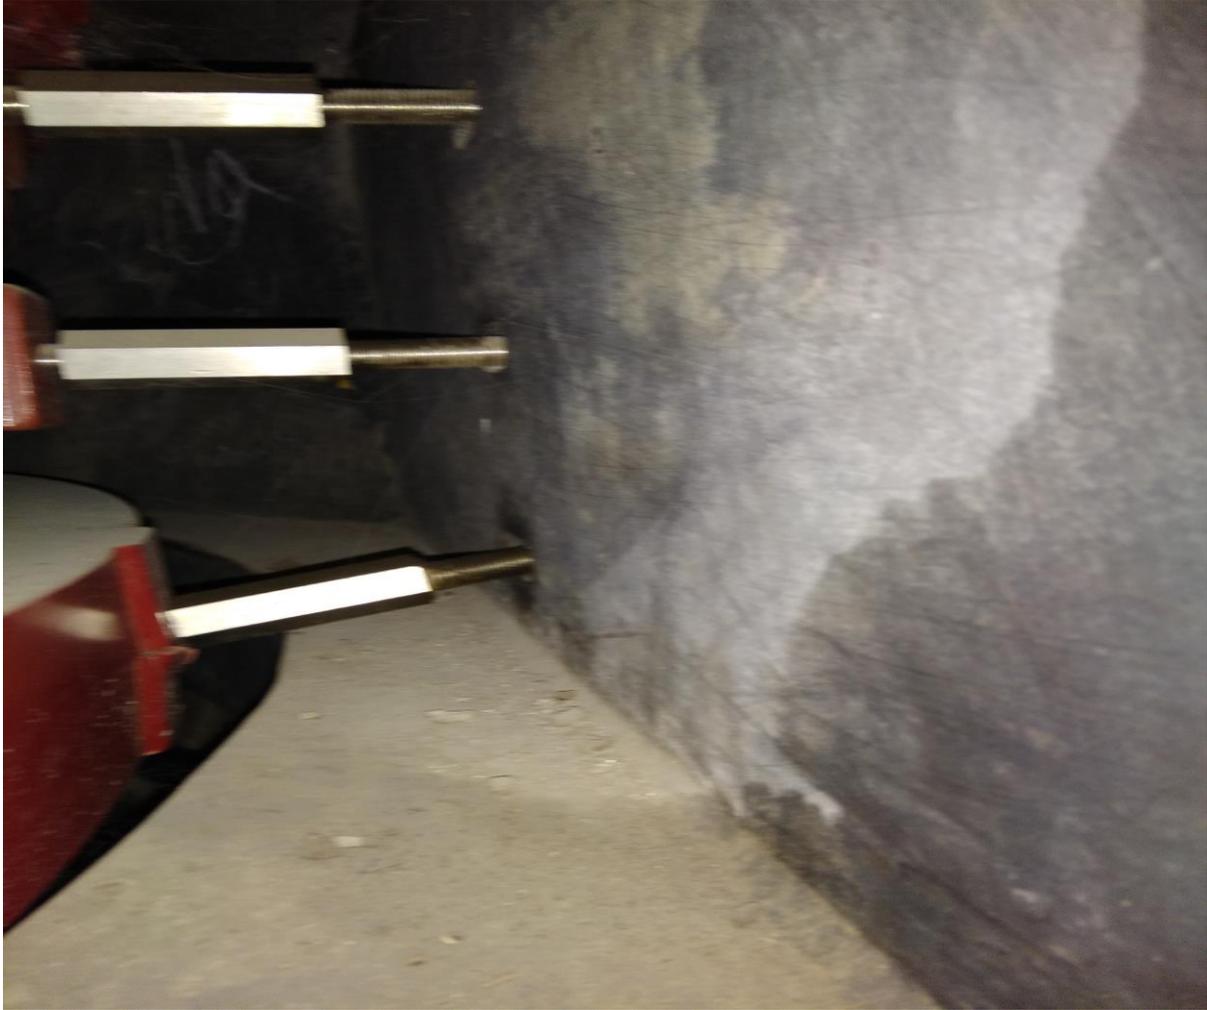
1. It was observed CT mounting bolts with Busduct enclosure were of longer length. Apparently after getting in to service they were not able to sustain the large weight of protection CTs under magnetic forces and resulting stresses on CT epoxy mold leads to breaking of epoxy material of CT.
2. Also the CT secondary terminals were not insulated/protected for this incident.
3. After discussion with OEM it was concluded that the failure is due to the larger and unequal spacing between CT and bus duct enclosure.
