Sustainable Evacuation of Dry Fly Ash at IGSTPP – A Unique Experience

ABSTRACT

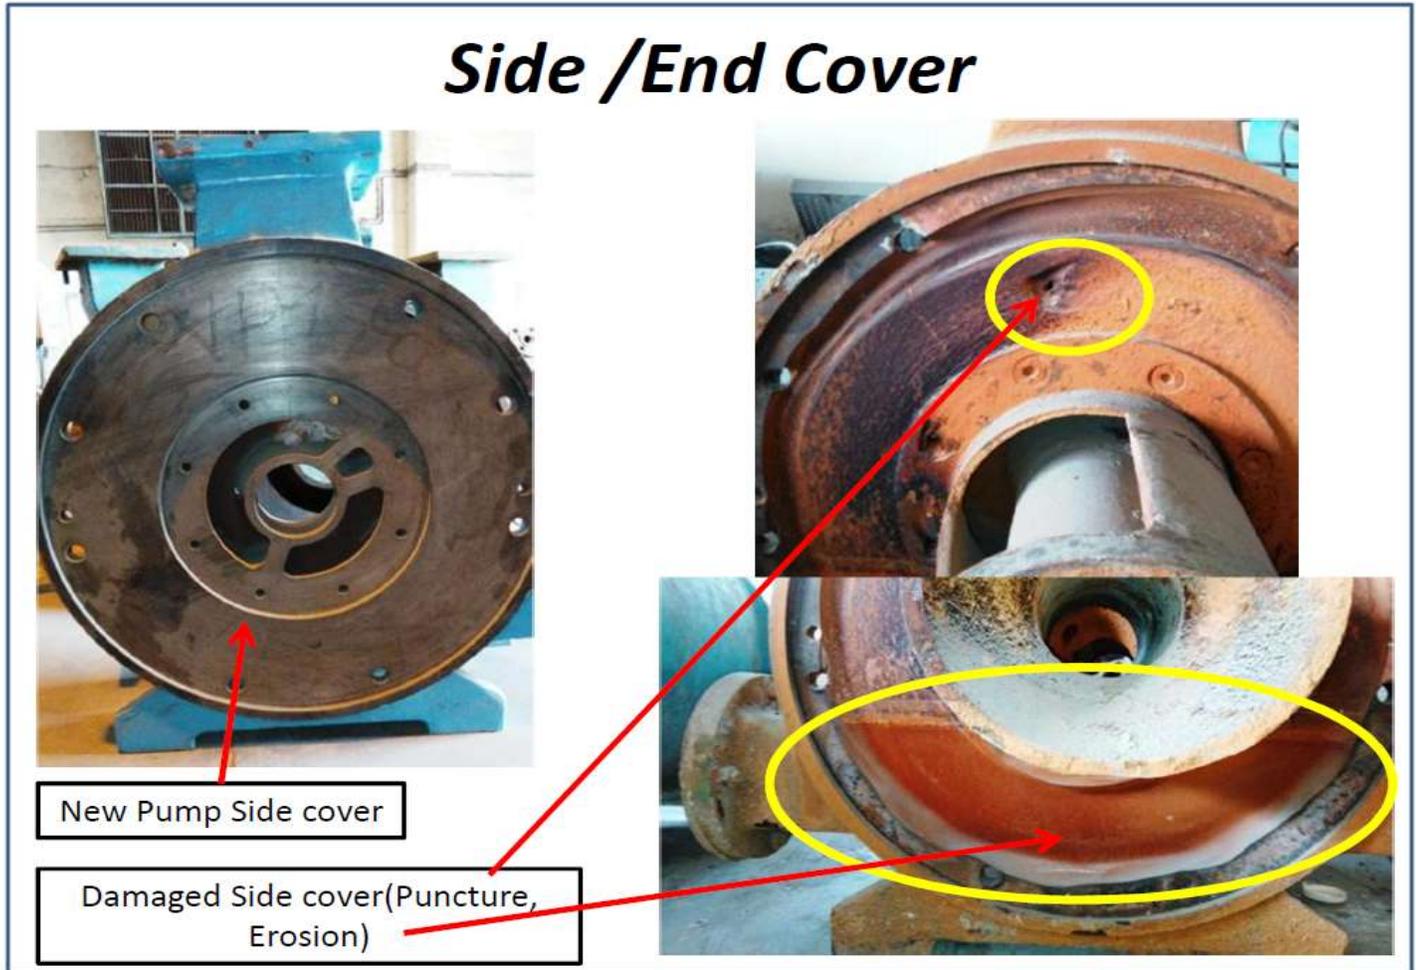
Root Cause Analysis for Fast Erosion of vacuum Pump Internals & Seal water Drain lines

- ✓ As Hopper becomes empty vacuum pumps extracts Flue gas from ESP hoppers and leads to Acidic seal water

Remedial action taken for elimination of fast erosion of vacuum pump Internals & seal water Drain lines

- ✓ Vacuum pump Internals materials has been changed from CI FG 260 to SS 410. The life has been improved to more than 1 year.
- ✓ Seal water Drain lines material has been changed from CS to SS 410.

- ✓ Silencer Cum Separator tank has been fabricated from SS 410 Sheet, Locally at Site.

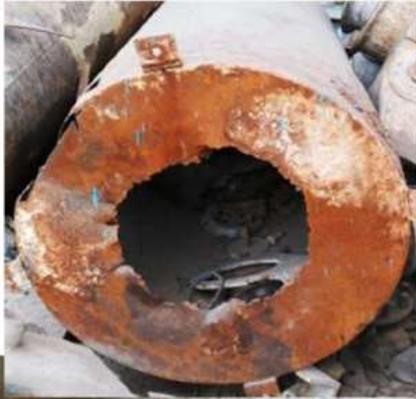
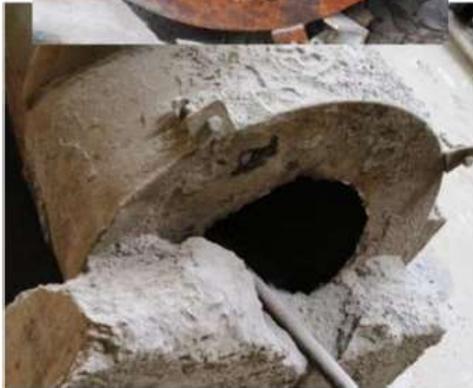
Silencer Tank

Damaged Silencers due to corrosion/erosion

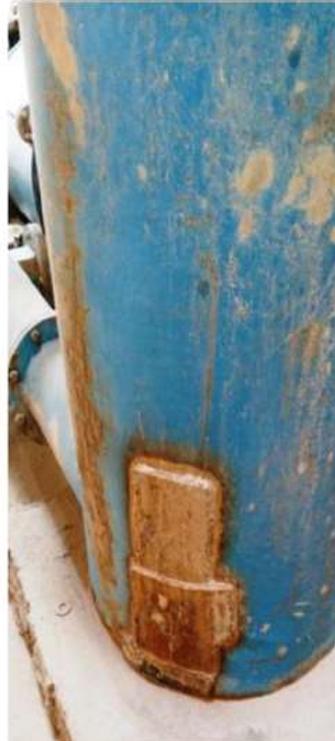
Repaired by Patch welding

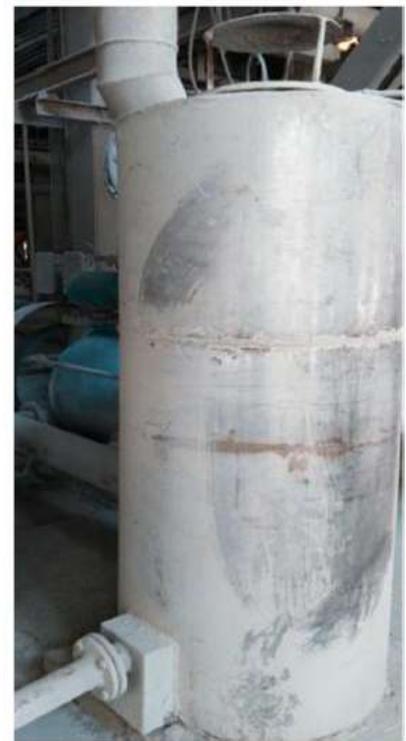
Stainless steel silencer Fabricated at site

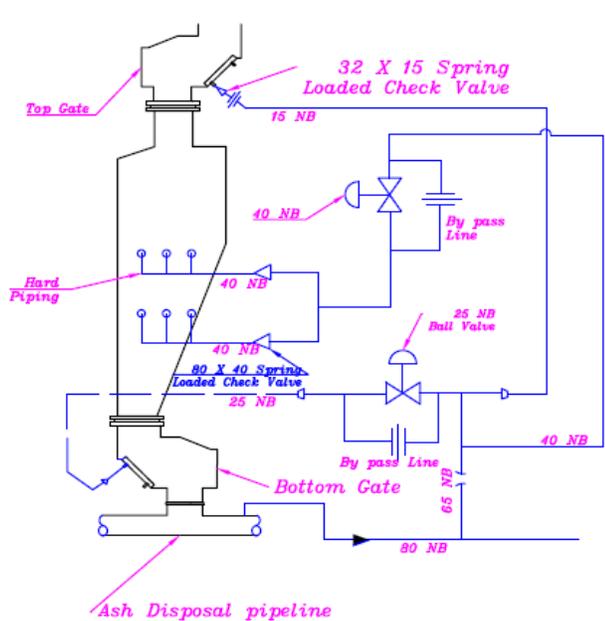
Earlier Box type fluidising hard piping scheme has been replaced by flexible hoses with M80 hexagonal adapter. In earlier scheme Champion Gasket & Neoprene Rubber gasket were used for sealing purpose (shown in above figure 2, LH side). These Gasket were got damaged as come in contact with high temperature Ash. Now, Silicone Rubber is being used in with M80 adapter (as shown in Fig. 2, Right side).

Existing Fluidising Scheme

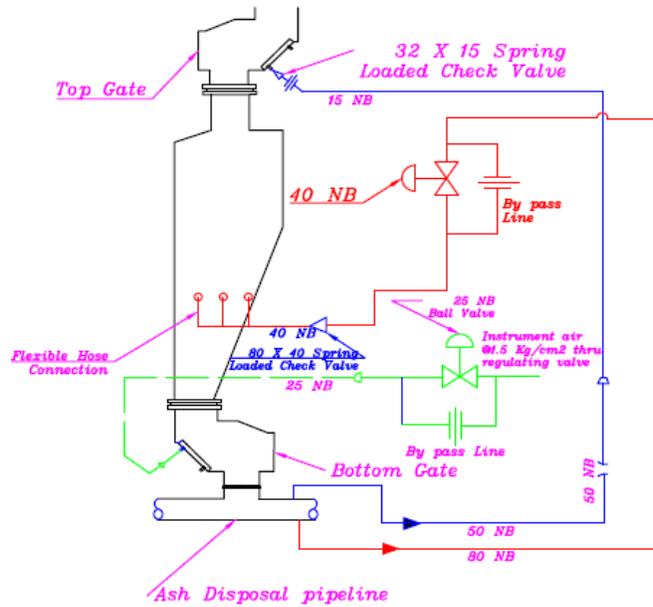
Modified Fluidising Scheme

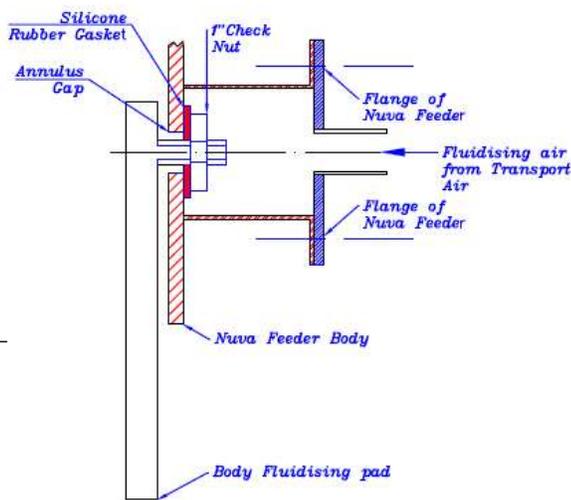
Current Body Pad Fluidising Arrangement

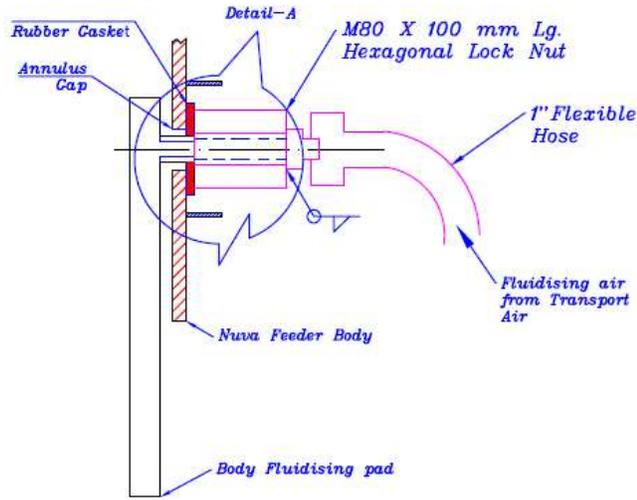
Modified Body Pad Fluidising Arrangement

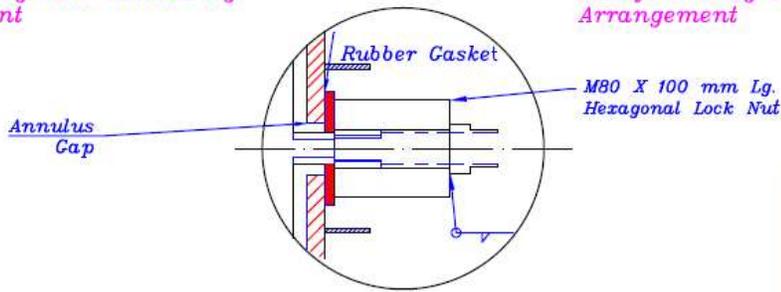
Fig: 2

Drawn by: ARAVALI POWER COMPANY
 PRIVATE LIMITED
 (A Joint Venture of NTPC, BHEL & IGCIL)
 Stage-1 (3 X 600 MW),
 Unit # 1, 2 & 3
 Date: 08/08/2010
 Modified Nuva Body Fluidising arrangement

Nuva Feeder Bottom gate Fluidising has been provided from Instrument Air, Pressure of this Instrument air is regulated to 1.5 Kgs. The modified scheme of bottom gate is as per figure 2.
