MEETING THE CHALLENGES OF MAKE-UP WATER REQUIREMENT FOR NTPC/BgTPP

By. **1. M M Ghosh, AGM (Opn.), NTPC/BgTPP**
2. S. K. Nayak, AGM (MM) , NTPC/BgTPP

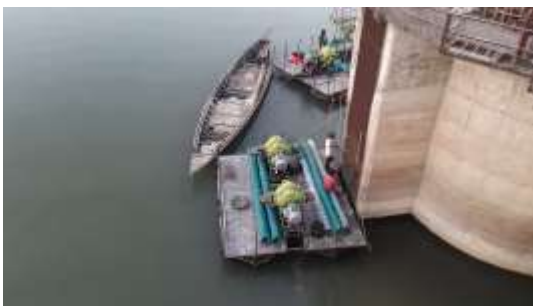
Fig-1 (Barge Pump under erection)

In order to run the main make-up pumps, as an alternate measure, low head high capacity barge mounted pumps are installed for trial in one of the pump pit (well). In this arrangement, for pumping water from river to pump pit, two nos. of barge pump having capacity 700 M3/Hr and 4 Mtr. head powered by 15 KW motor each are installed on each barge. Thus two barges with pumps are installed in the river for supplying water to the Pump Pit #1, so that Pump#1 can be run on full capacity. On 30.12.2016, main pump #1 could be run in association with barge mounted pump successfully.
