Improving Reliability of Stacker Reclaimers

B V Subramanyam
AGM(EM)
NTPC, RAMAGUNDAM

S Md Rasool
MANAGER (EM)
NTPC, RAMAGUNDAM

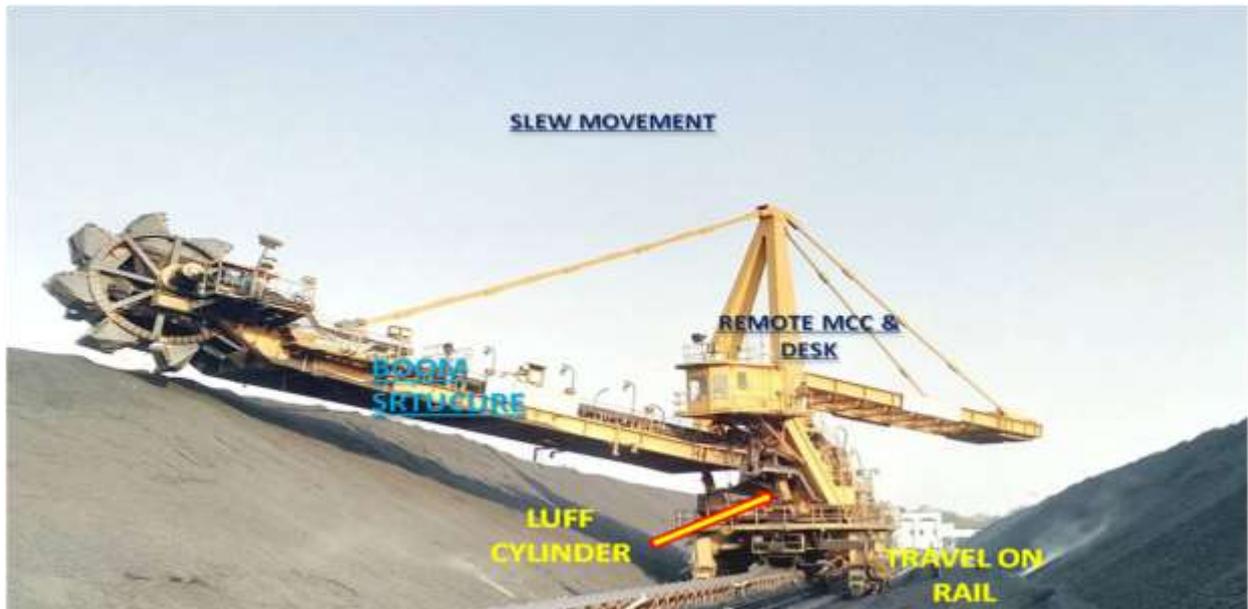
Figure.1:-S/R features

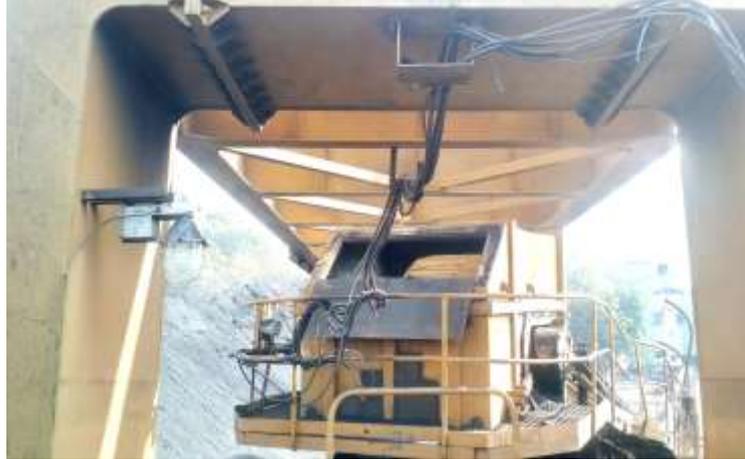
Fig.2. Profibus cable routed outside the inner slew ring

The PLC communication failure has been avoided by removing OFC cable and by a new profibus communication with new cables routed outside the inner slew ring.

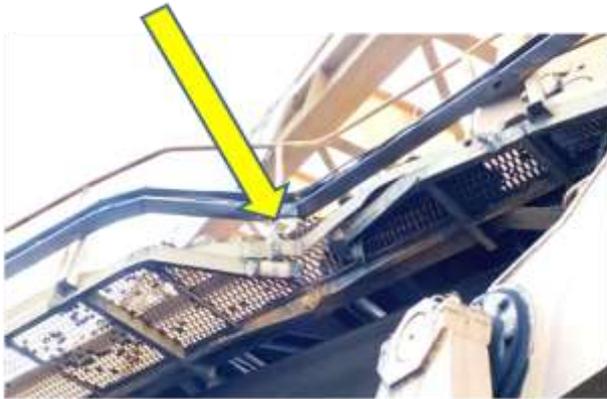
S/R-3 FIXED TROLLEY DAMAGE

1. The boom structure while moving at full slew speed and hitting the trolley structure due to inertia.
2. When boom is at full 90 deg with slew end limit acted condition and given travel forward command, then the Boom structure is forced to move back warded (when the bucket is stuck/jam in coal heap) and damage the fixed structure.

New logic was incorporated in S/R-3 PLC for long travel forward command. When the slew end limit switch is acted (i.e Boom is in 90 deg.) Long travel forward command is disabled.

To control the Slew speed of boom structure the speed control limit switch are placed before the end limit switches. The slew speed is reduced to 40% before the slew end limit (i.e Boom is in 90 deg.) is reached.

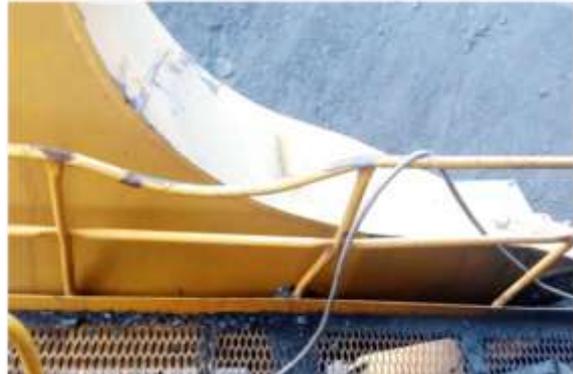
S/R-3 BOOM MOVING STRUCTURE TOUCHING THE TROLLEY

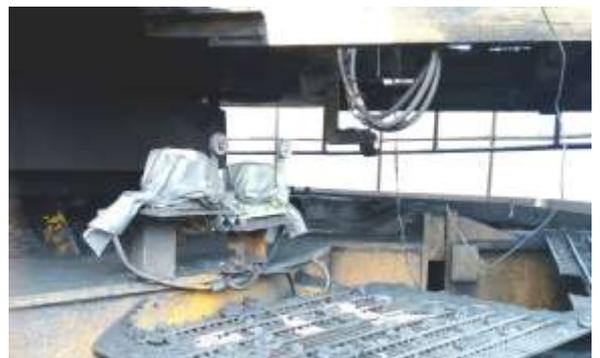
Fig.3:- Slew Speed reduction Switch

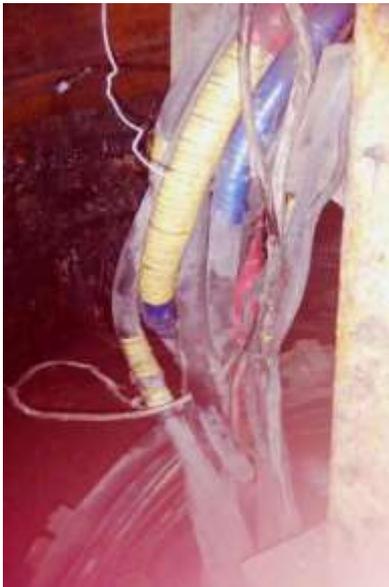
- On a helical plate, cables are dressed on two rounds of plate for expansion and compression movement.
- The plate is welded on either sides of moving and fixed body.
- Rollers are provided on the bottom of the plate for movement while slewing
- The helical plate expands on moving from -90 deg to +90 deg. And so the cable on it.
- Over the period, all the cables failed due to Mechanical jamming of rollers and other associated problems and the reclaimers were running with cable joints.
- The slew ring hull gets filled with coal dust and the wheels get jam.
- Any leakage coal is getting accumulated in the gap of plates.
- The compression and expansion of the helical plate is not possible ;with this the cable comes under stress and resulting in cables damage.
- The rubber cables were frequently getting damaged.

Fig.4:- Cables Damaged

Joining of the damaged cables in Inner slew ring was taking long hour due to limited Ventilation, Space, Access & Lighting. There were occasions of helical plate getting damaged, Boom Motor got burnt due to single phasing, Helical plate end welding failed due to jammed rollers below the plate.

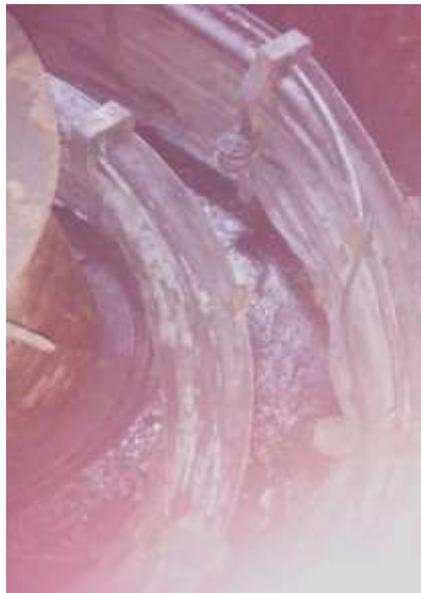
Fig.5:-Cables dressed on the Helical plate

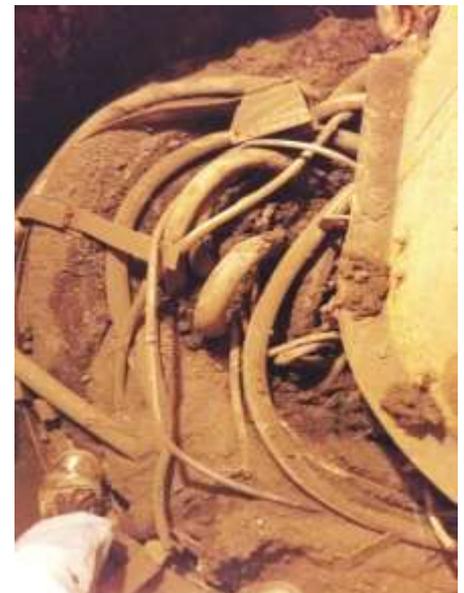
Fig.6:-Cables and rollers in jam cond.

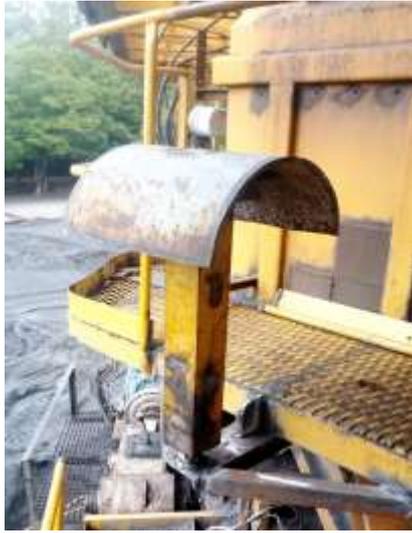
Fig.6:- Hinge support for Cable movement

- Required cable tray welded at fixed and moving body
- HDPF pipe kept ready for remote I/O panel communication cable.
- Cable moving part hinge supports made ready

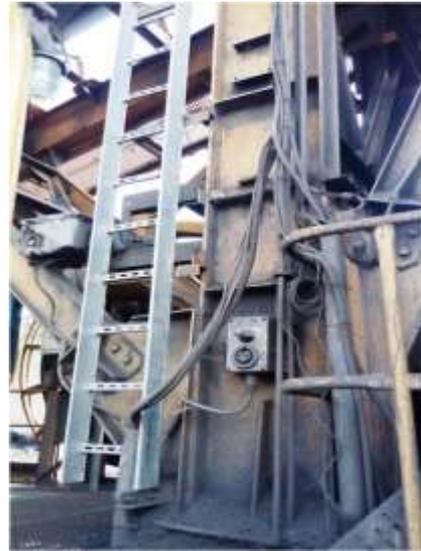
Fig.7:- New Cable trays laid

Permit taken and inner slew ring cleaning including cables trays done. Marked cable before removal and cables laid in the new route. Cable straight through jointing done. Un-used cables were removed.

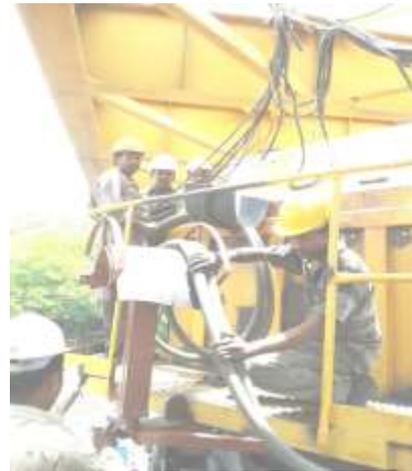
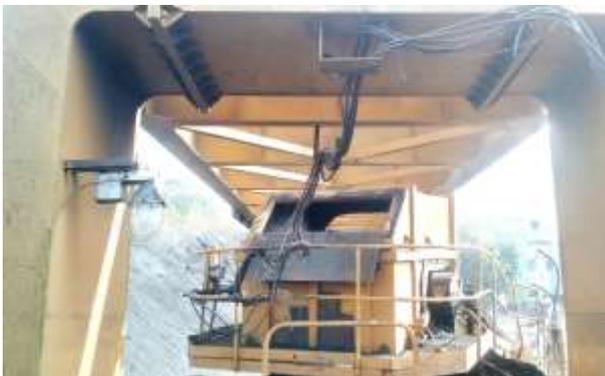
Fig8:- Before modification

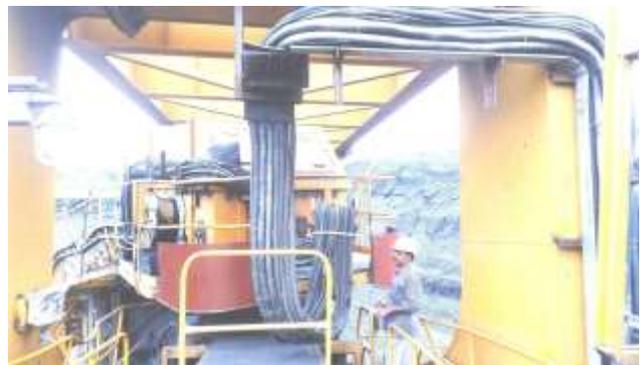
Fig9:-After modification

The power control and communication cables should be routed through the fixed structure by adequate loop in cables to the moving Boom structure to improve the safety of the personal and equipment; also to improve the working condition of the personal.
