# **“PENT HOUSE ASH REMOVAL THROUGH HYDRO EJECTOR IN TTPS”**

## **A CASE STUDY OF LEARNING THROUGH MISTAKE.**

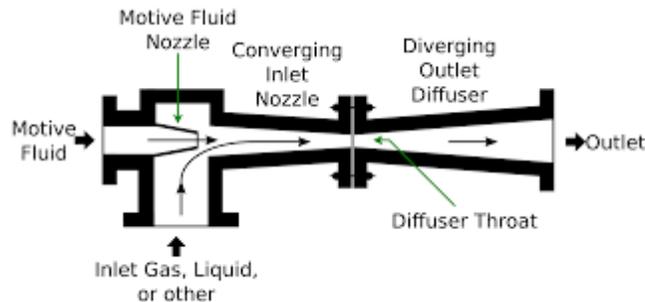
**BASICS OF EJECTOR:**

Ejectors are designed to convert the pressure energy of a motivating fluid to velocity energy to entrain suction fluid and then to recompress the mixed fluids by converting velocity energy back into pressure energy. This is based on the theory that a properly designed nozzle followed by a properly designed throat or venturi will economically make use of high pressure fluid to compress from a low pressure region to a higher pressure. This change from pressure head to velocity head is the basis of the jet vacuum principle.

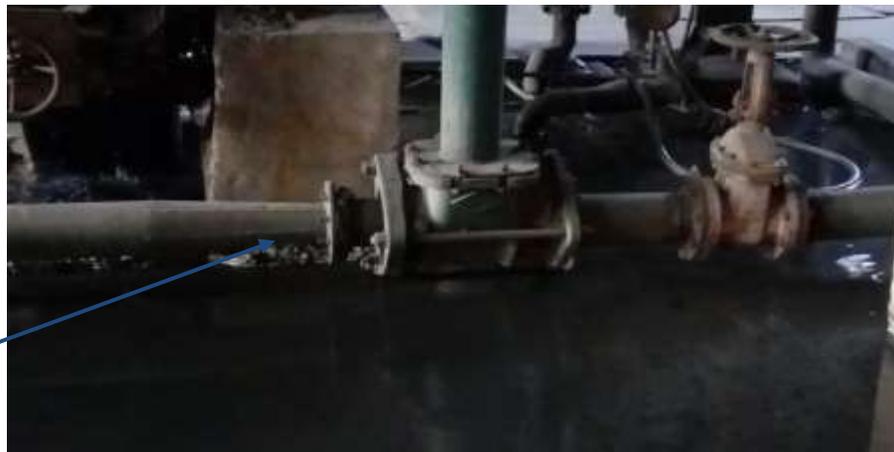
Fig- 1

**Earlier set up without throat**

As there was no improvement in ash evacuation, the complete ejector assembly was changed with diffuser throat increaser ( This was missing in the previous arrangement – Fig 1). The discharge line was modified for smooth flow of ash mixed water. The system was then put in service . Vacuum developed was in the range of 200 to 250 mm and found to be working even at 12 Kg water pressure. In previous arrangement , the ejector was found to be effective at water pressure of 15 to 17 kg. To maintain water pressure , one has to stop the pent house cleaning for bottom ash deashing of other unit . But with the modified arrangement , it was observed to be equally effective even at 12 kg pressure ( Pressure drops

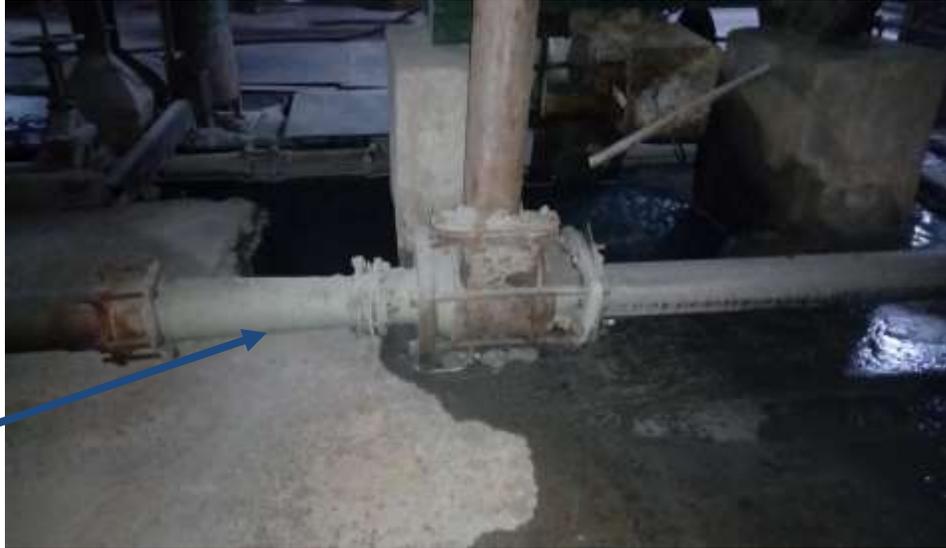
**Throat  
added to the  
existing  
ejector set**

when both units ejector are taken into service). Vacuum got maintained till the end of cleaning activities . Pent house ash removal could be completed in 3 to 4 days , which in future would help in potential saving in power and water consumption. The issue found to be the diffuser throat which forms the part of the venturi , which was missing in the earlier arrangement ( Fig 2).
