MODIFICATION OF CONSEP ASSEMBLY OF ARU 500 MW CPU NTPC FARAKKA-A CASE STUDY

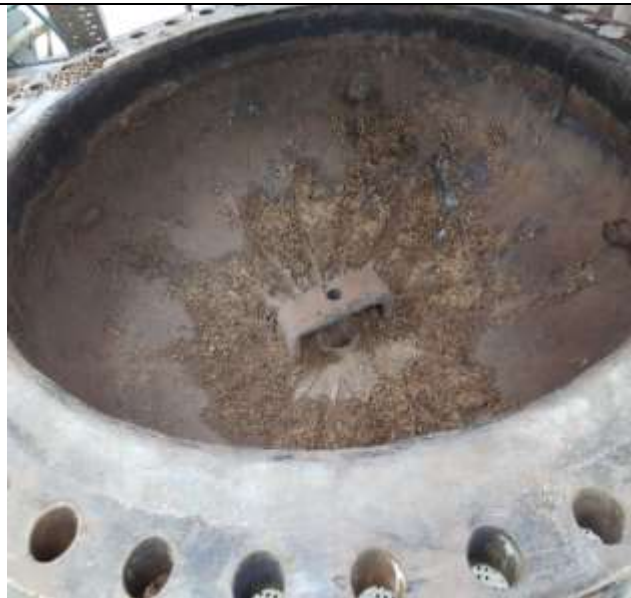
FIGURE 3

After dismantling the bottom CONSEP assembly it was observed that the central disc and its nearby sand matrix has got cracked (Fig1 &2) .It was decided to remove the entire sand material and laterals and collectors were exposed (Fig-4&5). Layerwise samples were collected as shown the figures below .It was found that bottom CONSEP assembly is casted in different size of sand grains and bonded with unknown chemicals.
