# HP TURBINE BREECH NUT REPLACEMENT-JHAJJAR EXPERIENCE

## (500 MW BHEL KWU)

**Vikram Jeet Saini, Manager (TMD), NTPC Jhajjar**  
**Sanjay Nandal, Manager (TMD), NTPC Jhajjar**

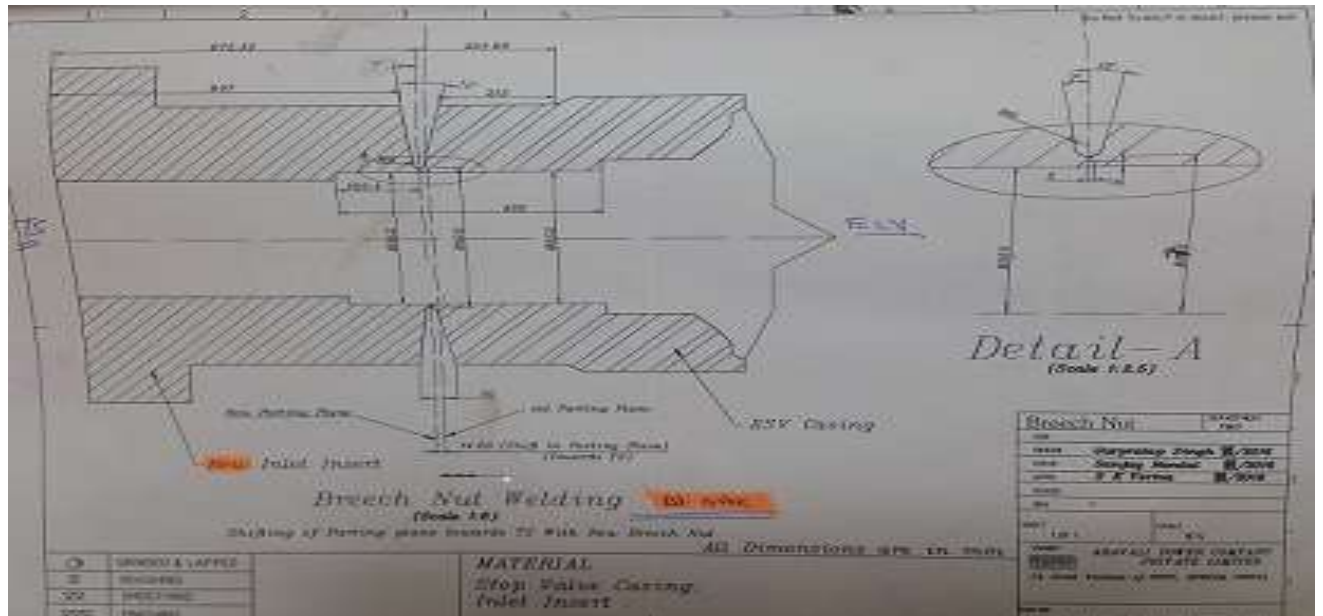
## FIT-UP OF INLET INSERT WITH VALVE BODY:

The new inlet insert was machined at APCPL workshop in the CNC vertical turret lathe (VTL) as per dimension. Edge preparation was carried out at valve body by same cutting arrangement. Fit-up of new insert with valve body was a critical job as it should be inserted with total 02 mm clearance diametrically.

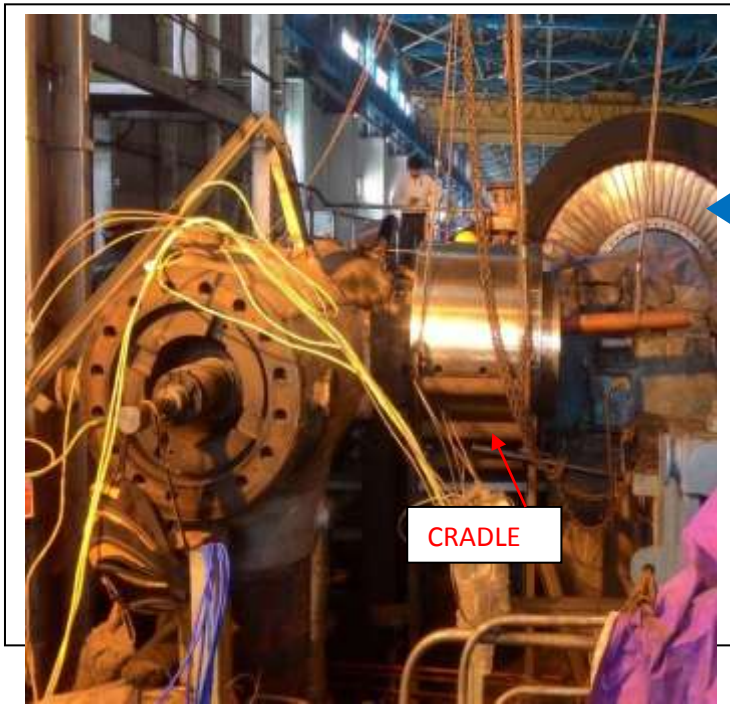
FINAL FIT-UP

Inlet insert with valve body was loaded over cradle and hanged with help of EOT crane and slided with help of fixture to fit with valve body. Than breech nut was tightened with HP turbine outer casing.

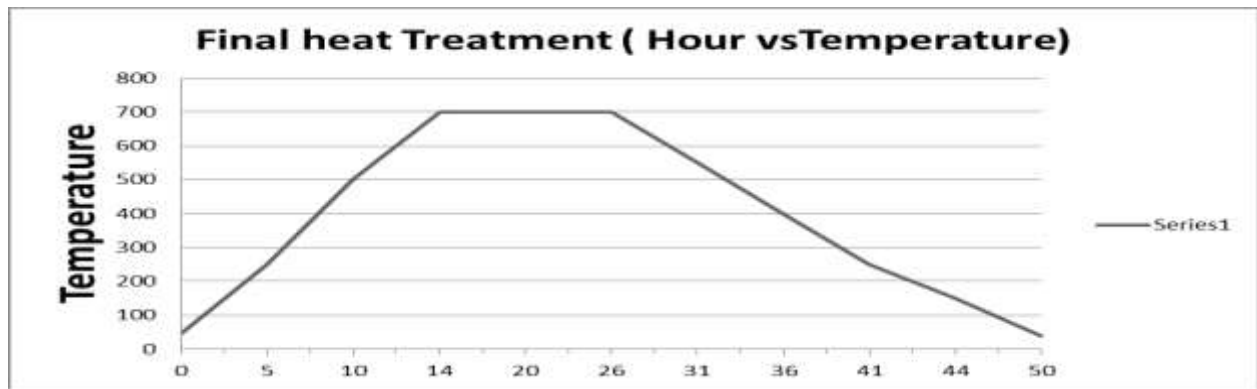
<b>4. Final Weld pass Joint</b>	
<ul style="list-style-type: none"><li>• Preheat Temperature : 300-350 Degree C</li><li>• Final Pass Joint (up to 150 mm)</li><li>• Final UT of weld joint at Ambient Temperature**</li><li>• MPI and DPT</li></ul>	
<b>5. Post Weld Heat Treatment</b>	
<ul style="list-style-type: none"><li>• Heating rate: 50 Degree C/ HR</li><li>• Soaking Temperature: 680-700 Degree C</li><li>• Soaking Period: 12 Hrs.</li><li>• Controlled Cooling rate: 30 Degree C /hr (upto 150 Degree C)</li><li>• Further Cooling (from &amp; below 150 Degree C): Ambient Cooling</li><li>• UT, MPI and DPT after SR</li></ul>	
<b>Note:</b> * Preheat Temperature : 300-350 Degree C	
Interpass Temperature (max.): 350 Degree C

** Controlled Cooling up to 150 Degree C & further Cooling in ambient conditions.

**\*\* Cobalt source is used for RT at 120 mm weld thickness. Special agency has been mobilised from Mumbai for this work. Extreme care was taken at site as cobalt is highly radioactive material.**
