LEARNING BY FAILURES – A TRANSFORMER CASE STUDY

A QUALITY PRESPECTIVE

NTPC, Regional Inspection Office, Bhopal

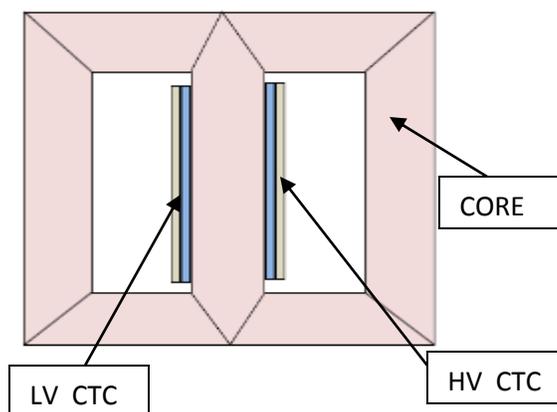
FIG. 1 315 MVA Generator Transformer

The design specification of GT was provided by a foreign collaborator to reputed and experienced Indian manufacturer. The subject transformer manufacturing was going on well with all quality checks and records till the Vapour Phase Drying (VPD) process. After VPD at the stage of servicing before tanking, as per scheduled check an isolation test at 10 KV between Core laminations and Core clamping structure was performed. On application of high voltage, voltage couldn't reach beyond the level of 8 KV and collapsed. On second attempt voltage collapsed only at 800 Volts.

Investigational isolation tests were done by separating various parts of core clamping structure. On investigation it was found that the HV side top and bottom, LV side top structures withstood the test. However, LV side bottom along with LV side clamp plate could not withstand the voltage.

An 8 MM insulation of Nomex paper board was used to withstand 10 KV between clamp structure and core. Although Nomex paper is having good electrical properties but mechanically it is compressible (soft). Due to compression of insulation paper the designed thickness got reduced and the insulation failed to withstand 10 KV voltage.

The details of failure were reviewed by the design group of collaborator and the Indian manufacturer. It was observed that the Indian manufacturer conventionally is using Bakelite plate in between the core and clamp along with paper insulation to provide specified dielectric strength. Bakelite is non-compressive having good mechanical strength and therefore more suited to withstand the technical requirement. Hence, it was agreed that the manufacturing be redone using Bakelite plate after replacement of Nomex sheet.

All the transformer cores were dismantled, Nomex paper was removed, bakelite sheets were replaced and the core was rebuilt. The time taken to rebuild each transformer core was one month.

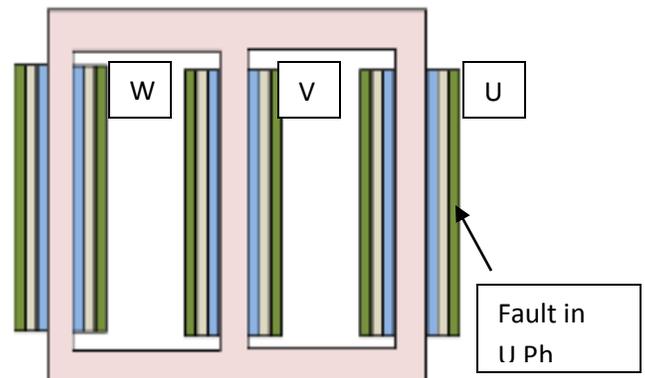
FIG. 2 : 50 MVA STATION TRANSFORMER

This station transformer successfully passed various low voltage tests, IR (Insulation Resistance),

- i. Internal surface of tank was clear and there were no blackening marks etc.
- ii. No abnormality noticed in the vicinity of any HV, LV or Tapping Leads. The OLTC was also clean and there was no abnormality.
- iii. However Tracking/ treeing marks observed on the outer surface of outermost pressboard barrier of U-phase coil (Pic.2). These marks were on diametrically opposite side of HV lead & approximately at centre location vertically. The progression of treeing/ tracking marks was in horizontal direction i.e. along horizontal periphery of outer surface of outermost barrier in the vicinity of high voltage discs.
- iv. No abnormality was observed on inner surface of the outermost barrier.

- a) The failure was a result of surface discharge phenomena i.e. treeing/ tracking on outer surface of outermost pressboard barrier.
- b) Various literatures related to this phenomena was studied and after analysis the phenomena, it emerged that fundamentally such treeing/tracking can be attributed to either of the following reasons :

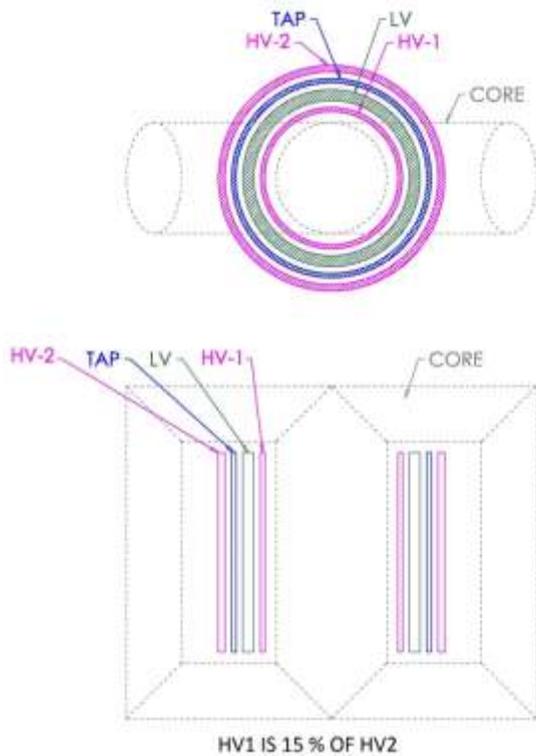
- a. 82 MVA, 13.8/420 kV, 1-Phase Generator Transformer (GT) was manufactured and dispatched for a Hydro Electric Project of NTPC Ltd. After receipt at site, GT was kept stored in N2 filled condition for almost 2 years and then in oil filled condition for 4 years till its commissioning.
- b. After commissioning, first DGA of GT conducted revealed C2H2 of 13 ppm and after 2 week DGA result for C2H2 was 15 ppm. GT was taken out of service and after degassing, GT was charged again with zero C2H2 and next DGA was taken after few

months that showed presence of high fault gases as under and GT was taken out of service for internal inspection.
