REPAIR, RESTORATION & RETROFITTING OF IN SERVICE CONCRETE STRUCTURES IN POWER PLANTS

Satish Sharma, TVG Reddy & Ankit Sharma
National Council for Cement and Building Materials

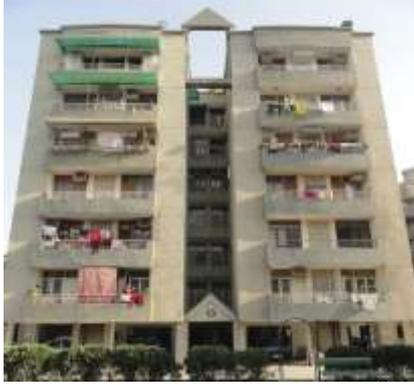
Fig.8: Front view of Housing society quarters

Distress in the form of cracking, spalling of concrete & corrosion of reinforcing rebar was observed at work site in different RCC members of different blocks of the society. Cracks were observed along the longitudinal direction of reinforcing rebar. Based on the geometric line of cracks, it seems corrosion has caused these cracks. Grit wash applied on the RCC members of different blocks was found to be de-bonded at many locations. Water Proofing was observed to be damaged in terrace. The quarters were 16 years old.
