A CASE STUDY ON BOILER TUBE FAILURE AT JPL

Introduction:

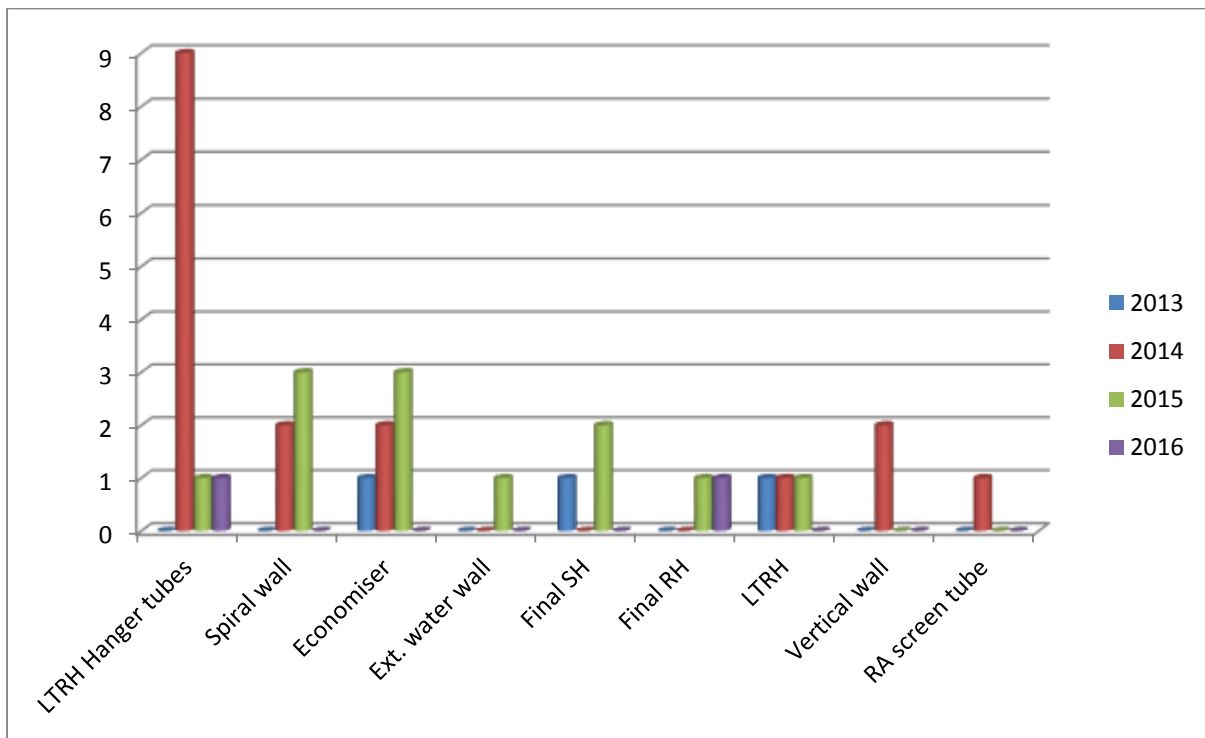
Unit Shut down due to Boiler tube failures from 2013 to 2016(till date) – area/location wise

Location	2013	2014	2015	2016	Total
LTRH Hanger tubes	-	9	1	1	11
Spiral wall	-	2	3	-	5
Economiser	1	2	3	-	6
Ext. water wall	-	-	1	-	1
Final SH	1	-	2	-	3
Final RH	-	-	1	1	2
LTRH	1	1	1	-	3
Vertical wall	-	2	-	-	2
RA screen tube	-	1	-	-	1
Total	3	16	12	2	23

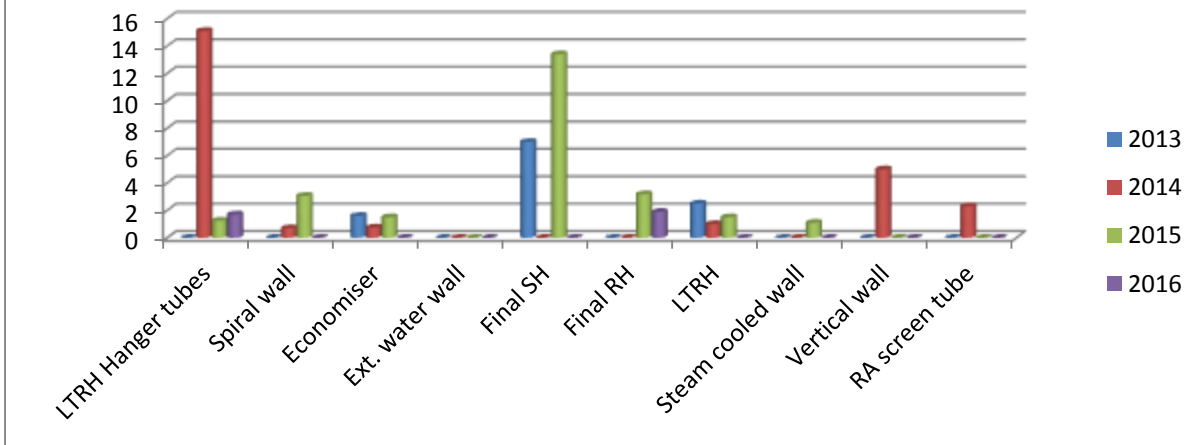
Time lost in failure repair - Location

Location	2013	2014	2015	2016
LTRH Hanger tubes	-	15.1	1.25	1.7
Spiral wall	-	0.7	3.06	-
Economiser	1.6	0.75	1.5	-
Ext. water wall	-	-	-	-
Final SH	7	-	13.4	-
Final RH	-	-	3.18	1.9
LTRH	2.5	1	1.5	-
Steam cooled wall	-	-	1.1	-
Vertical wall	-	5	-	-
RA screen tube	-	2.3	-	-

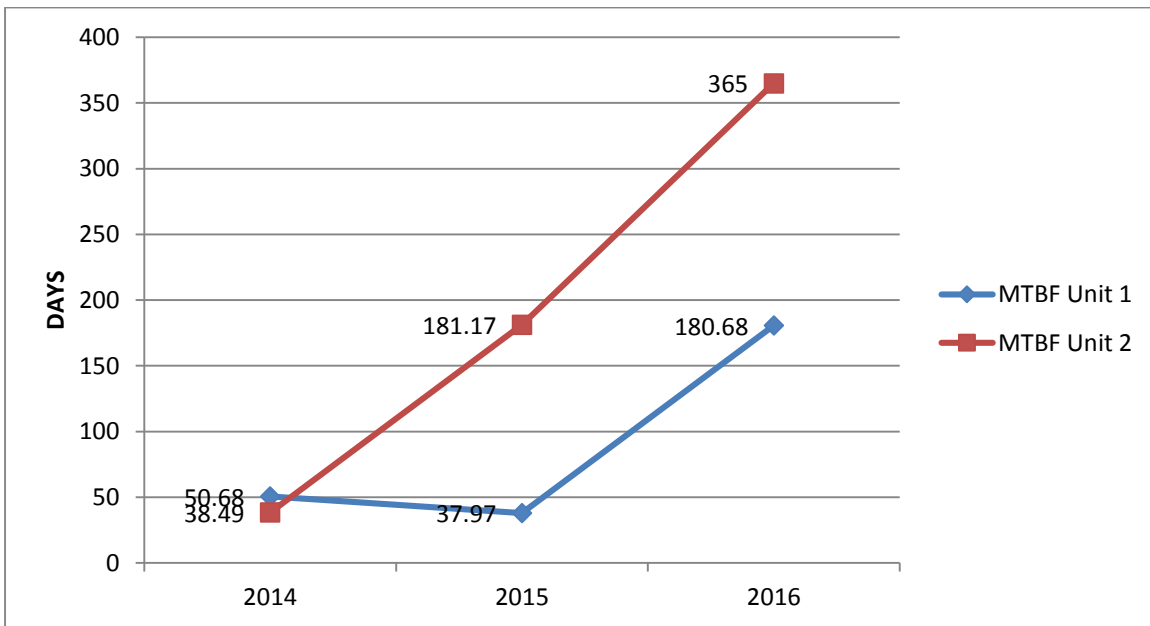
Mean time between failures (days)

MTBF	2014	2015	2016
Unit 1	50.68	37.97	180.68
Unit 2	38.49	181.17	365

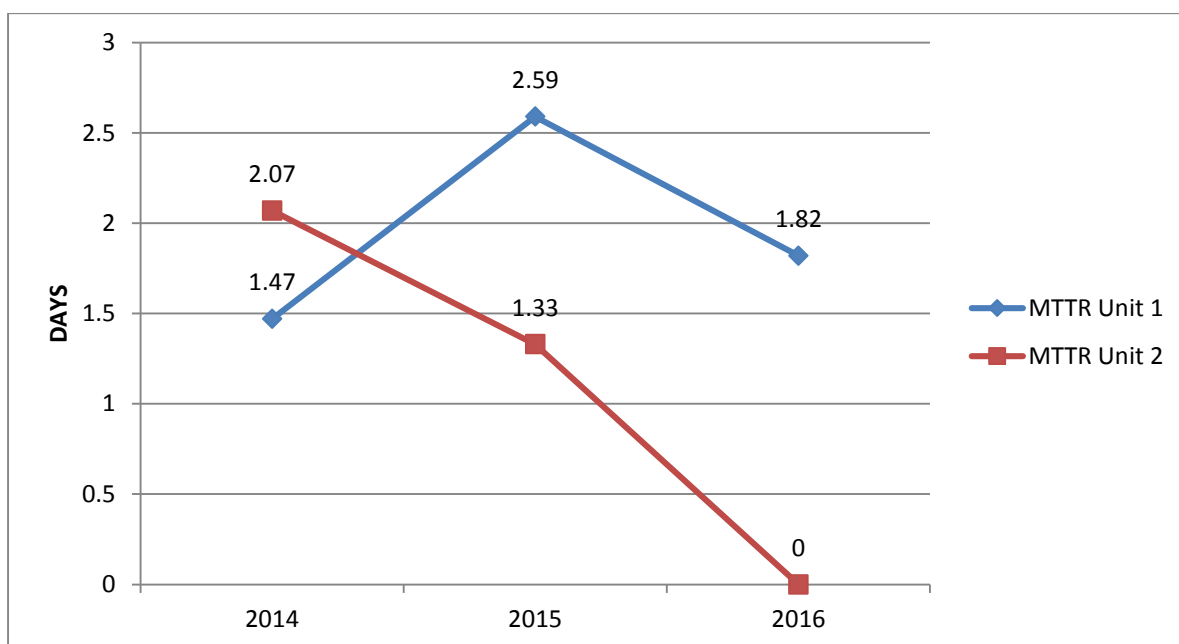
Mean time to repair: (days)

MTTR	2014	2015	2016
Unit 1	1.47	2.59	1.82
Unit 2	2.07	1.33	0
